## MARINE INVESTIGATION REPORT

M09C0029

EXPLOSION

TANKER *ALGOCANADA*

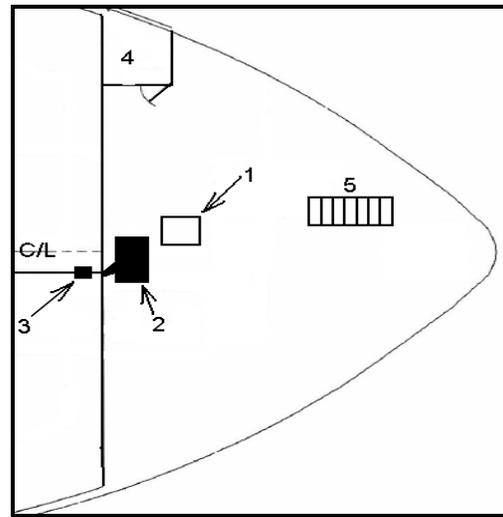
**Figure 1.** Arrangement of tank-drying unit and forecastle

The vessel was initially equipped with an approved tank-drying system<sup>2</sup>, as well as portable water-driven air fans for ventilating. The tank-drying system includes a fan unit located in the forecastle adjacent to the aft bulkhead. This fan unit was connected to piping, which penetrates the bulkhead and was in turn affixed to a double, non-return valve situated in the deck trunk (see Figure 1).<sup>3</sup>

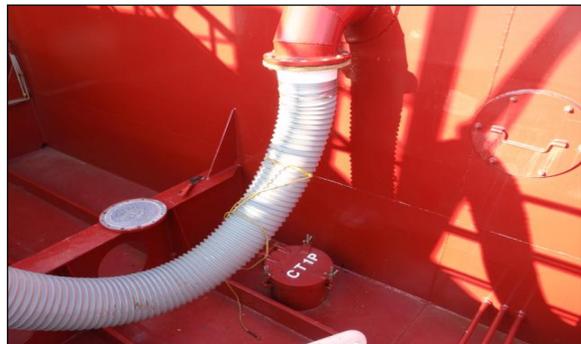
**Photo 2.** Flex hose to the tank-drying system

At about 0930, the GPs removed the tank-drying flange covers and hooked one end of the flexible hoses to the tank-drying system (see Photo 2). At 0944, the other ends of the flexible hoses were inserted through the tank-cleaning hatches close to the bottom of tanks No. 1 port and starboard. The GPs then proceeded aft to assist with the pilot transfer.

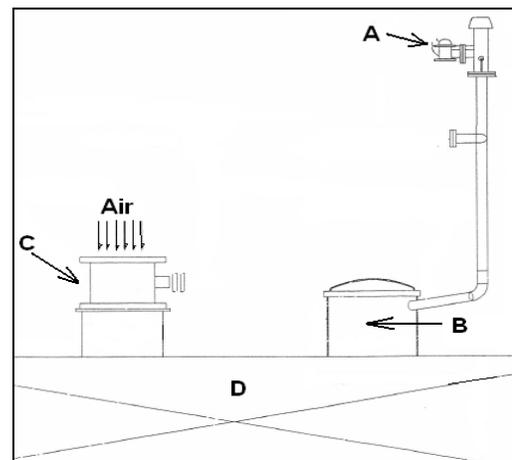
**Figure 2.** Normal venting arrangement

The *AlgoNova* P&A Manual states that tank ventilation is to be performed using portable water-driven air fans placed at the tank-cleaning hatches (see Figure 2). The practice of using the fixed tank-drying system for ventilation had been carried over from another company vessel, the *AlgoScotia*.

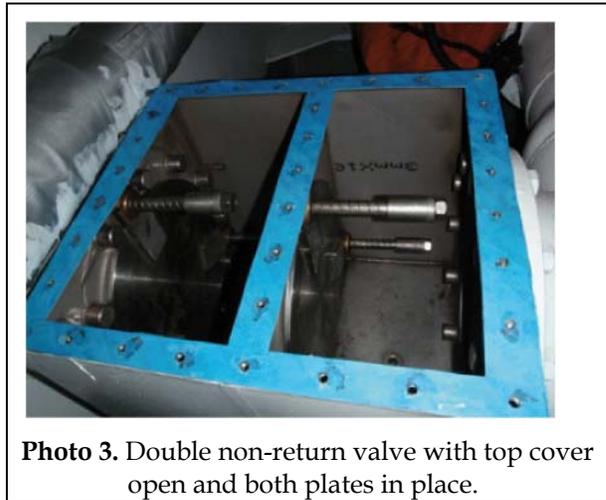
**Photo 3.** Double non-return valve with top cover open and both plates in place.

Prior to this voyage, a modification on the tank-drying system was performed by the vessel's crew in order to speed up venting times.<sup>11</sup> The company was aware of the modification and had provided instructions for the removal of 1 of the 2 baffle plates in order to improve the air flow of the tank-drying system (see Photo 3). However, neither the valve's manufacturer nor the classification society was consulted.

It was the practice on the *AlgoCanada* to use the tank-drying system to vent and gas-free the cargo tanks. However, the air flow of the tank-drying unit was found to be inadequate for this purpose. Modifications to the double non-return valve were subsequently performed, which included the removal of 1 of the 2 valve plates. This improved air flow and shortened ventilation times.

Neither the valve's manufacturer nor the classification society was consulted regarding the valve's modification, which had effectively rendered it a single, non-return valve. Given that the

vapours were subsequently able to migrate into the forecastle and bow thruster compartment, the remaining single valve plate was not an effective seal.

- The *AlgoCanada*'s fixed tank-drying system was switched off and fitted with a lock so that it could not be operated. The master posted a notice indicating that the system was not to be used.
- Blanks were fitted to each of the tank-drying system's outlet covers on both *AlgoCanada* and *AlgoNova*. These blanks are fitted with locks, preventing connection of the cargo tanks to the tank-drying system and forecandle space.
- On the *AlgoCanada* and *AlgoNova*, both double non-return valve plates were reinstalled.

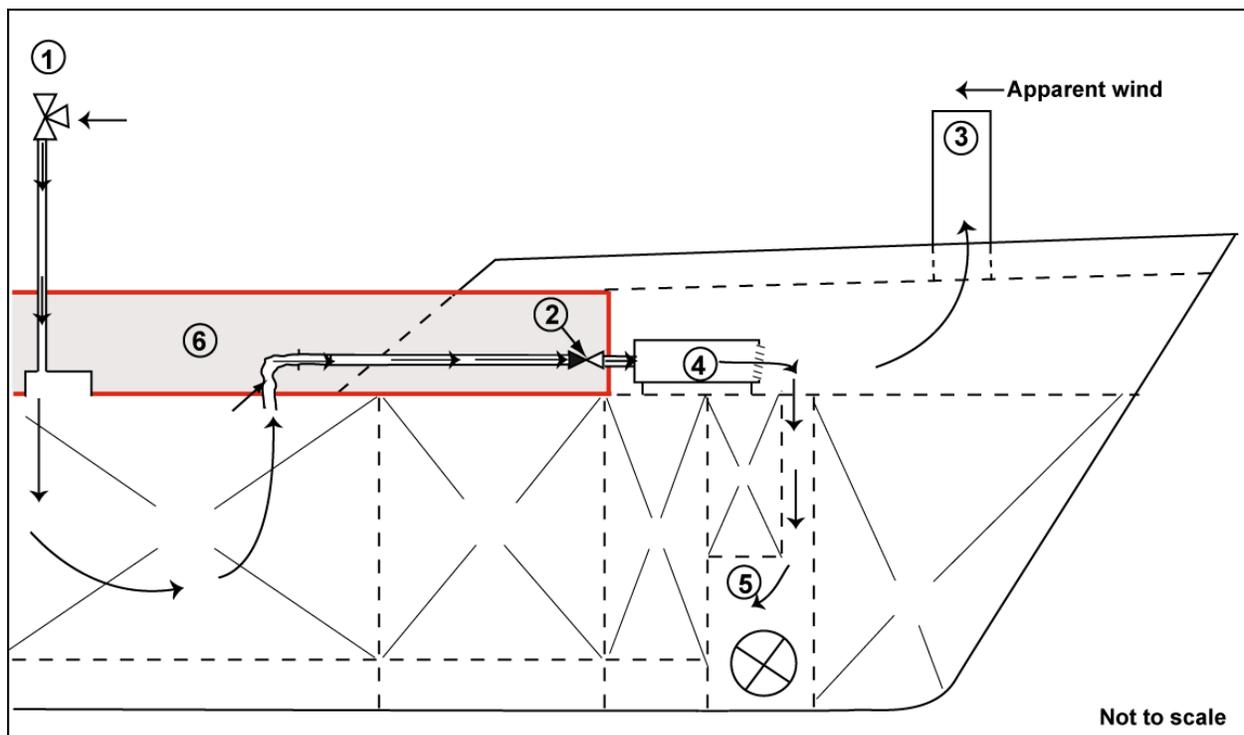
Figure 3. Migration of flammable vapours from cargo tank to bow thruster compartment

In this occurrence, given that the forecastle door was open, the apparent wind across the vessel's bow created an area of lower pressure in the forecastle. This, coupled with the open PV valves, induced a flow of gasoline vapours from the cargo tank into the forecastle through the drying unit and the modified non-return valve. Once the heavier-than-air vapours passed through the tank-drying unit, they settled downward and into the bow thruster compartment (see Figure 3).

This compartment contained a heater unit that was automatically controlled by a thermostat, along with electrical lighting fixtures and a ventilation fan, none of which were explosion-proof. Smoke and burn patterns on the electric heater indicated that it was likely the ignition source.
