**MARINE INVESTIGATION REPORT
M11C0001**

**GROUNDING
MULTIPURPOSE CARGO SHIP *BBC STEINHOEFT*
SOUTH SHORE CANAL OF THE
ST. LAWRENCE SEAWAY,
SAINT-LAMBERT, QUEBEC
31 MARCH 2011**

Report Number M11C0001

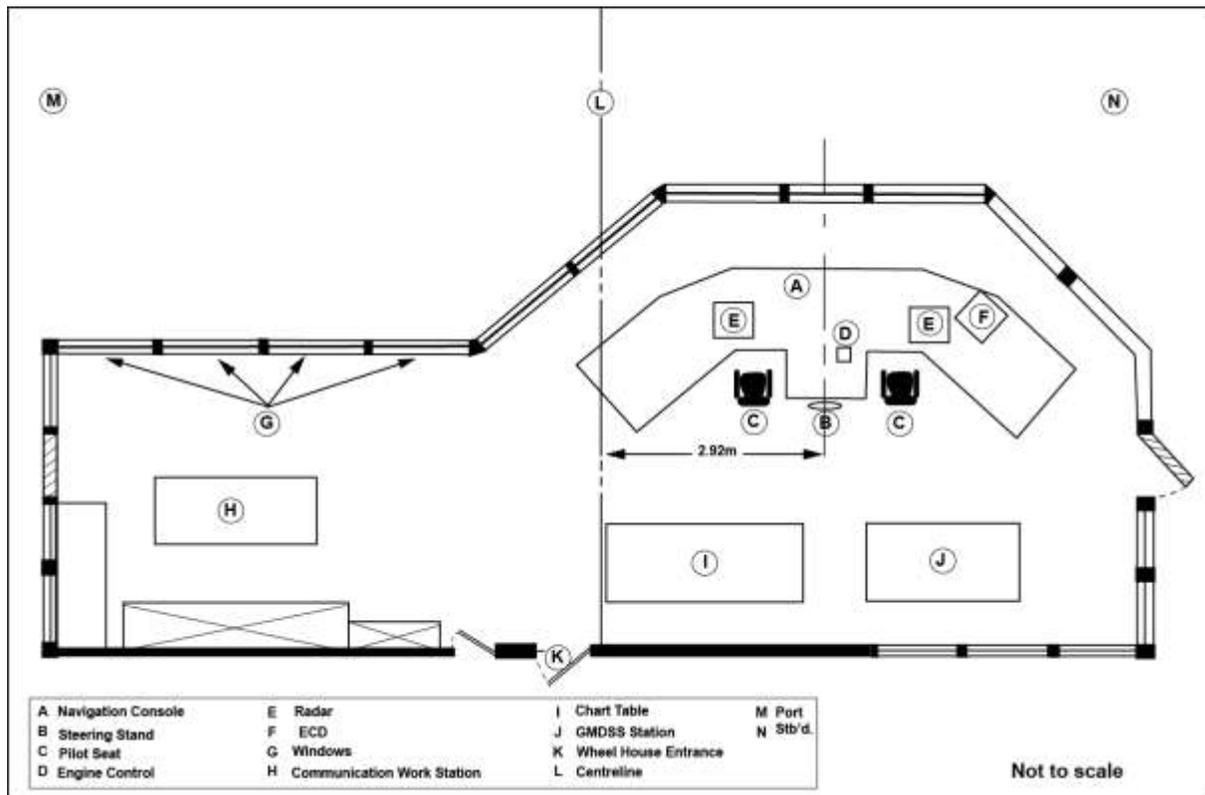
To improve visibility with the fitting of these 2 cranes, the conning position (the helmsman's steering stand) is offset to the starboard side of the centreline of the vessel (Figure 1).

Figure 1. Layout of the bridge on the *BBC Steinhoeft* with pertinent navigational equipment.

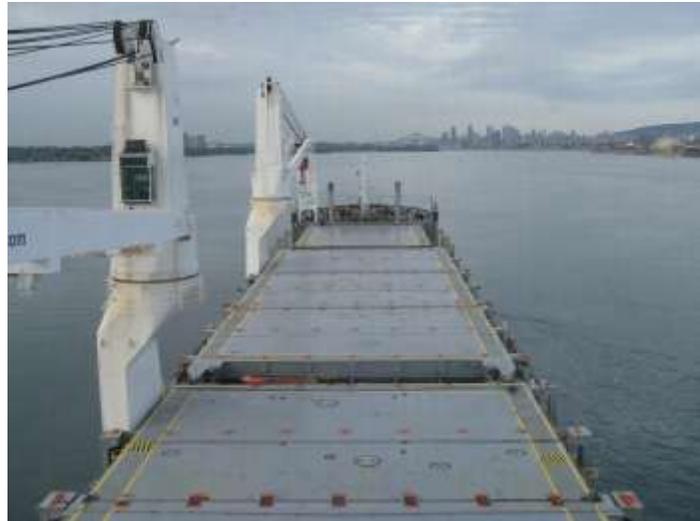
Photos 2, 3, 4 and 5 were taken on board a sister vessel of the *BBC Steinhoeft* and illustrate this concept. Photo 2 shows a view taken from the steering stand position on the bridge.

Photo 2. View from helmsman's position at steering stand.

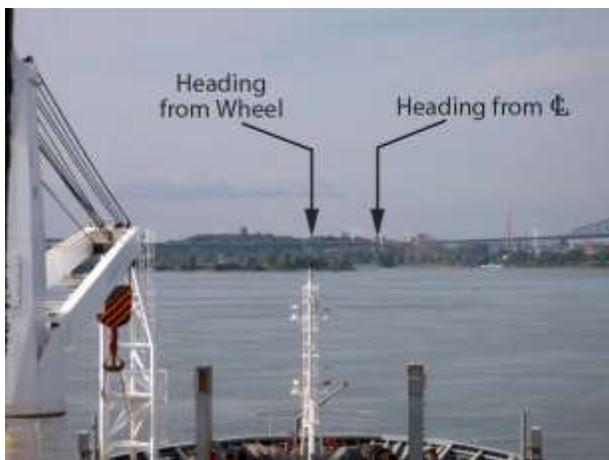
Photo 3 shows a zoomed view taken from the steering stand position on the bridge. When viewing in line with the forward mast from this point, the left-hand arrow indicates the reference point ashore being viewed, whereas the right-hand arrow indicates the reference point ashore as it would be viewed if one stood on the centreline and took a line of sight with the forward mast. Photo 4 is of the same view, but taken when standing on the centreline of the bridge.

Photo 3. Zoomed view from helmsman's position at steering stand.

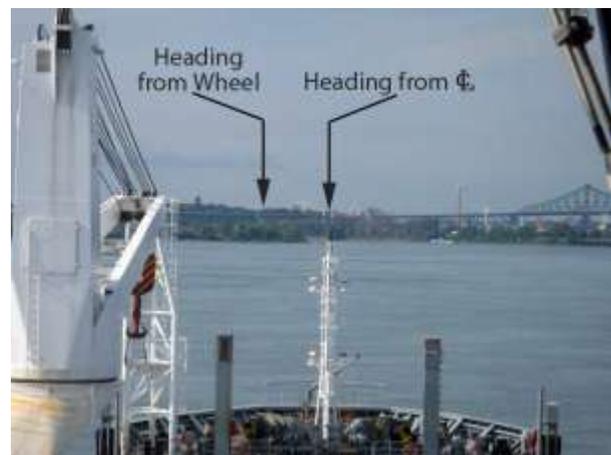
Photo 4. Zoomed view from centreline of vessel.

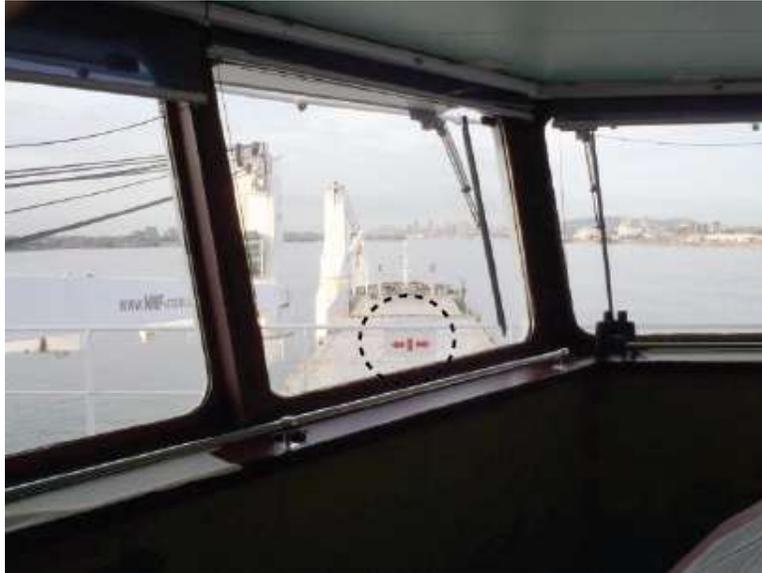
Photo 5 shows how, on the sister vessel to *BBC Steinhoeft*, the centreline of the vessel is marked on a plate in front of the bridge windows to aid the navigating officer in lining up the vessel.

Photo 5. View from centreline of *BBC Steinhoeft* sister vessel showing the centreline marker (within the dashed circle).

There are various means by which vessels with an offset bridge configuration can indicate the appropriate line of sight to prevent parallax errors. These means include physically marking the centreline of the vessel on the bridge, and/or installing a marker at the bow of the vessel that would be positioned with the same offset as the steering stand on the bridge and would assist the helmsman to steer on a parallel line of sight with the centreline. On the *BBC Steinhoeft*, there were no such physical indications. In the absence of such measures, the risk of navigational errors due to parallax increases.

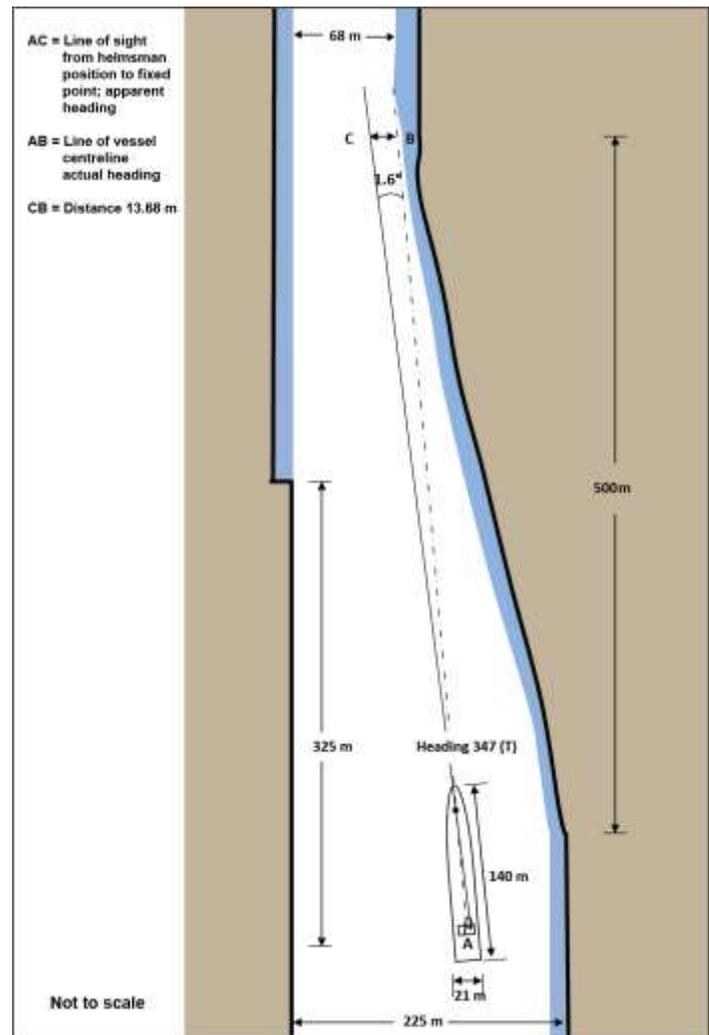
On the *BBC Steinhoeft*, the steering stand was 2.92 m to starboard of the centreline of the vessel. This resulted in a parallax error of approximately 1.6° to starboard if the line of sight is taken from the steering stand (Appendix E). Pilot No. 1 was aware that the steering stand was offset from the centreline, but had estimated the potential error to be about 0.5° .

The helmsman's position at the wheel was offset to starboard of the centreline and he was using the forward mast as a reference to point the vessel. As a result, there was a parallax error of about 1.6° to starboard of the Pilot No. 1's intended track. For this reason, the vessel followed a path that brought it closer than desired to the south bank of the channel, despite a subsequent correction to line up the vessel with the north pillar.

Figure 2. Parallax error on the *BBC Steinhoeft*

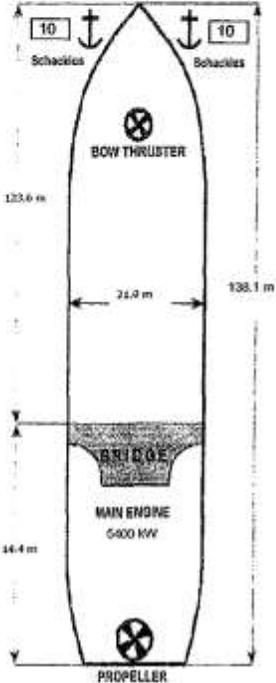
Appendix C – Pilot Card

The pilot card on board the *BBC Steinhoeft* did not provide any specific information about the offset steering stand position and the accompanying potential for parallax error (Appendix C), nor did the master-pilot exchange. As demonstrated by this occurrence, the absence of this type

The Pilot Card also did not contain information that the vessel was equipped with an articulated flap type of rudder. The rudder arrangement type is one of the essential vessel particulars that need to be known to safely conduct a vessel.

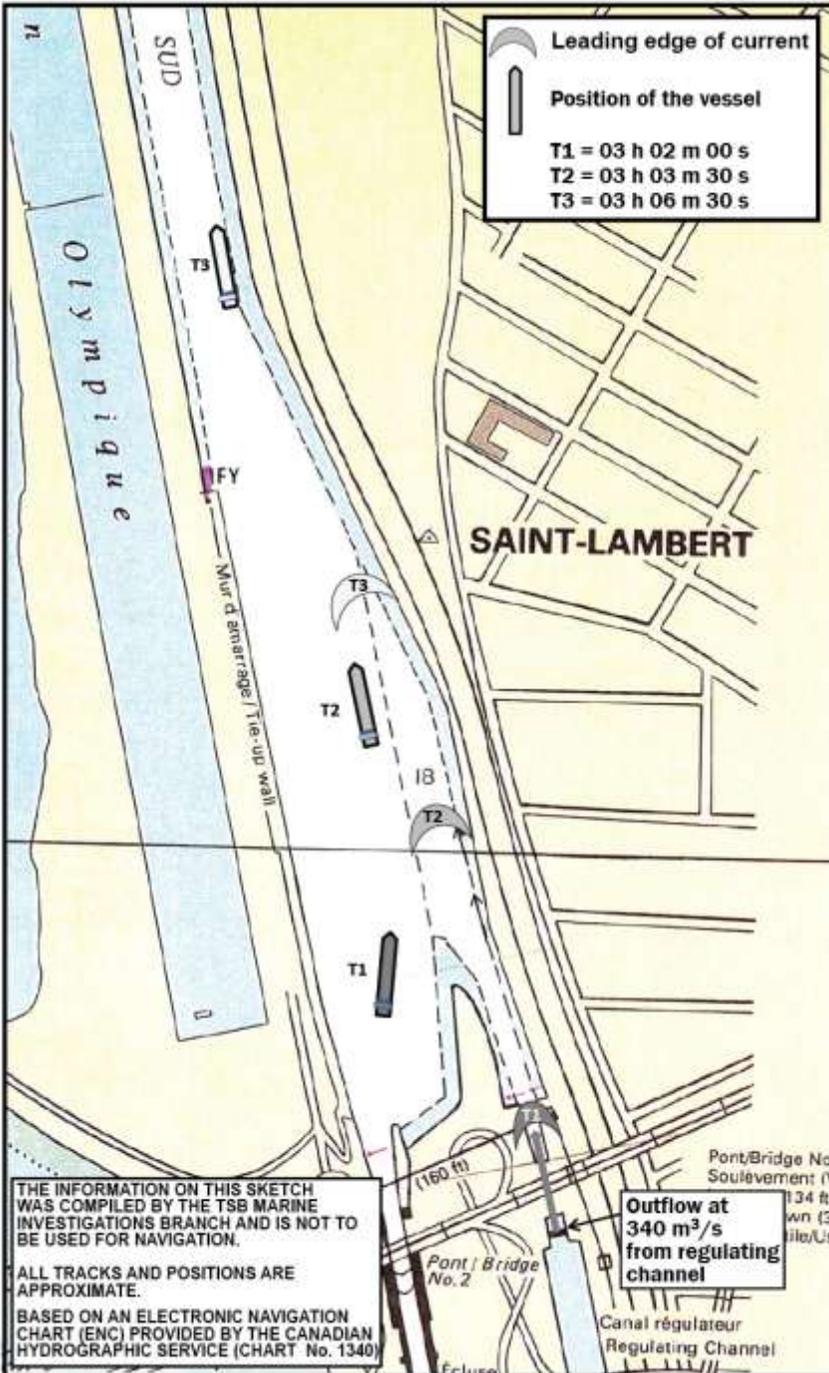
Appendix F – Vessel Position Relative to Leading Edge of Current

The schematic in Appendix F shows the positions of the vessel and the corresponding position of the leading edge of the current, starting just after the time at which the outflow increased to

340 m³/sec (T1).¹⁷ When the vessel experienced the bank effect (T3 in Appendix F), the flow had reached only a point past the mid-wall and could not have any effect on the vessel. Ice flushing operations were not being carried out at the time of the occurrence and thus had no influence on the current. As the vessel approached the entrance to the narrower part of the channel, it began to experience a bow cushion effect; the helmsman responded by applying starboard helm to keep the vessel on course. Once the vessel became parallel with the bank, it experienced the full bank suction effect and started its sheer to port. All attempts to counteract the sheer¹⁸ were ineffective in the short time and limited space available, and the vessel ran aground, blocking the channel.
