**MARINE INVESTIGATION REPORT  
M13N0001**

**LOSS OF TOW**

**TUG *CHARLENE HUNT* WITH  
PASSENGER VESSEL *LYUBOV ORLOVA*  
OFF CAPE RACE, NEWFOUNDLAND AND LABRADOR  
24 JANUARY 2013**

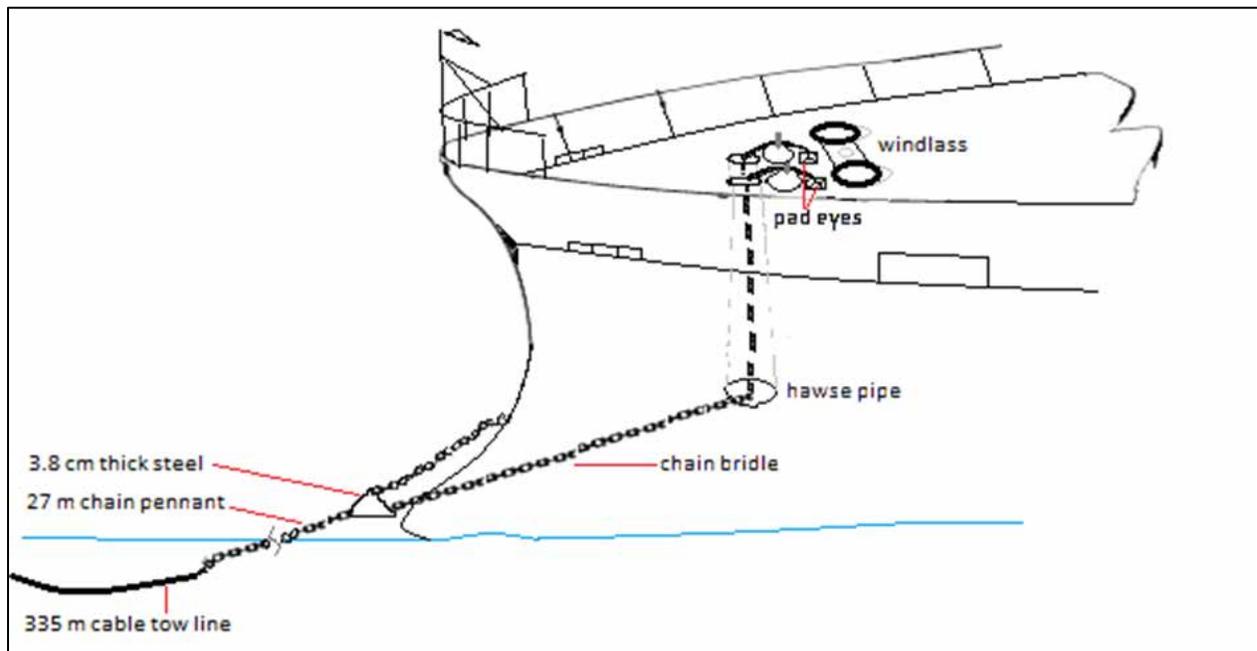
Figure 1. Diagram of the towing arrangement on the *Lyubov Orlova*

The towing arrangement in this occurrence had been constructed mostly using materials salvaged from the *Lyubov Orlova*. The crew selected pieces of used anchor chain with the least wear to construct 2 towing bridles, each long enough to clear the vessel's bulbous bow (Figure 1).

The end of each bridle connected to the forward deck of the *Lyubov Orlova* via shackles and pad eyes that were welded to the deck between the windlass and the hawse pipes.<sup>26</sup> From each pad

eye, the bridles passed through an arrangement that secured them on the guide roller and then down corresponding hawse pipes. The used anchor chain failed at the point where the bridles passed through the guillotine/chain stopper<sup>27</sup> securing them on the guide roller located on the foredeck of the *Lyubov Orlova*. From the bottom of each hawse pipe, the bridles extended to a 3.8 cm-thick triangular steel plate. Another 27 m piece of salvaged anchor chain shackled to the steel plate served as a pennant. New shackles, each with a 45-ton safe working load, connected all of the towing arrangement components.

After leaving the protective lee of the Newfoundland shore and rounding Cape Race, the tug and tow encountered heavy seas. The *Charlene Hunt* had no additional tow line to pay out to soften the shock load and reduce the strain of the towing arrangement. This strain likely created chafing of a chain link on the guillotine/chain stopper. In addition, the available shock line had not been installed. Subjected to increased forces caused by the combined 40 knots winds, 5-6 m seas, and the course change to starboard into the wind, the chain link eventually failed at the guillotine/chain stopper.

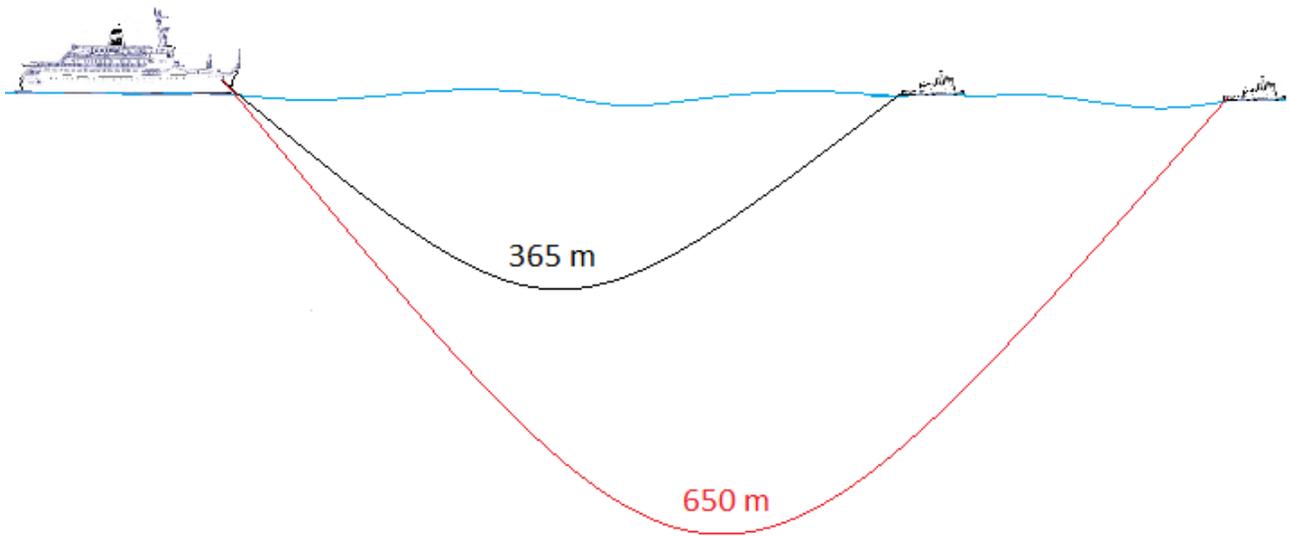
### *Appendix C – Catenary between tug and tow*

The towing winch drum on board the *Charlene Hunt* was capable of holding 365 m of 3.8 cm cable. As such, the available tow line length on the tug was approximately half the length recommended by GL Noble Denton and less than the IMO minimum guideline. The relief master had ordered a new shock line,<sup>29</sup> but the crew encountered problems attaching it between the tow line and the triangular steel plate. As a result, it did not become a working part of the towing arrangement.

In this occurrence, the relief master did not have additional tow line to pay out when the sea conditions increased and was therefore unable to generate the additional catenary necessary to soften the shock load acting on the towing arrangement (Appendix C). Furthermore, although the relief master had identified the need for a shock line and ordered one prior to departure, the crew had difficulties attaching it and the tug and tow left without the shock line becoming a working part of the towing arrangement.

This diagram illustrates how the catenary changes as the length of the tow line increases. A tow line of 650 m absorbs more peak shock loads than a tow line of 365 m.
