MARINE INVESTIGATION REPORT M15A0348

Person overboard and subsequent loss of life

Small fishing vessel *Cock-a-Wit Lady*
23 nautical miles SSW of
Clark's Harbour, Nova Scotia
30 November 2015

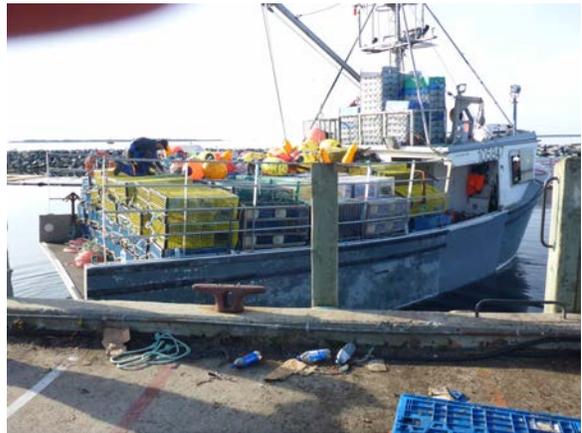
The vessel has an open stern to facilitate the setting of lobster traps (Photo 2). A permanent aluminum rail is fitted on the starboard side. A temporary rail of equal scantlings¹ is fitted on the port side and is used only at the beginning and end of the lobster season, to provide stability for the traps on deck. A cargo boom with a small winch is mounted on top of the wheelhouse. There is a trap hauler on the starboard side with a block located above it that can be raised or lowered into position for use. The vessel is used primarily for fishing lobster and longlining.

Photo 2. The *Cock-a-Wit Lady* in a partially loaded condition

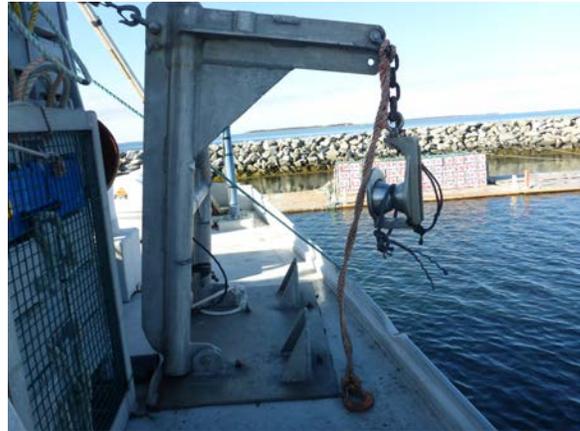
While they were under way, the crew lowered the overhead block that is mounted on top of the wheelhouse and above the trap hauler (Photo 3). They began hauling from this end and, after retrieving 3 traps, they brought up the deckhand who had fallen overboard. At approximately 0905, after being underwater for approximately 10 minutes, the deckhand was recovered and brought on board. As no pulse was detected, cardio-pulmonary resuscitation was administered immediately.

Photo 3. Overhead block in raised position

As the *Cock-a-Wit Lady* was intending only to set traps on the day of the occurrence, the overhead block was not lowered into the horizontal position; it was lowered only when it was intended to be used for hauling traps. Performing regular emergency drills would provide an opportunity for crew members to identify shortcomings in the retrieval of a person overboard, such as the fact that, in the vertical or raised position, the overhead block was not available for immediate use to haul a person overboard and that, when lowered, the block allowed for the most efficient angle for hauling the heavy traps and the weight of the person in the water.
