## MARINE INVESTIGATION REPORT M16A0327

### **Sinking and subsequent loss of life**

Small open fishing vessel *Pop's Pride*

06 September 2016

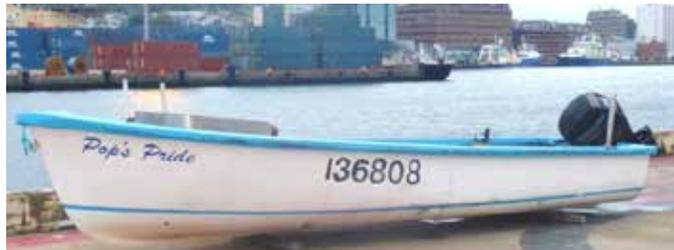
Figure 1. The *Pop's Pride*

The *Pop's Pride* (Figure 1) is a small fishing vessel constructed of moulded, glass-reinforced plastic. It is propelled by a single 60 hp outboard motor aft. The vessel is used to fish multiple species, including cod and lobster.

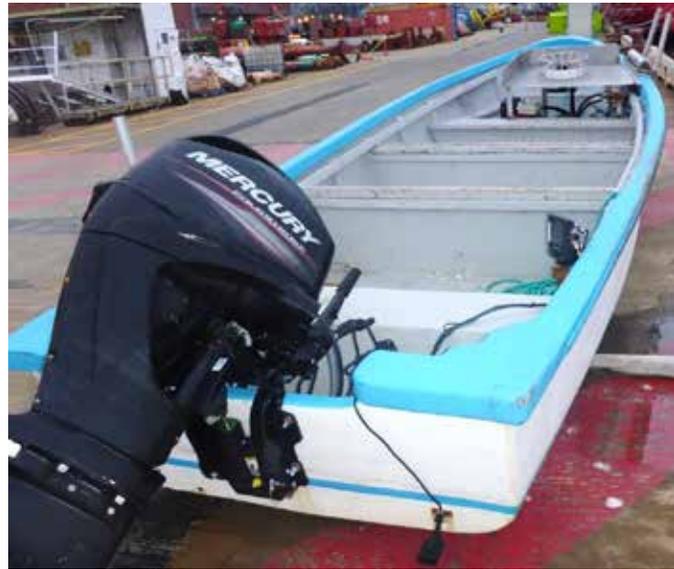
Figure 2. Interior of the *Pop's Pride*

The hull of the vessel is of open construction, with a small enclosed compartment forward and 4 transverse bulkheads dividing the vessel into 5 sections (Figure 2). The forward section contains an aluminum table and hydraulic net hauler powered by a gas engine, which is mounted below the table. An aluminum roller and 2 uprights are mounted on the starboard gunwale outboard of the net hauler. The aft section immediately forward of the transom is narrow and, at the time of the occurrence, likely contained portable gas cans and a battery for the outboard engine. The 3 middle sections are empty and were used for stowing nets and catch as well as for a workspace for the crew.

The forward and aft bulkheads are fitted with 2 semi-circular openings (9 cm in diameter) at deck level, and the 2 middle bulkheads are fitted with 4 circular openings (5 cm in diameter) to allow water to flow aft toward the vessel's transom. The transom is fitted with a drain hole, 2.5 cm in diameter, with a removable plug (Appendix A).

The drain hole is 35 cm to port of the vessel's centreline, and is just above the vessel's inner bottom but below the waterline. To drain any water that has accumulated on board, the crew would normally accelerate the vessel until it was planing. The forward motion of the vessel and raising of the bow when planing forces the water on board to flow aft, toward the vessel's transom. When the drain hole plug is removed, the water accumulated at the stern then drains out of the drain hole until the plug is reinserted.

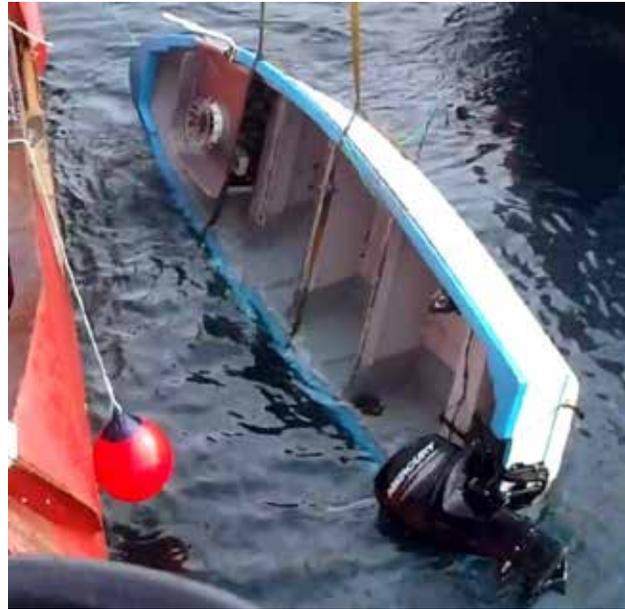
Figure 3. Recovery of the *Pop's Pride* (Source: Canadian Coast Guard)

Inspection of the vessel after its recovery determined that there was no damage to the vessel's hull. The drain hole plug was in the transom drain hole. The forward storage compartment cover was missing and the compartment was empty. The metal gas tank on the gas engine that powered the hydraulic net hauler was crushed, presumably from water pressure when the vessel was submerged in 75 m of water. A large portion of the outboard engine's skeg was missing from a previous incident unrelated to the occurrence. The top of the engine cowl was cracked; however, it could not be determined if this damage was pre-existing or a result of contact with the bottom after the vessel was submerged. The outboard motor was in the fully up and stowed position, and the 12-volt battery was connected by only 1 lead.
