Marine Transportation Safety Investigation Report M17P0406

COLLISION

Dredger *FRPD 309*
Fraser River, British Columbia
05 December 2017

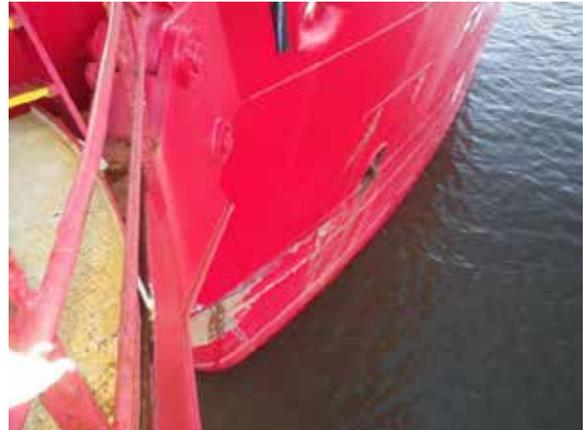
As a result of the collision, the *FRPD 309* sustained damage to the shell plating (Figure 2) and forepeak tank forward of the collision bulkhead (Figure 3). Additionally, the port anchor was disconnected from its housing and became wedged in the *Evco 60*'s hull. The *Evco 60* also sustained structural damage due to the impact of the collision (Figure 4).

Figure 2. Damage to the hull of the *FRPD 309*

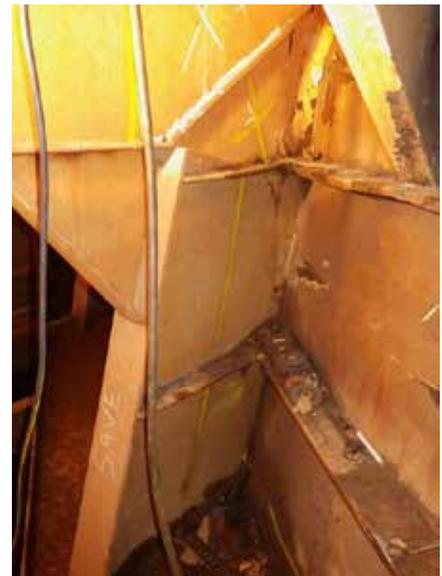
Figure 3. Damage to the forepeak tank

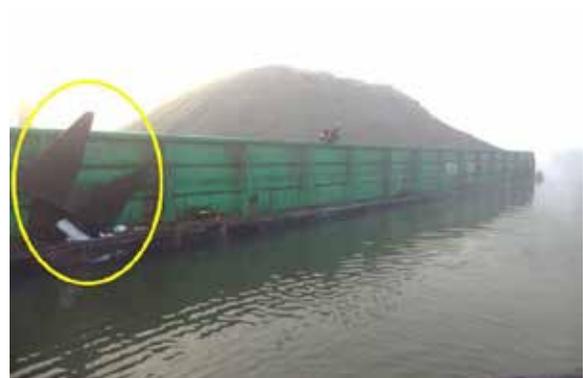
Figure 4. Port anchor of the *FRPD 309* (circled in yellow) wedged in the hull of the barge *Evco 60*
