# MARINE INVESTIGATION REPORT

## M17A0039

### **Catastrophic failure of machinery**

Fishing vessel *Atlantic Destiny*  
Halifax, Nova Scotia, 200 nm SW  
14 March 2017

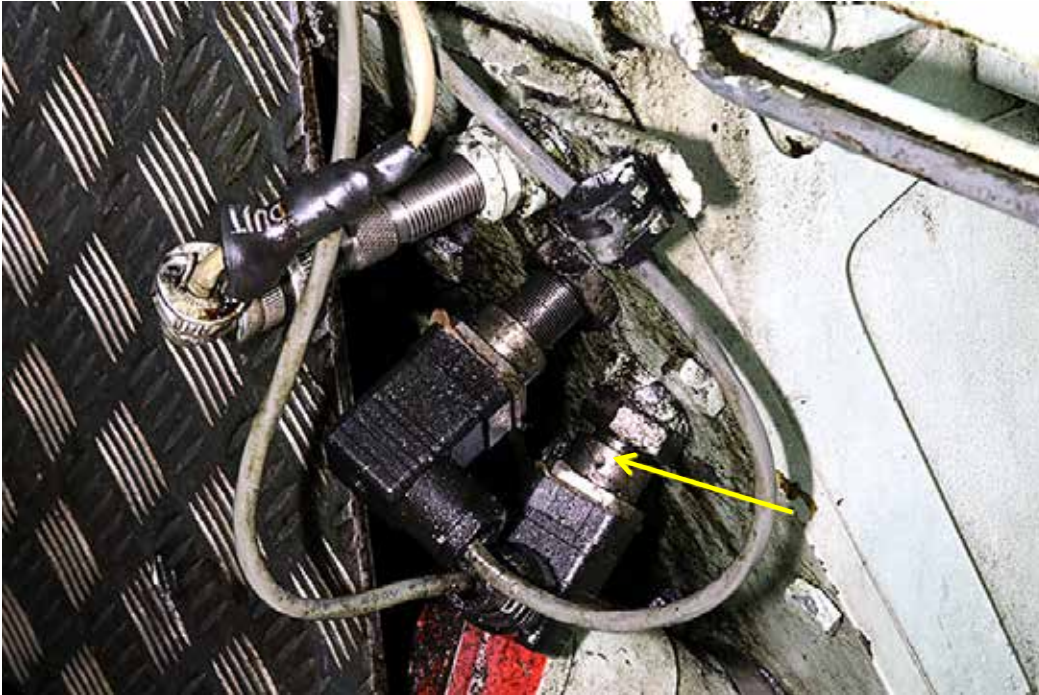
*Appendix D – Speed sensor arrangement*

A post-occurrence examination of the vessel determined that the main engine's electronic governor and overspeed protection were compromised by speed sensors that were either installed incorrectly or functioning intermittently due to electrical shorting. The governor speed sensor was intermittently electrically shorted at the connector and installed with excess clearance. The 15% overspeed sensor was installed with excessive clearance and was 90° off of its proper orientation. The 22% overspeed sensor was electrically shorted, installed with excessive clearance, and was 30° off of its proper orientation (Appendix D); it likely shorted due to cracked wire insulation and broken strands of wiring.

The investigation determined that the governor speed sensor had deteriorated over time and would intermittently electrically short; it could not transmit a continuous signal to the governor, causing unexpected engine shutdowns. Because the crew was not aware of this electrical short, the unexpected engine shutdowns persisted.

Close-up of governor and overspeed sensors. The yellow arrow shows the orientation of the 22% overspeed sensor index hole.

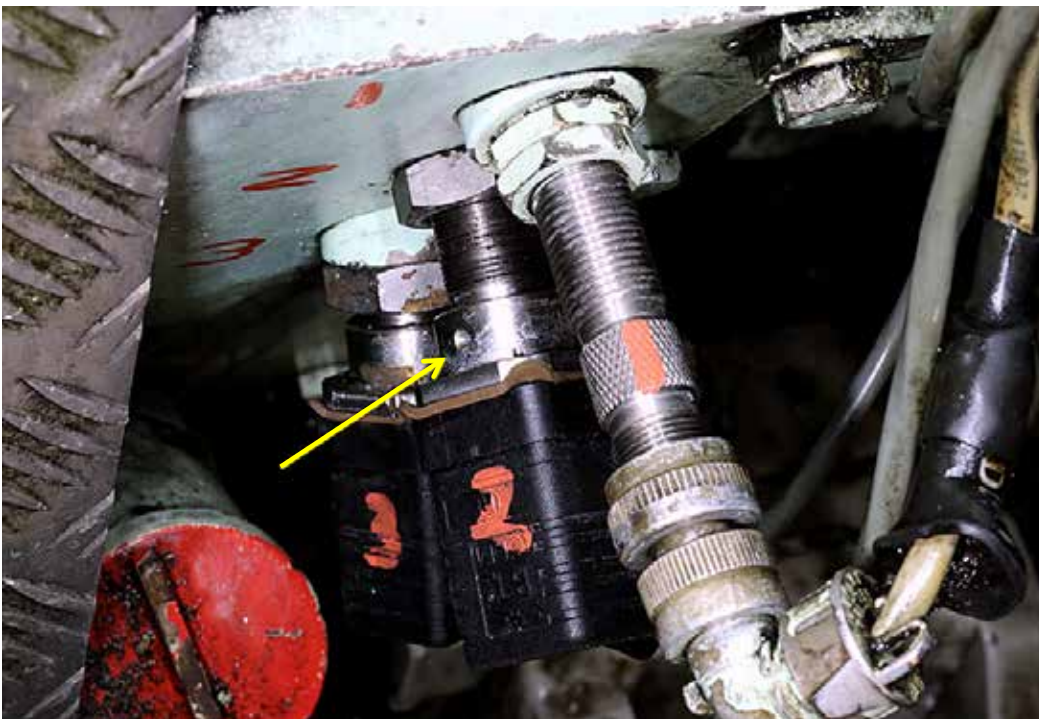
Close-up of governor (1), and 15% (2) and 22% (3) overspeed sensors. The yellow arrow shows the orientation of the 15% overspeed sensor index hole.
