MARINE INVESTIGATION REPORT

M17C0060

Mooring accident

Bulk carrier *Nord Quebec*
Trois-Rivières, Quebec
22 May 2017

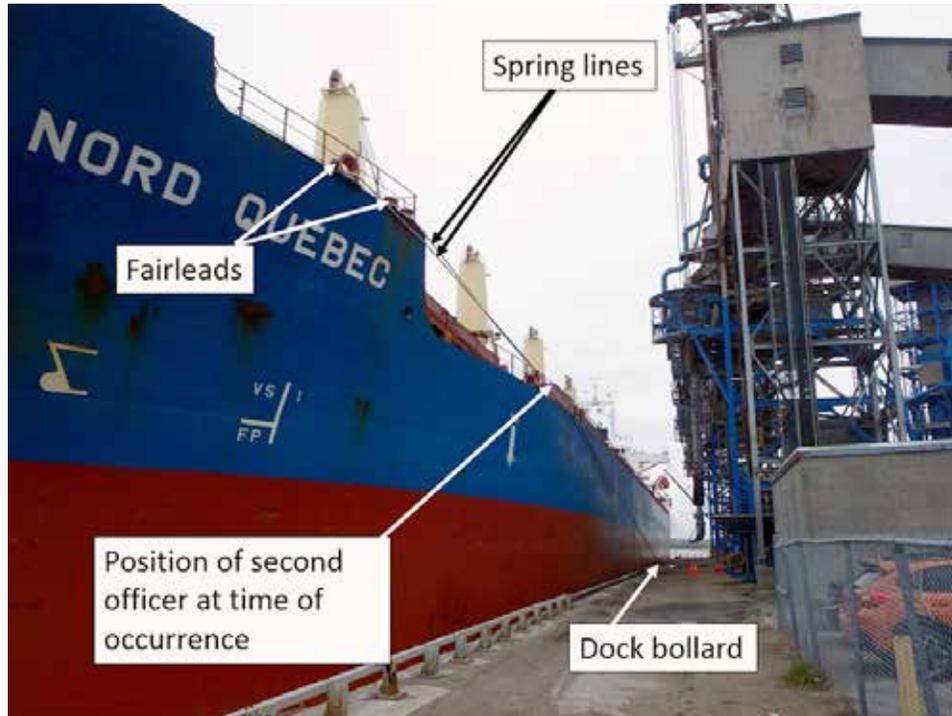
lines were winched by the vessel's port mooring unit, on the inner and outer drums, and were passed through different fairleads on the port bow (Figures 2, 3, and 4).

Figure 2. *Nord Quebec* alongside section 16 of Port of Trois-Rivières, Quebec, showing mooring configuration and location of bollard, fairleads, and forward spring lines following occurrence

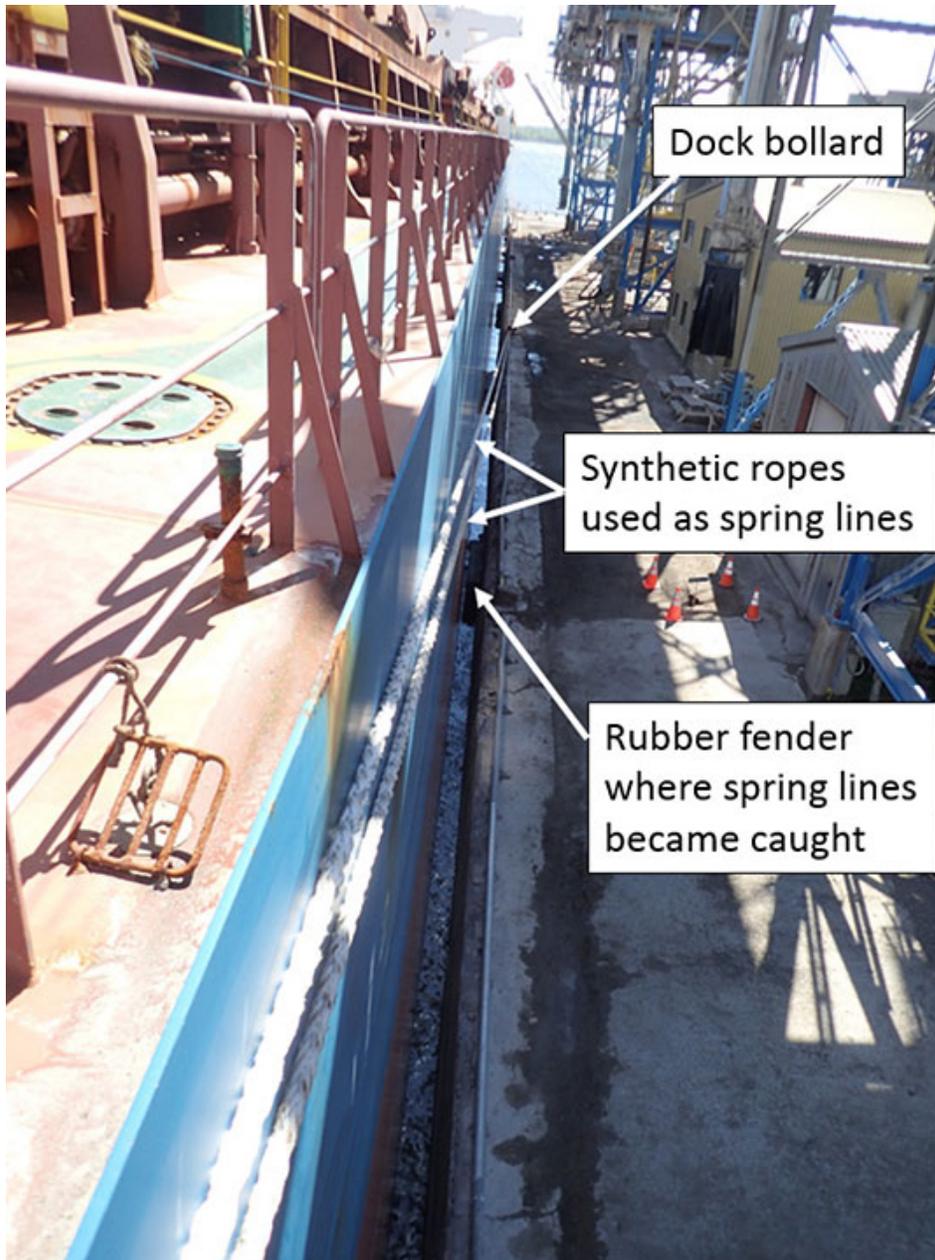
Figure 3. *Nord Quebec* alongside section 16 of Port of Trois-Rivières, Quebec, showing mooring configuration and location of bollard, fender, and forward spring lines following occurrence

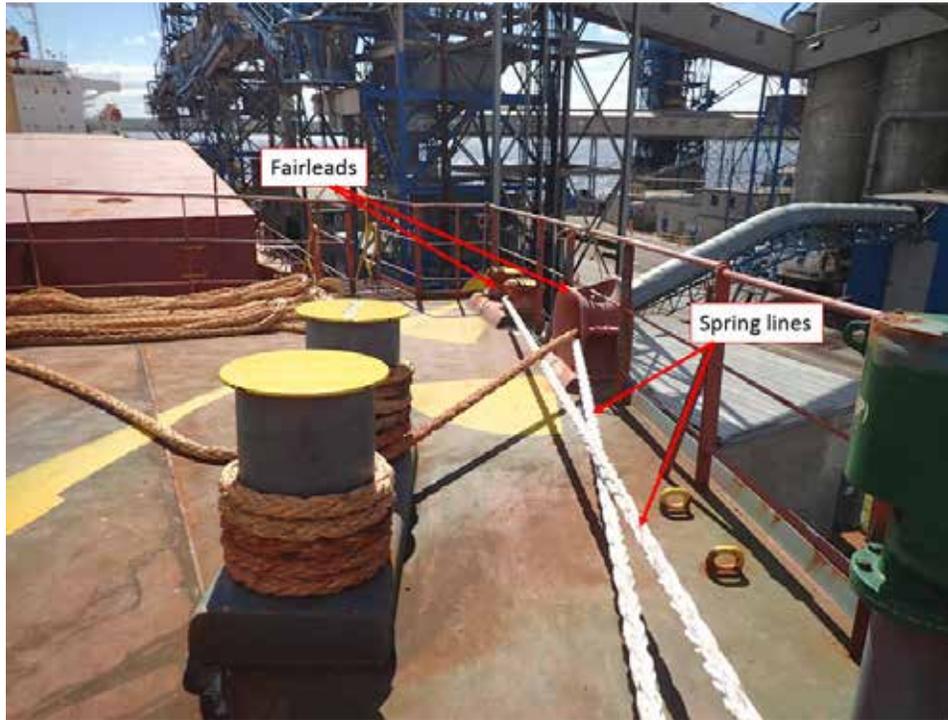
Figure 4. *Nord Quebec* alongside section 16 of Port of Trois-Rivières, Quebec, showing mooring configuration on forecastle deck and location of fairleads and forward spring lines following occurrence

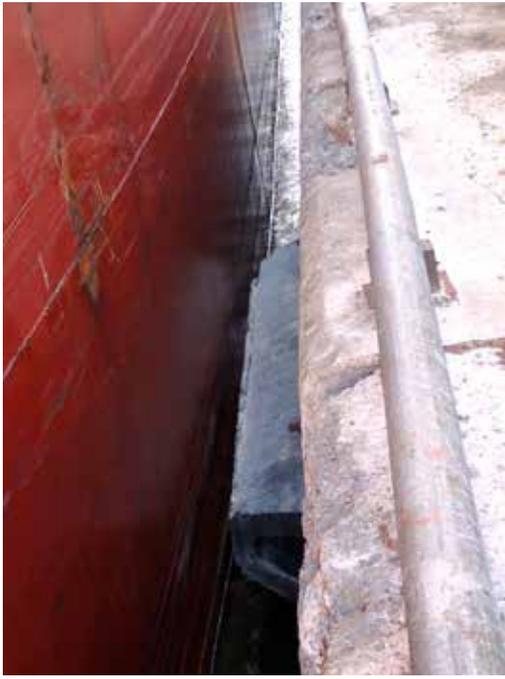
Figures 5, 6, and 7 offer a close view of the dock's rubber fender, and a depiction of the spring lines caught under the fender. Figures 6 and 7 are still images from an animation that the TSB created to demonstrate the events of this occurrence, and are for illustrative purposes only.⁴

Figure 5. Close-up of dock rubber fender

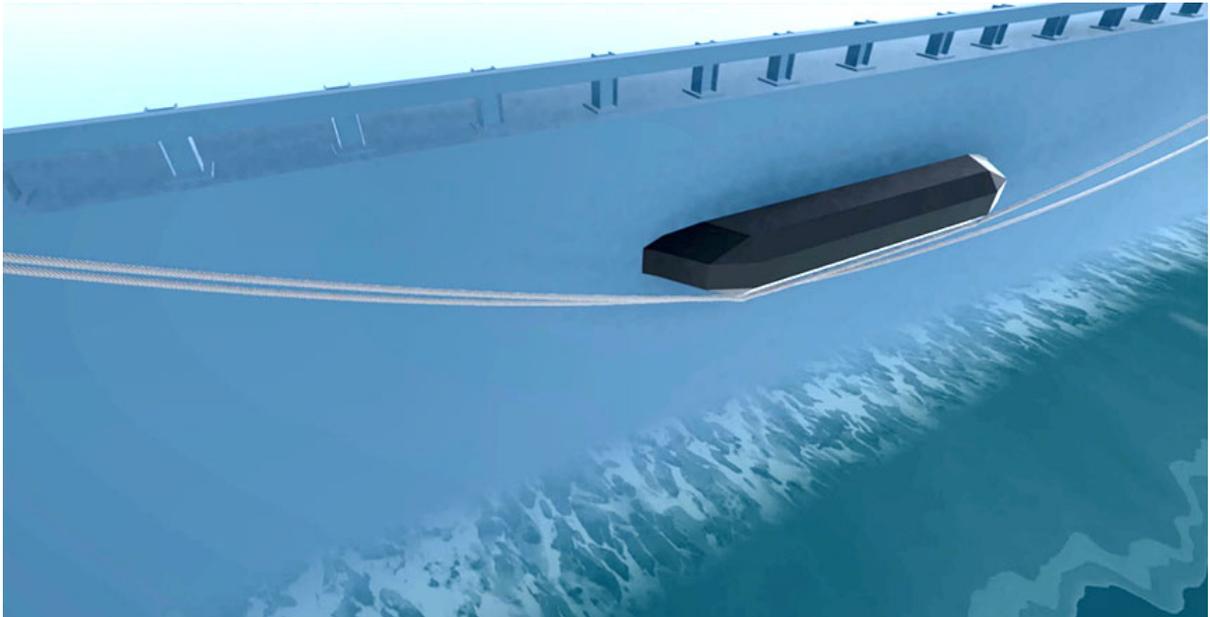
Figure 6. Illustration of spring lines caught under fender

The plan for mooring the vessel was not uncommon and followed standard seamanship practices: the 2 spring lines were the first lines sent ashore but were initially kept loose, because the vessel was making way at a low speed toward the required position relative to the dock's cargo loading gear. When the pilot determined that the vessel was in position, its residual forward motion had to be stopped. While the 2 tugs maintained the vessel alongside the dock, the spring lines were tensioned to stop the vessel. There was no room between the vessel's hull and the dock fenders for the spring lines to straighten between the vessel's fairleads and the dock's bollard. Consequently, the 2 spring lines became caught under one of the dock's rubber fenders.

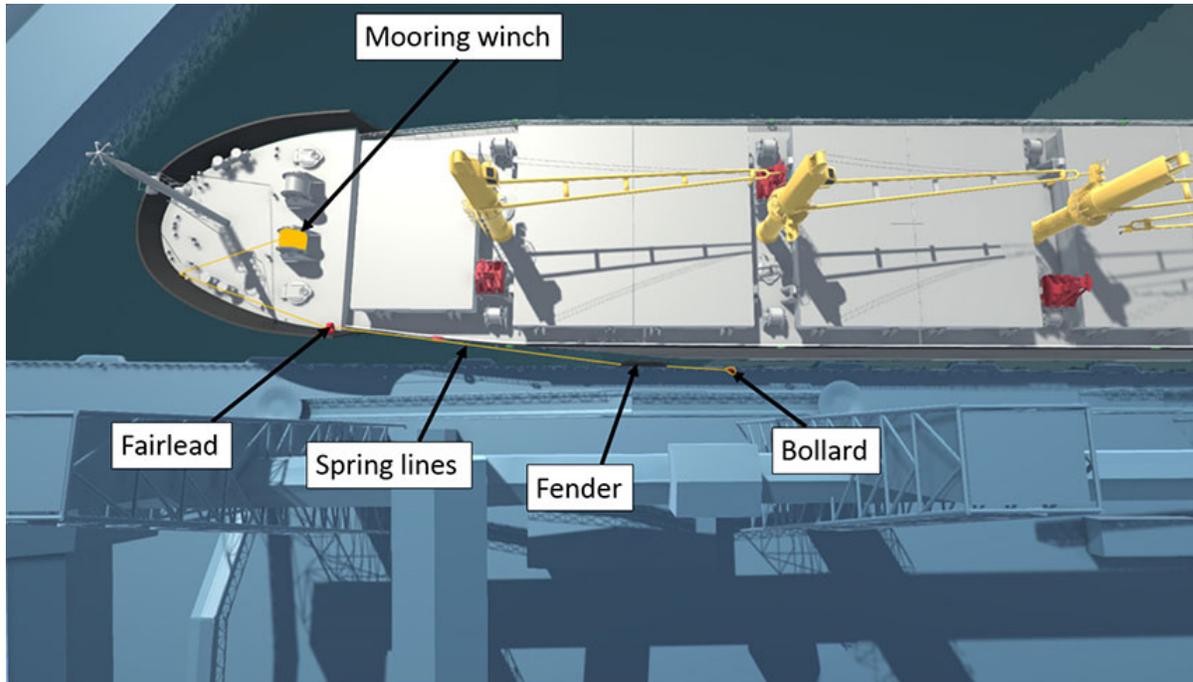
Figure 7. Illustration of spring line layout and spring lines caught under fender

As the vessel's hull moved away from the rubber fender and the spring lines were freed, the energy stored in their synthetic fibers caused them to snap upward in a slingshot motion along the *Nord Quebec's* side shell plating. The first spring line went above the main deck handrail, fatally injuring the second officer.
