## MARINE INVESTIGATION REPORT M17P0052

### **Capsizing and sinking with loss of life**

Fishing vessel *Miss Cory*

06 March 2017

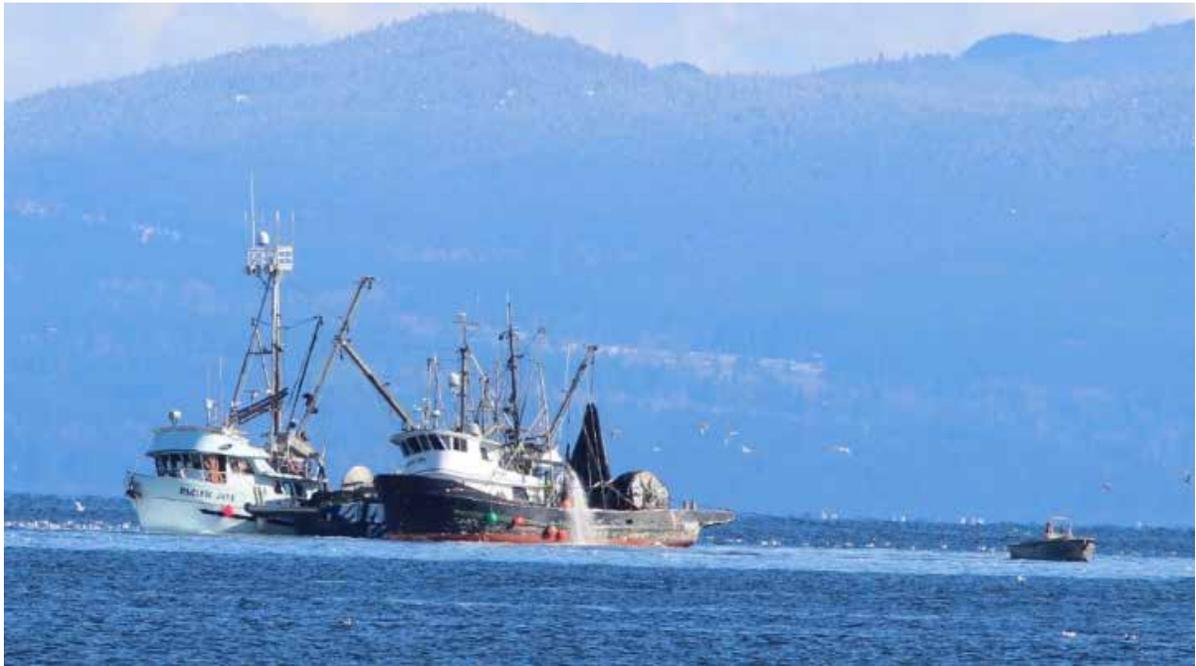
Figure 2. The *Miss Cory* (right) and the *Pacific Joye* (left), with the *Proud Venture* between them. The *Miss Cory*'s power skiff is shown at the far right. (Source: Fisheries and Oceans Canada)

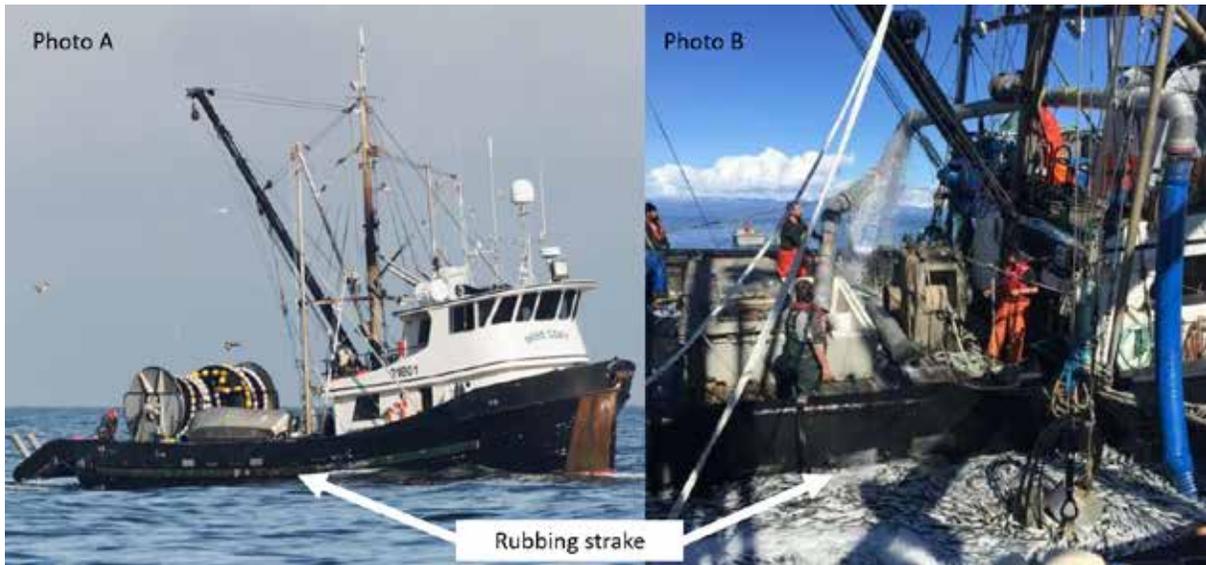
Figure 3. The rubbing strake on the *Miss Cory*, shown above the surface of the water while the vessel is voyaging (Photo A) and submerged while the vessel lists during operations (Photo B)

A delay in the availability of a packing vessel resulted in a large set of fish being tightly pursed in the seine along the *Miss Cory's* starboard side for several hours. Unable to swim freely, many of the fish died, and as they sank and settled to the bottom of the pursed seine, their weight increased the load on the net. The load transferred to the starboard side of the *Miss Cory* and to the top of the boom, raising the vessel's centre of gravity and causing the vessel to increasingly list to starboard. This, together with a reduced freeboard caused by loading the forward holds, resulted in the vessel listing to the point where the rubbing strake was submerged in water.

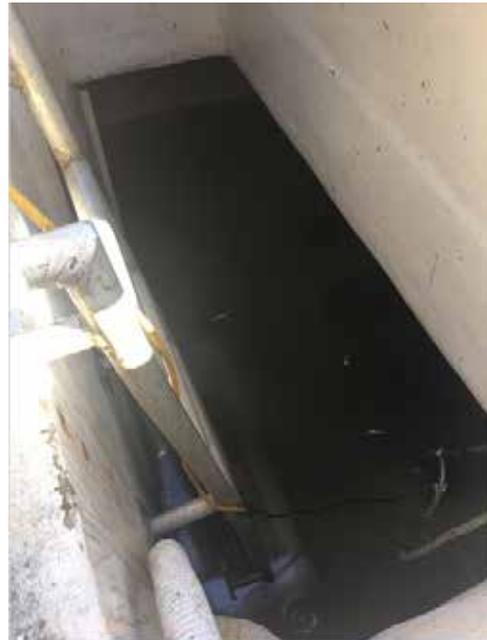
At approximately 1530, while fish were being pumped into the *Proud Venture*, the *Miss Cory* listed further to starboard. While monitoring the vessel's compartments, the crew of the *Miss Cory* detected water in the engine room and in the aft hold. The crew noted that the water level was rising rapidly and that the aft hold appeared to be approximately 50% to 75% full (Figure 4).

Figure 4. Water in *Miss Cory*'s aft hold

Approximately 15 minutes before the *Miss Cory* capsized and sank, a progressive downflooding situation was identified. Assisted by the *Miss Cory's* deckhand and the *Proud Venture's* mate, the master of the *Miss Cory* immediately addressed the unsafe situation on board and attempted to reduce the risk of progressive downflooding by pumping water out of the aft hold using the fish pump.

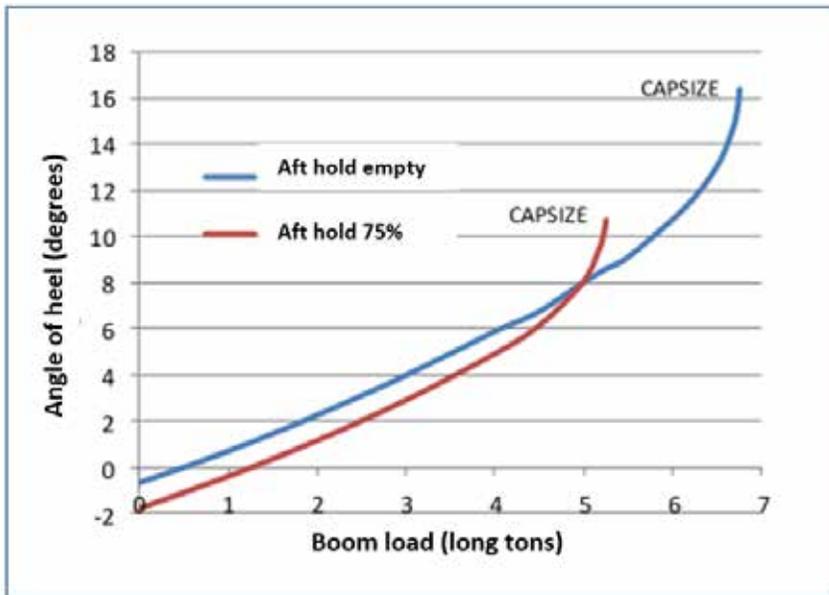
Figure 5. Limit of boom load (Image: MerLion Marine Services, with TSB annotations)

With the given parameters, it was calculated that the vessel would capsize at a boom load of 6.76 long tons with the aft hold empty, and at a boom load of 5.26 long tons with the aft hold 75% full. Figure 5 shows the angle of heel with increasing boom loads for the 2 conditions.

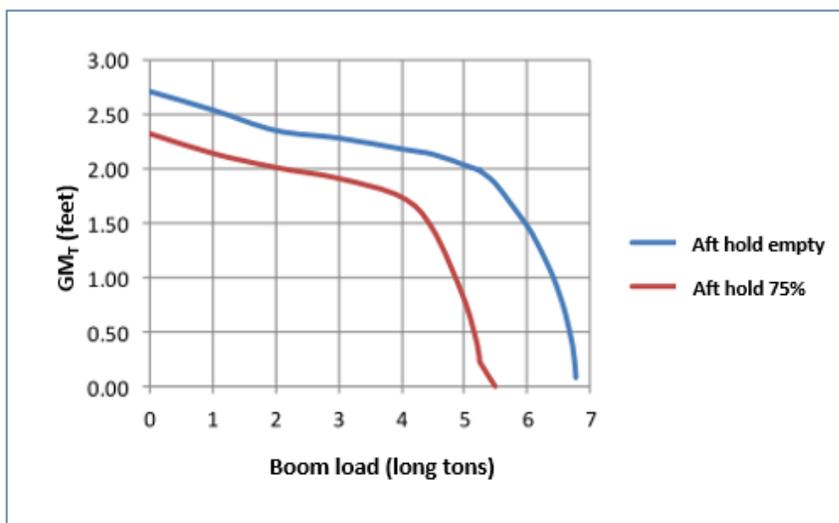
As the boom load increases, the value of the transverse metacentric height ( $GM_T$ )<sup>30</sup> decreases in a virtually linear fashion until a certain point is reached, at which point the  $GM_T$  decreases exponentially (Figure 6).

Figure 6. Transverse metacentric height ( $GM_T$ ) with increasing boom load (Image: MerLion Marine Services, with TSB annotations)
