Marine Transportation Safety Investigation Report M18A0425

taking on water and sinking

Fishing vessel *Charlene A*
Boutiliers Cove, Nova Scotia
01 December 2018

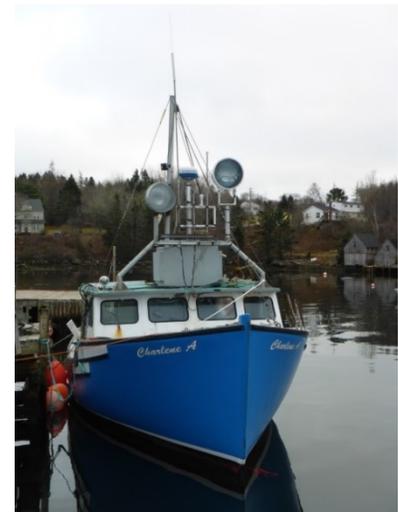
The *Charlene A* (Figure 1) is a Canadian-registered (registration no. 395971), 10.15 m longliner-style fishing vessel of 13.49 gross tonnage (GT). The vessel is constructed of moulded glass-reinforced plastic and powered by a diesel engine turning a single propeller shaft. The wheelhouse is equipped with an electronic chart plotter system,¹ a radar, an echosounder, a GPS (global positioning system), and 2 very high frequency (VHF) radiotelephones. The vessel is also fitted with 2 bilge pumps, 1 automatic and 1 manual. An inflatable life raft, 4 lifejackets, and 4 survival suits were also carried on board.

Figure 1. Fishing vessel *Charlene A*
(Source: TSB)

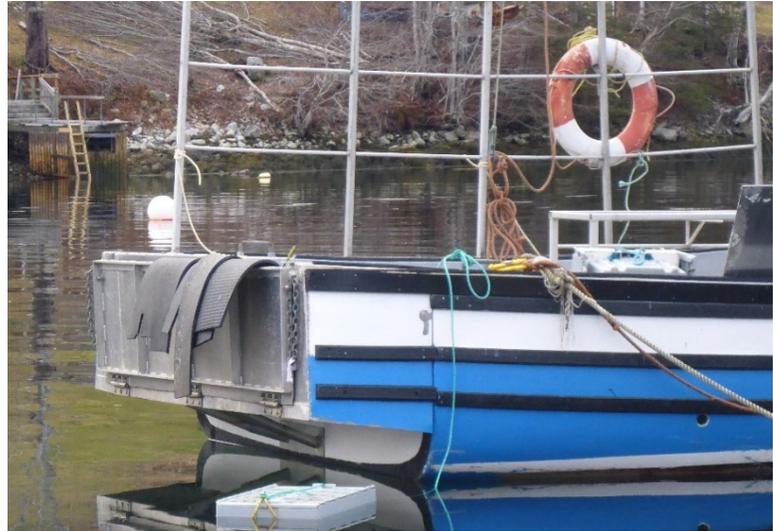
The vessel had been modified in the summer of 2018, when a stern extension and hinged tailgate-style bulwark² (Figure 2) was installed. The vessel was not fitted with a bilge alarm system or an emergency position-indicating radio beacon.

Figure 2. The *Charlene A's* stern extension (Source: TSB)

TC guidelines on fishing vessel major modifications indicate that the addition of a permanent stern ramp extension, such as the extension and hinged tailgate added to the *Charlene A*, will change the position of the vessel's centre of gravity.¹⁴

The master of the *Charlene A* modified the vessel's stern in the summer of 2018 by installing a stern extension that included a hinged tailgate (Figure 2). The tailgate could be opened by lowering it, and it provided an open stern for setting traps. The extension increased the length of the vessel, and when the deck was fully loaded with traps, the vessel's stability and trim was altered from its original condition. Having the tailgate open also reduced the protection afforded by the transom to prevent water from ingressing over the stern.

Before installing the extension and tailgate, the master did not determine if the vessel had sufficient reserves of stability that would allow it to be safely modified. After the vessel was modified, no

stability assessment was conducted, nor was a record of stability prepared as required by the FVSR.¹⁵ Similarly, a Fishing Vessel Modification History Form was not completed.

Under the FVSR, it is the responsibility of the master and the authorized representative of a fishing vessel to ensure that the vessel is compliant with applicable regulatory and safety requirements. If vessels are modified and stability assessments not conducted, masters, authorized representatives and crew may be unaware of adverse changes in vessel stability characteristics which may affect the safety of the vessel.

It is important for masters, authorized representatives, and crew of fishing vessels to keep themselves informed of any changes in the regulations and of the issuance of any guidance documents that apply to their vessels. Masters and other mariners can research or subscribe to Ship Safety Bulletins through TC's website to obtain this information.
