MARINE TRANSPORTATION SAFETY INVESTIGATION REPORT M19P0057

STRIKING OF THE ANCHORED VESSEL PAN ACACIA

Bulk carrier *Caravos Harmony*
Vancouver Harbour, British Columbia
17 March 2019

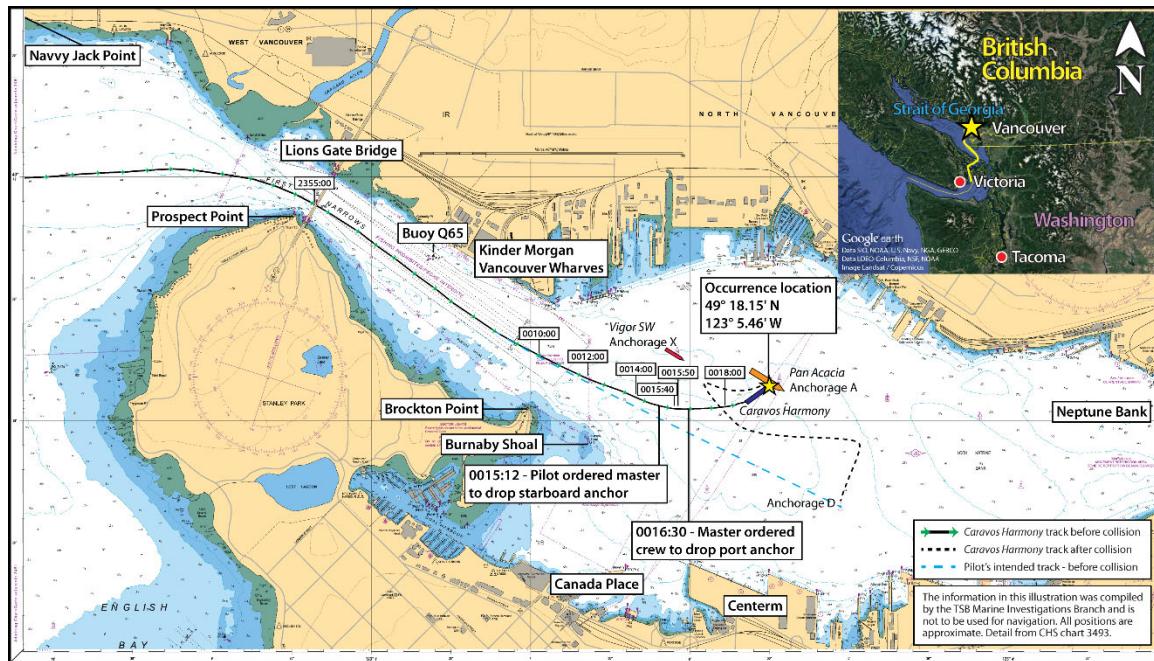
As the *Caravos Harmony* entered First Narrows, the strong current and eddies caused the vessel to move to port. The pilot gave full ahead and starboard helm orders in an attempt to increase water flow across the rudder and correct the vessel's course. Because the second officer was not familiar with the bridge control automation he was pausing about 4 seconds at each intermediate step for fear of overloading the engine. The pausing of 4 seconds at each intermediate step meant that the main engine responded to each of the intermediate steps in sequence as typical engine orders rather than as a single order.

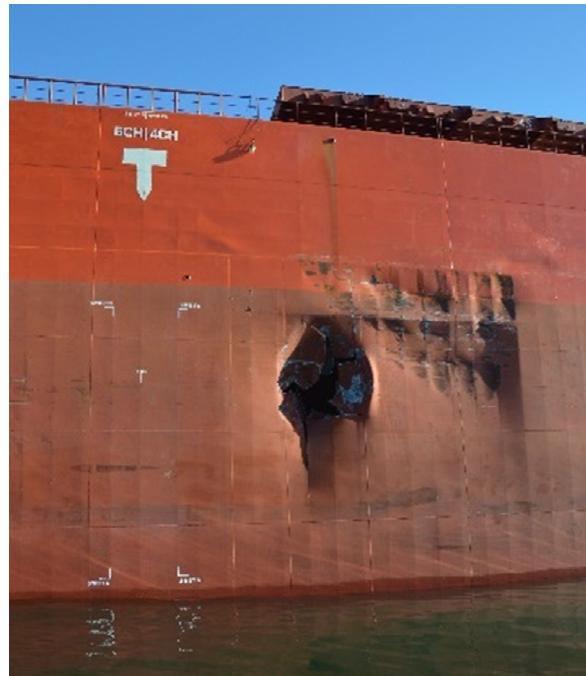
Figure 4. Damage to the *Pan Acacia* (Source: TSB)

The starboard side of the *Pan Acacia* was dented and punctured through to the No. 4 cargo hold (Figure 4). The *Caravos Harmony* sustained dents and damage to its port bow hull structure (Figure 5).

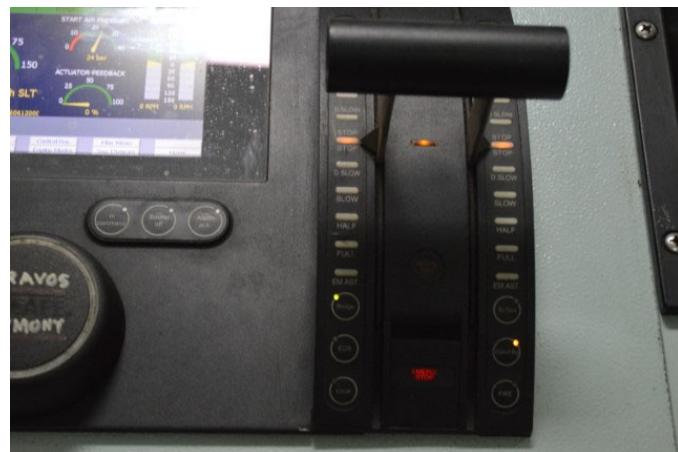
Figure 6. Combined lever and telegraph unit (LTU) on the Caravos Harmony (Source: TSB)

In this occurrence, the 2 conditions required to initiate emergency astern had not been covered in the familiarization for the master or the bridge officers. There was no information on the bridge about these 2 conditions, nor were they mentioned in the vessel's documentation. None of the bridge team members or engineers was aware of them, and the bridge team and the engineers believed that the main engine would be overloaded if the rpm was increased or decreased rapidly between full ahead and emergency astern.
