Marine Transportation Safety Investigation Report M20A0003

FIRE

Fishing vessel *Newfoundland Lynx*

29 January 2020

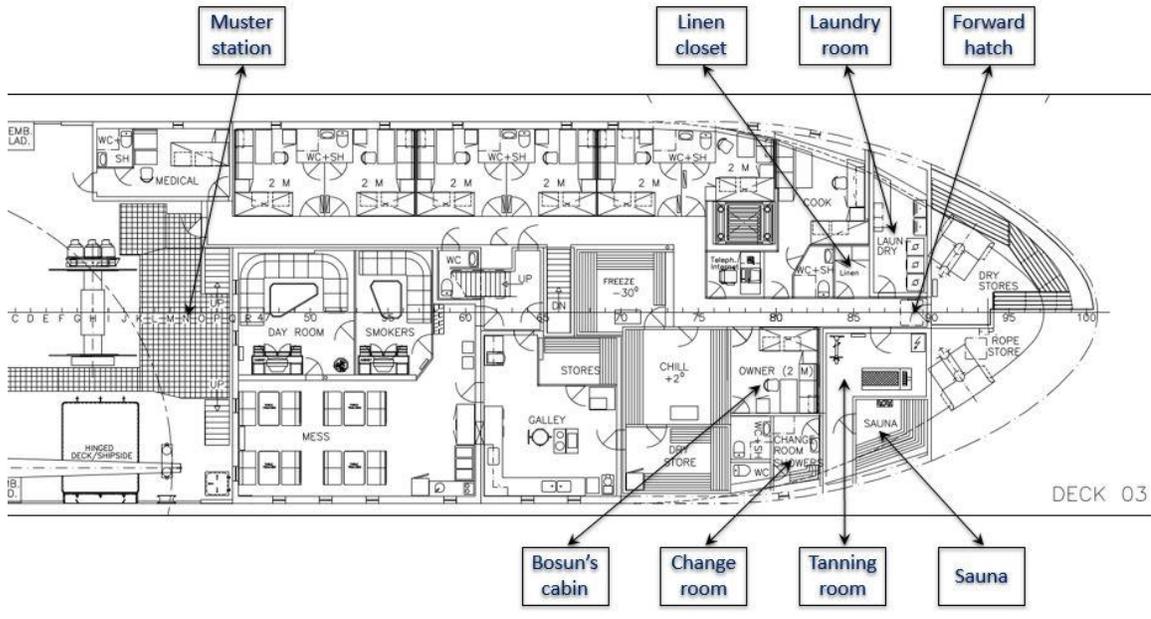
At approximately 1515, the bosun, who was in his cabin adjacent to the vessel's tanning room and sauna (Figure 3), awoke to the smell of smoke and left his cabin to locate the source of the smell. Flames were visible through the window of the closed sauna door, and smoke was escaping between the top of the door and the doorframe. The bosun went to the messroom and alerted other crew members about the fire. One crew member immediately grabbed a fire extinguisher and went with the bosun to the sauna, while another crew member went to the bridge.

Figure 3. General arrangement of Deck 03 of the *Newfoundland Lynx*, showing the locations of the muster station, the linen closet, the laundry room, the forward hatch, the bosun's cabin, the change room, the tanning room, and the sauna (Source: ShipCon ApS, with TSB annotations)

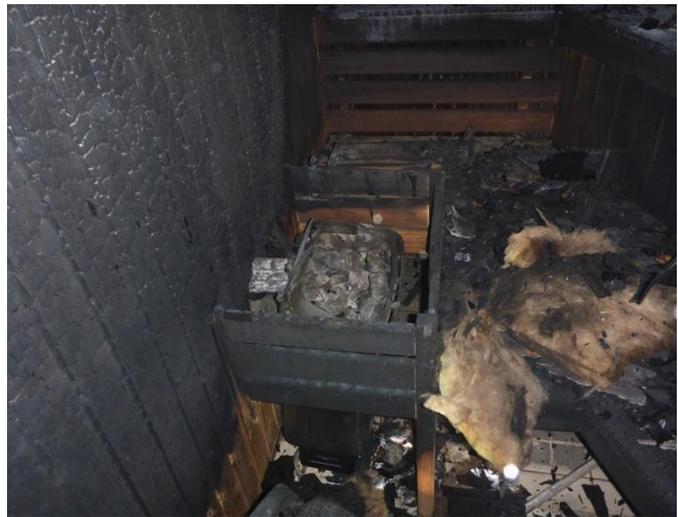
The heat detector in the sauna was destroyed in the fire, and the investigation could not determine the exact cause of the fire detection system's failure.

The fire started in the sauna located on Deck 03 (Figure 5). Burned pieces of a wooden footrest were found below the sauna's electric heater, indicating that the footrest may have been on the heater when the heater was turned on. With the heater left unattended, the heat likely eventually ignited the footrest, starting the fire. The heater controls are located outside the sauna, meaning that objects left on the heater could remain undetected when the heater was turned on.

Figure 5. Damage to sauna interior, including electrical heater (Source: TSB)

Following the occurrence, Ocean Choice International removed the sauna from the *Newfoundland Lynx*. The space was converted into a storage area and equipped with a smoke and

heat detector. Ocean Choice International also ordered additional firefighting equipment to be placed on board.
