RAILWAY INVESTIGATION REPORT

R02T0149

CROSSING COLLISION

VIA RAIL CANADA

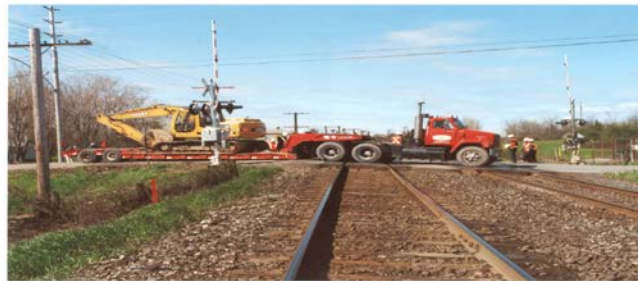
The TSB Engineering Laboratory (report LP 037/2002) examined the crossing surface, geometric and vertical road alignment and the tractor-trailer combination unit, and concluded the following:

- There was nothing unique about the vehicle involved in the accident that would have differentiated it from the thousands of other similar vehicles travelling on North American roadways. The trailer's ground clearance and wheelbase were typical for this unit type.
- Based on scale drawings and the simulation test, it was considered that the bottom of the accident trailer could have contacted the roadway.
- It was not determined whether the tractor would have had sufficient power and traction to successfully pass through the crossing with the bottom of the trailer dragging on the ground.
