RAILWAY INVESTIGATION REPORT R15M0034

**MAIN-TRACK DERAILMENT
CANADIAN NATIONAL RAILWAY
FREIGHT TRAIN M30511-17
MILE 212.8, NAPADOGAN SUBDIVISION
SAINT-BASILE, NEW BRUNSWICK
17 APRIL 2015**

Railway Investigation Report R15M0034

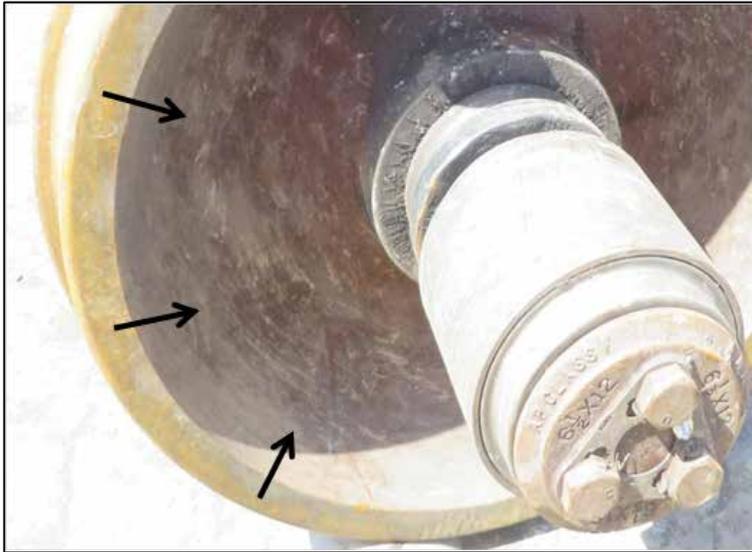
Photo 3. Scuffing on wheel plate, trailing truck of the 61st car (CN 624072)

The 61st car (CN 624072) was travelling with its B-end leading. The leading truck was still attached to the car. There was a shiny contact area noted on the body side bearing at the same end, on the right side (BR location). Because the bearing surfaces are in contact, they will rub and wear; as a result, they can polish. The trailing truck (A-end) was located approximately 30 feet behind the car. Its components were still assembled. The coupler housing on the trailing end of the car was deformed, with the coupler rotated in a clockwise direction. The plates of the wheels in the trailing truck showed significant scuffing, typically associated with contact with track ballast (Photo 3).

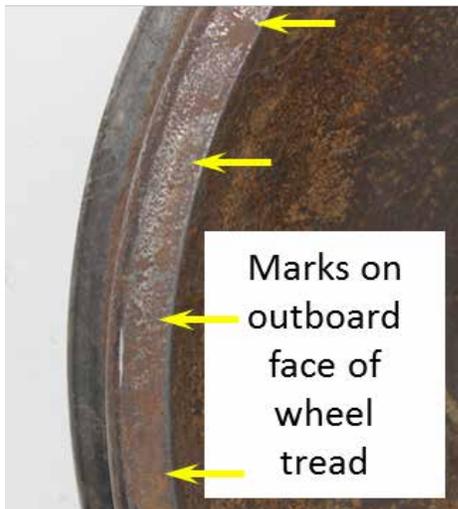
Photo 4. Wheel R-1 from the 62nd car (DWC 627099)

The 62nd car (DWC 627099) was travelling with its A-end leading. The car came to rest separated from the other cars. The trailing truck was behind the car on the same (north) side of the track. It was mostly disassembled, with its wheels, springs, and other truck parts strewn about the derailment site. The R-1 wheel had marks on the outboard face of the tread (Photo 4).

The marks on the car body of the 62nd car indicated that it moved in a northwest direction relative to its trailing truck. There were corresponding marks on the truck in the direction of movement. The rubbing marks on the outboard tread face of the R-1 wheel on the 62nd car indicated that the wheel was down inside the gauge and had rolled against the north rail. These marks were matched by the scratches on the bottom of the car's truck side frame, which were made when the wheel dropped off the rail. The derailed equipment continued to move until it encountered the partially fractured weld near Mile 212.84. At that point, the rail fractured suddenly and completely owing to high tensile stresses.

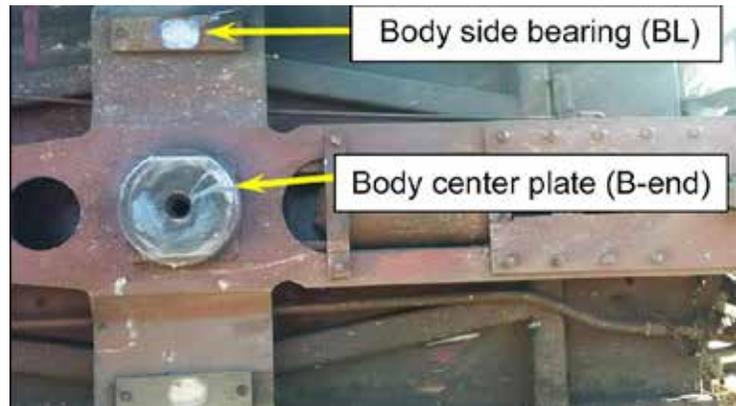
Photo 5. Bottom of the 62nd car, B-end, showing marks on body centre plate and uneven contact surface marks on BL body side bearing

There was a heavy mark on the body centre plate on the trailing end of the car (B-end). The marks extended from the centre-pin hole toward the end of the car and slightly toward the south (Photo 5). There were also uneven contact surface marks on the body side bearing at the same end, on the left side (BL location). The coupler housing on the trailing end was broken horizontally on the north side of the opening. There was no indication of significant coupler shank twist at this end.

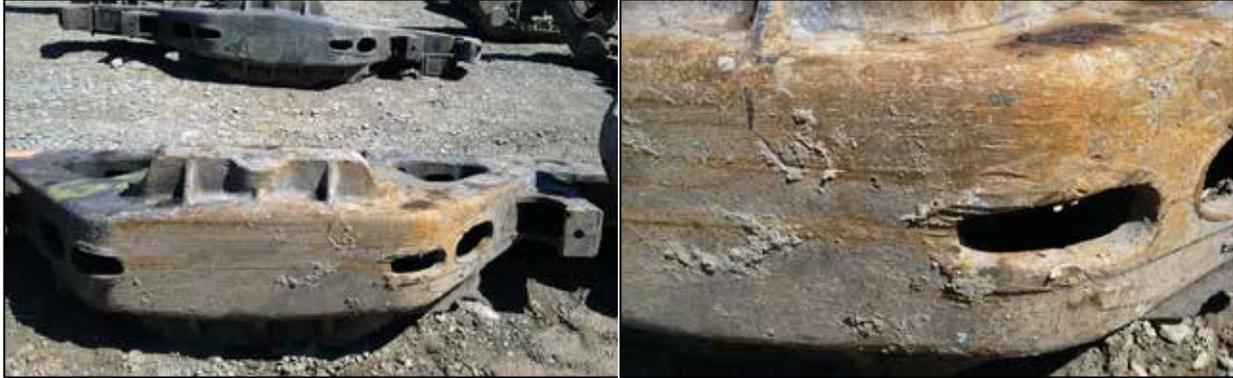
Photo 6. Scratches on bottom of one truck side frame from B-end of the 62nd car

There were scratches on the bottom of the truck side frame on the B-end of the 62nd car (Photo 6 and Photo 7).

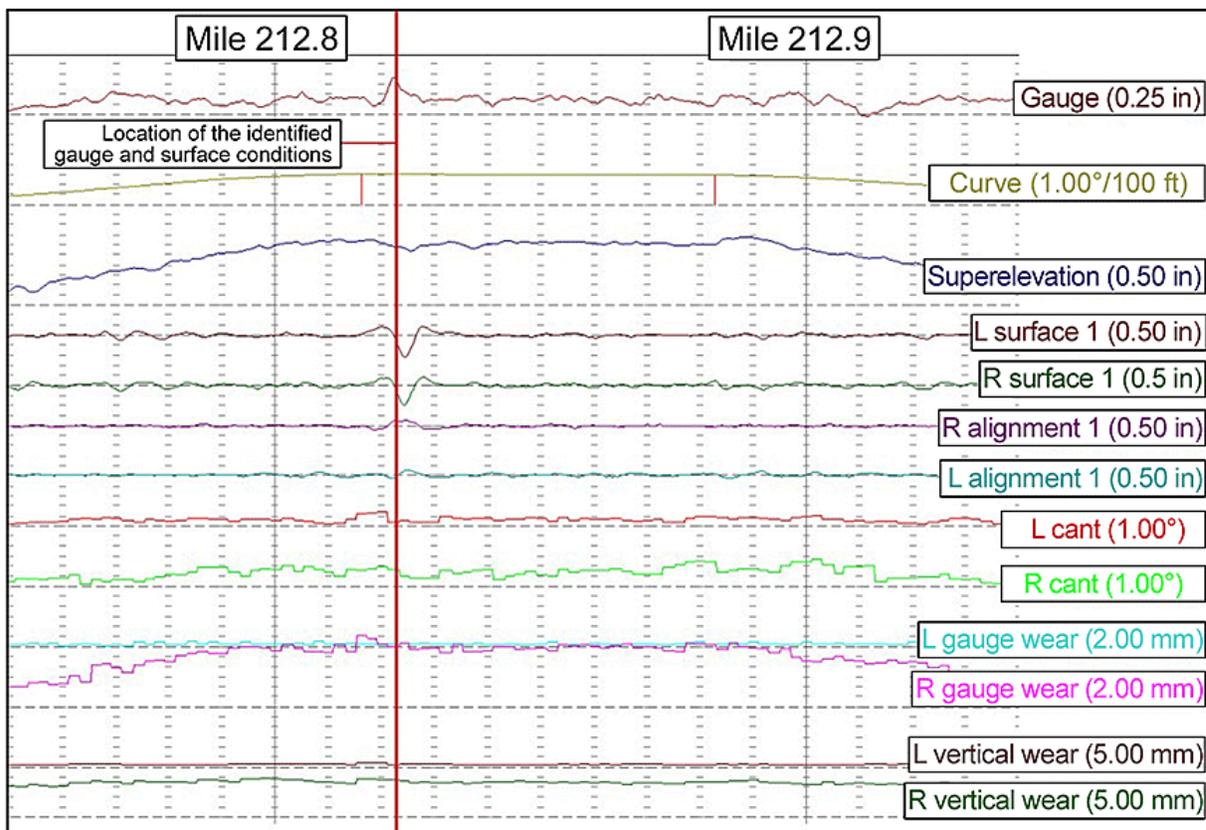
Figure 3. Track evaluation system (TEST) car measurements taken on 15 April 2015 for Mile 212.8 to Mile 212.9 (Source: Canadian National Railway TEST car, with TSB annotations)

Between 07 May 2014 and 15 April 2015, CN conducted 4 track geometry inspections on the Napadogan Subdivision using one of its TEST cars. During these inspections, the measurements were based on the dynamic forces generated while the TEST car was travelling at track speed. Figure 3 shows the recorded data between Mile 212.8 and Mile 212.9 from the 15 April 2015 inspection.

During the April 15 inspection, the TEST car identified several defects in the derailment curve (Table 5), including a near-urgent⁵ wide-gauge defect and 2 priority surface defects at Mile 212.82.

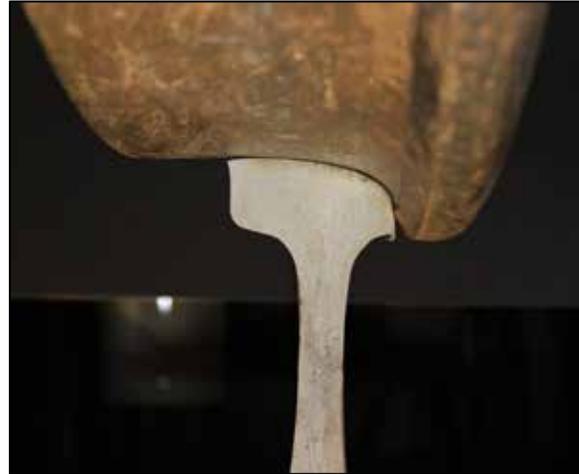
Photo 8. Actual wheel profile of L-1 wheel of the 62nd car compared with contour of high (south) rail. Note: The wheel-rail contact surface has shifted towards the field side of the rail.

- When there is wear on the gauge face of the high rail, 2-point contact between the wheel and the rail can occur when flanging around the curve. Wheel load that is shifted toward the field side of the rail reduces the lateral stability of the rail, lowering the L/V threshold for rail rotation or rollover.

The high rail in the derailment curve had significant gauge face wear. This wear pattern would have resulted in a wheel-rail interface with multiple points of contact. As the wheel-rail contact shifted toward the field side of the rail, the lateral stability of the high rail was

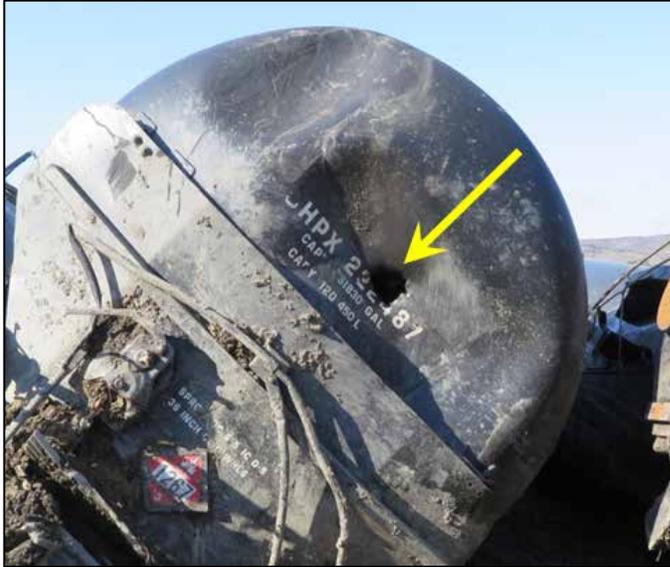
Photo 9. Puncture in unprotected portion of the upper head

in their tank shells and heads as a result of these impacts. One of the tank cars equipped with a half-height head shield experienced a puncture in the unprotected part of the head (Photo 9). There were no leaks, as the derailed cars were not loaded.¹³

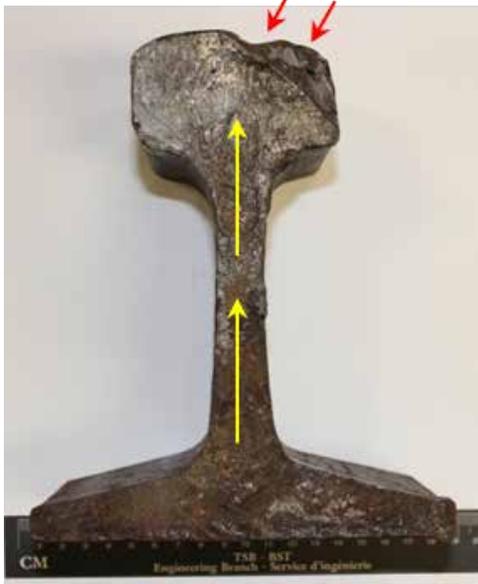
Photo 10. Fracture surface on rail piece number 9 showing direction of fracture propagation (yellow) and impact marks on head (red)

- Fractures on the subject rail pieces were consistent with sudden overstress rupture.
- The fracture surface on rail piece number 9 (Photo 10) indicated that it had broken at a flash butt weld. It exhibited a darker corrosion deposit and rounded edge at the base (Photo 11), suggesting that it had been partially fractured for some time.
- The orientation of chevrons and ridges on the fracture of rail piece number 9 indicated that it had started at the base of the rail and moved upward into the web and head.
- The Sydney rail had significant vertical and gauge wear (Figure 8).

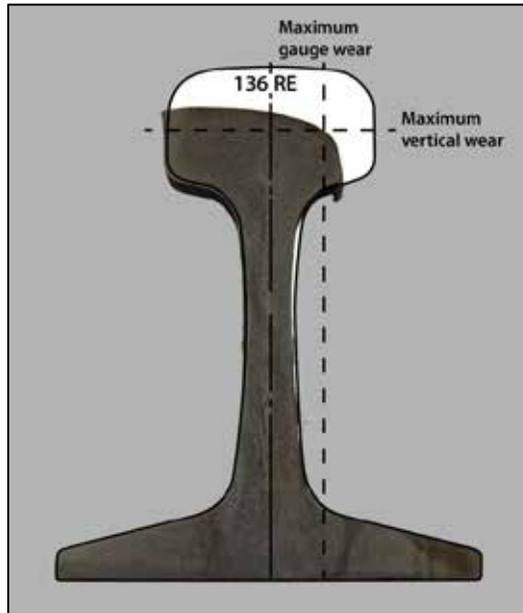
Figure 8. Comparison of the actual profile of the south rail with its original rail profile, showing the extent of vertical and gauge wear

The rail on the north (low) side of the curve was HH VT Nippon, manufactured in December 2007. This rail had minimal wear. The rail on the south (high) side of the curve was RE Sydney, manufactured in January 1992. On the south rail, the maximum combined rail wear (that is, vertical wear as well as gauge wear) was 1 ⁹/₃₂ inches (33 mm). Before the derailment, the south rail had been scheduled for replacement in summer 2015.

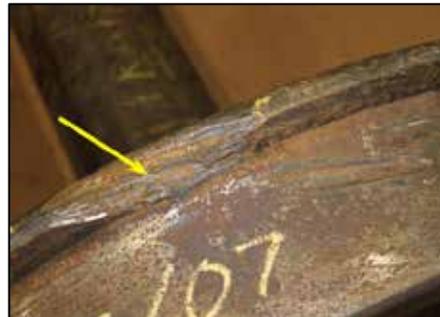
Photo 12. View of mechanical damage on wheel from car DWC 627099

- shells observed on the wheel set from non-derailed car CRLE 19431 were within the AAR allowable limits, and
- impact damage that appeared to be fresh was observed on the wheel sets from derailed cars DWC 627099 (Photo 12) and AOK 27626. This damage had likely occurred during the derailment.
