# Rail Transportation Safety Investigation Report R18C0076

## MAIN-TRACK DERAILMENT

Canadian Pacific Railway  
Freight train A13-31  
Mile 50.7, Montana Subdivision  
Stirling, Alberta  
30 July 2018

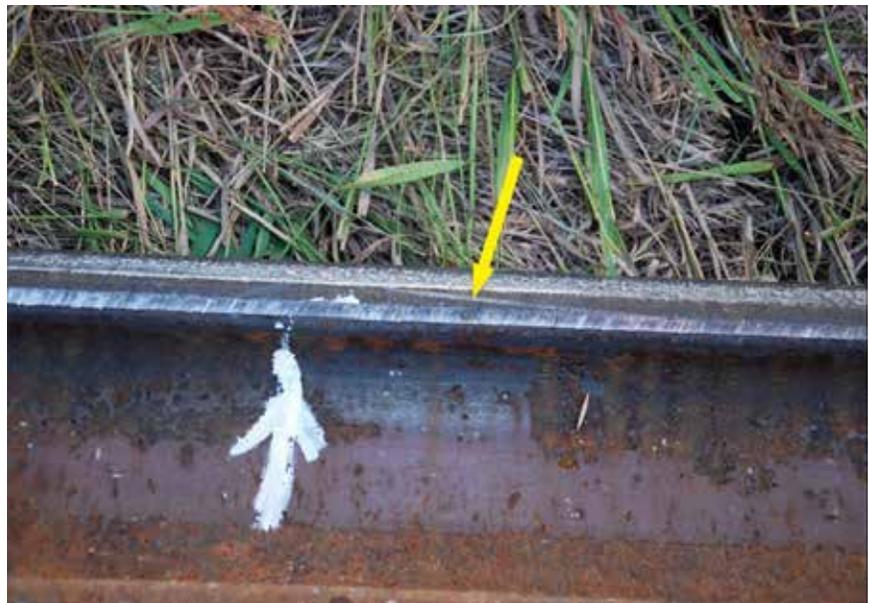
Because Class 3 track will typically have 23 ties for every 39 feet of track, the requirement to have 10 good ties per 39-foot segment could mean that there are up to 13 defective ties (i.e., up to 57% of the ties could be defective). Based on the railway inspection records, about 42% of the ties between Mile 50.6 and Mile 51.0 were defective.

Based on the wheel flange marks across the rail head (Figure 2), the high rail had likely canted outwards, allowing the wheel on

the inside rail to drop into the gauge. For lateral forces of 10 to 12 kips<sup>12</sup> to cause the gauge to spread, weakened securement of the rail (e.g., poor tie condition) was likely present.

Figure 2. Wheel flange marks across the rail head at the point of derailment (indicated by the yellow arrow)

Although only a small section of track (between Mile 50.53 and Mile 51.01) had been identified by the track evaluation car as having wide gauge, the gauge of the track can spread if defective ties are clustered rather than being evenly distributed.

In this occurrence, the track met the requirements of the TSR and CP's Red Book with respect to the allowable percentage of defective ties. However, the track was still vulnerable to lateral in-train forces in the range of 10 to 12 kips. This occurrence illustrates the importance of performing timely replacement of defective ties, particularly on curves.
