RAIL TRANSPORTATION SAFETY INVESTIGATION REPORT R20V0185

MAIN-TRACK TRAIN DERAILMENT

Canadian National Railway Company
Freight train J60352-12
Mile 44.4, Yale Subdivision
Floods, British Columbia
14 September 2020

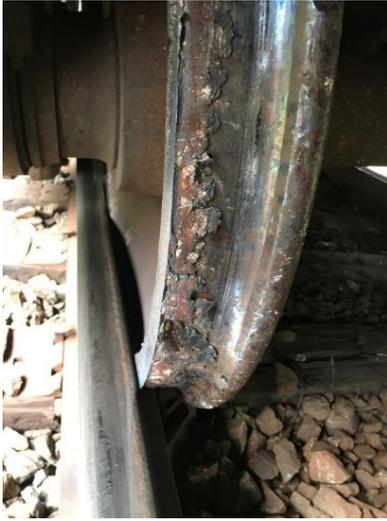
Figure 3. L3 wheel of car CNPX 3373 derailed inside the track gauge of the south rail (Source: Canadian National)

Both wheel sets were extensively damaged; the L4 wheel exhibited severe slid flats¹⁰ at multiple locations and 2 distinct gouges across the wheel tread surface. The L3 wheel was missing 1.75 inches of rim width from the outboard rim face of its entire circumference (Figure 3). The 2 wheel sets were recovered from the wreckage and sent to the TSB Engineering Laboratory in Ottawa, Ontario, for further examination and analysis.

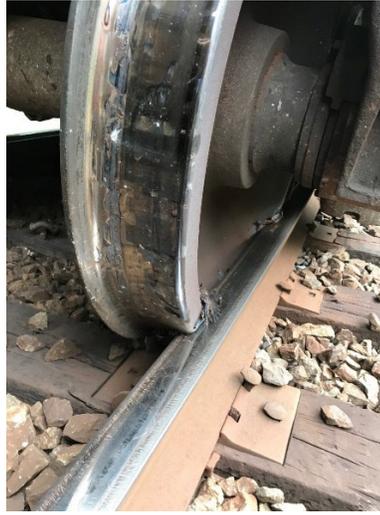
Figure 4. L4 wheel of car CNPX 3373 derailed inside the track gauge of the south rail (Source: Canadian National)

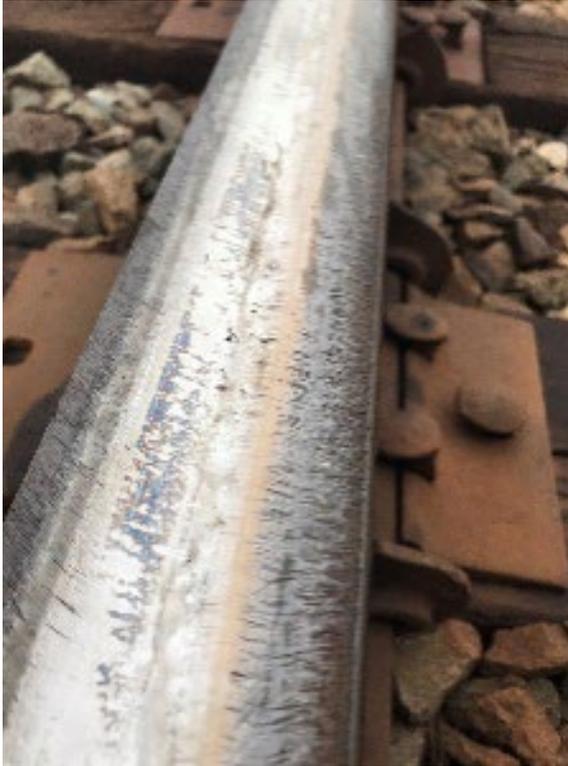
These observations were made 2 days after the derailment. Sections of rail with blueing were observed under parked CN train 113, which had also been proceeding westward along the Yale Subdivision at the time of the derailment but was required to stop and remained stationary due to the impassable track ahead. Because of the parked train, the track from Mile 40.0 to Mile 42.3 was not inspected.

Figure 5. Blueing on the south rail head (Source: Canadian National)

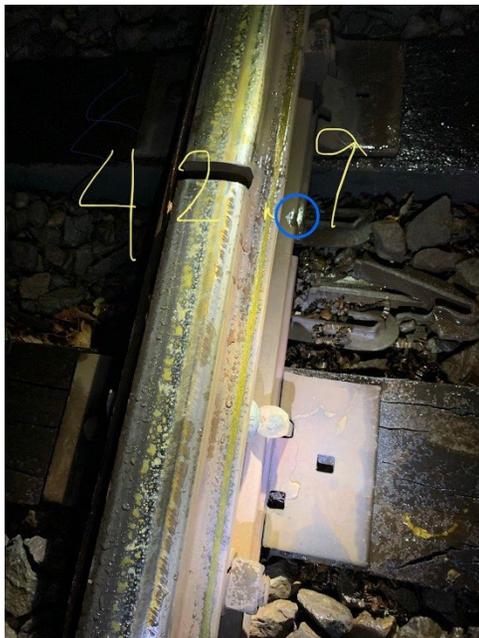
At Mile 42.9, there were rail anchors on the side of the track and there were steel shavings on the gauge side of the rail.¹² A pre-existing impact mark was evident on the gauge side of the joint bar and there was also a shiny mark on the base of the rail (Figure 6).

Figure 6. Condition of the track at Mile 42.9, including an impact mark on the gauge side of the joint bar (circled), a shiny mark on the base of the rail, and steel shavings on the gauge side (Source: Canadian Pacific)

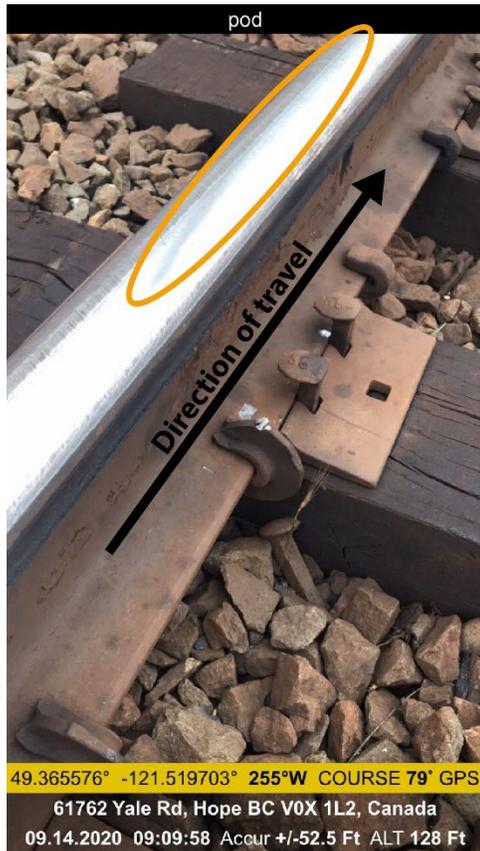
A few ties east of Mile 44.4, the first mark on the top of the south rail was noted (Figure 7); in this area, the track is aligned with a 1.23° right-hand curve that extends from Mile 44.34 to Mile 44.49. At Mile 44.4, the top of the insulated joint bar was sheared off, and bolts and anchors were missing (Figure 8). In addition, there was evidence of lateral movement of the south rail, and the gauge face had the appearance of a machined surface,¹³ suggesting that a car wheel dropped into the gauge at that location. All of this is consistent with this location being the initial POD.

Figure 7. Mark on top of the south rail a few ties east of Mile 44.4 (Source: Canadian National, with TSB annotations)

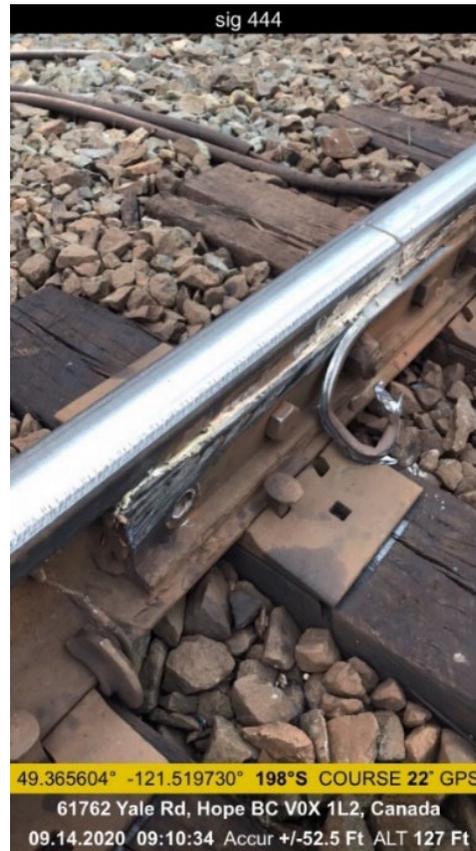
Figure 8. Sheared-off bolt and damaged insulated joint bar at Mile 44.4 of the south rail (Source: Canadian National)

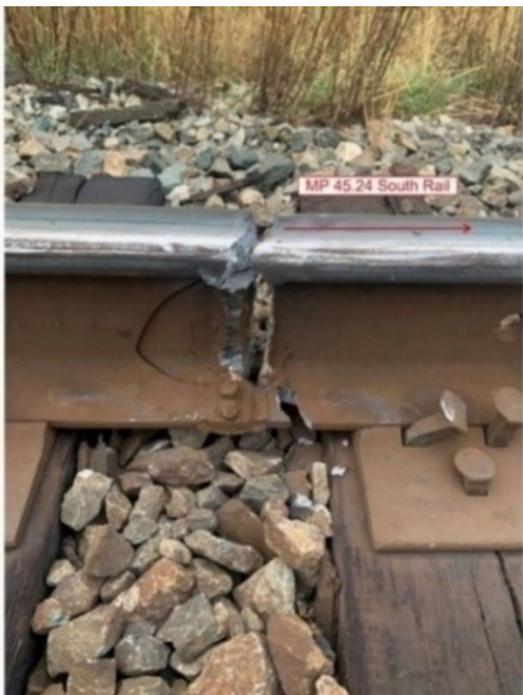
- On a piece of rail from Mile 45.24, the web and base were broken (Figure 9).
- On a piece of rail from Mile 46.7 (the closest to the main pile-up over the Hunter Creek Bridge), there were about 4 to 6 inches of fracture at the rail head, web, and base (Figure 10).

Figure 9. South rail at Mile 45.24, showing that the web and base of the rail are broken (Source: Canadian National)

It was determined that, in all cases, the fractures were located at thermite welds and were brittle in nature, which indicates that the rails did not have pre-existing defects.

The fractures were all consistent with lateral force applied to the gauge side of the rail and were attributed to lateral gauge movement from a wheel dropping into gauge.²⁹

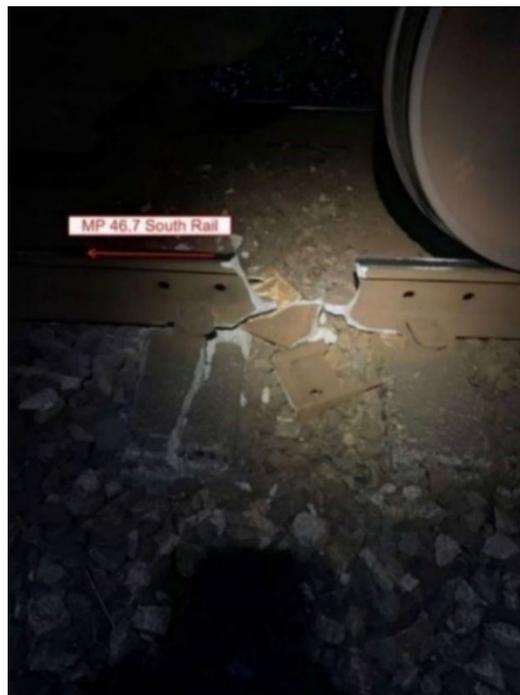
Figure 10. Broken south rail at Mile 46.7, showing a fracture measuring about 4 to 6 inches (Source: Canadian National)

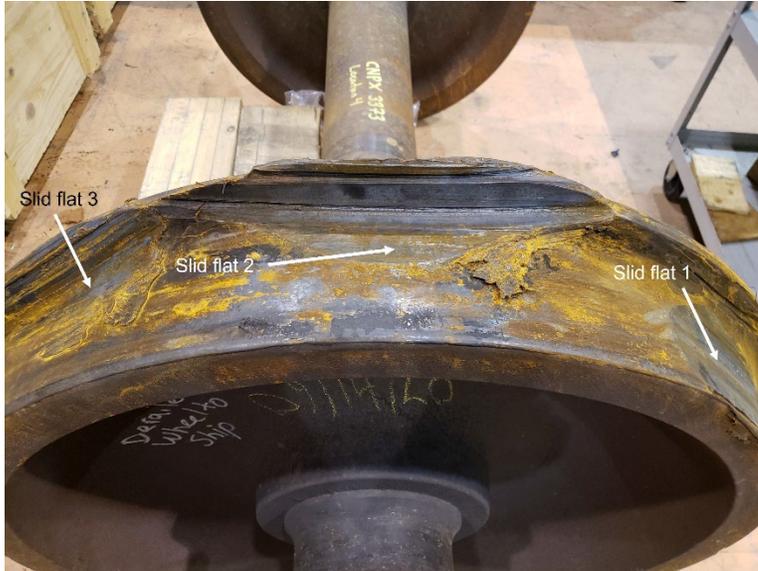
- There were 3 slid flat spots, ranging in size from 8 to 14 inches.
- Two of the 3 slid flats had abrasion, reducing the wheel's flange thickness to less than 1 inch at the thinnest.
- Displaced material was observed at the trailing edge of the slid flats.
- There was evidence of blueing, masked by rust.

Figure 14. Tread damage on the R4 wheel showing the location of the 3 slid flats (Source: TSB)

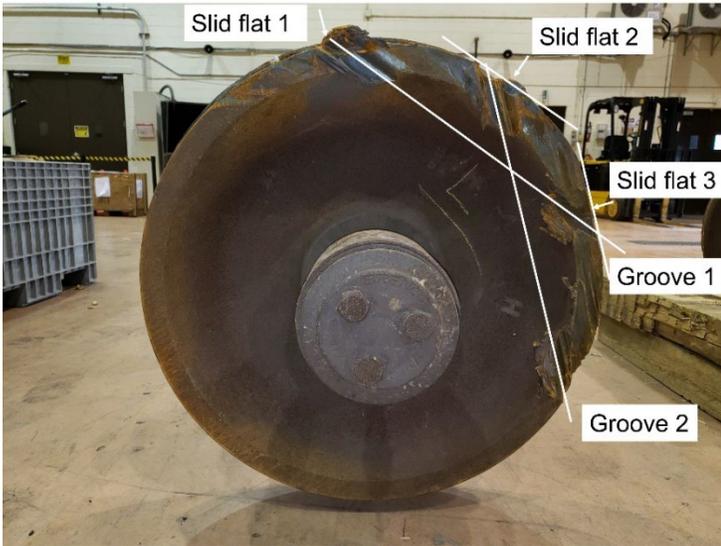
Figure 15. Condition of the L4 wheel after the derailment (Source: TSB)

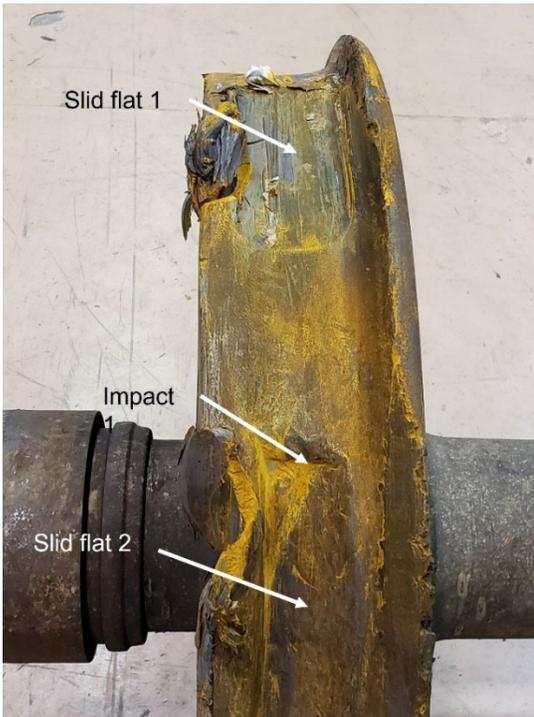
Figure 16. Tread damage on the L4 wheel showing the location of the first impact and the first 2 slid flats (Source: TSB)

The slid flats to the L4 wheel were consistent with the wheel set stopping to rotate and then skidding on top of the rail over a distance. The 2 grooves were consistent with the wheel gradually dropping into gauge and rubbing against the rail head while the wheel set was not rotating. Figure 18 shows a close-up of the second groove.

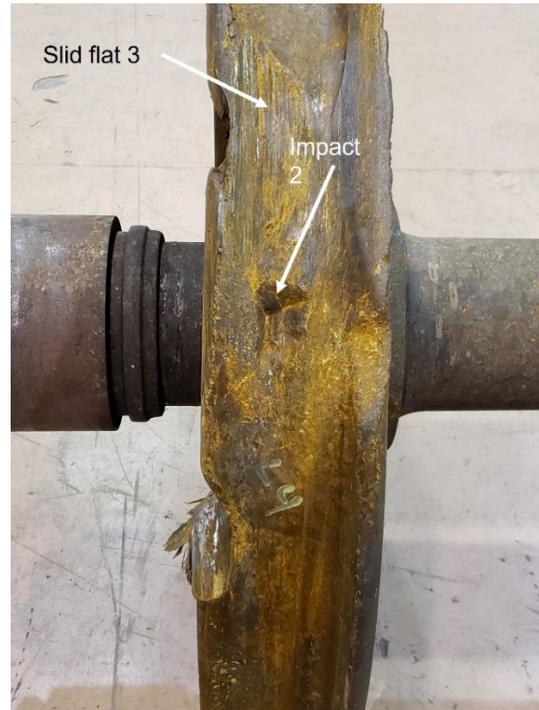
Figure 17. Tread damage on the L4 wheel showing the location of the second impact and the third slid flat (Source: TSB)

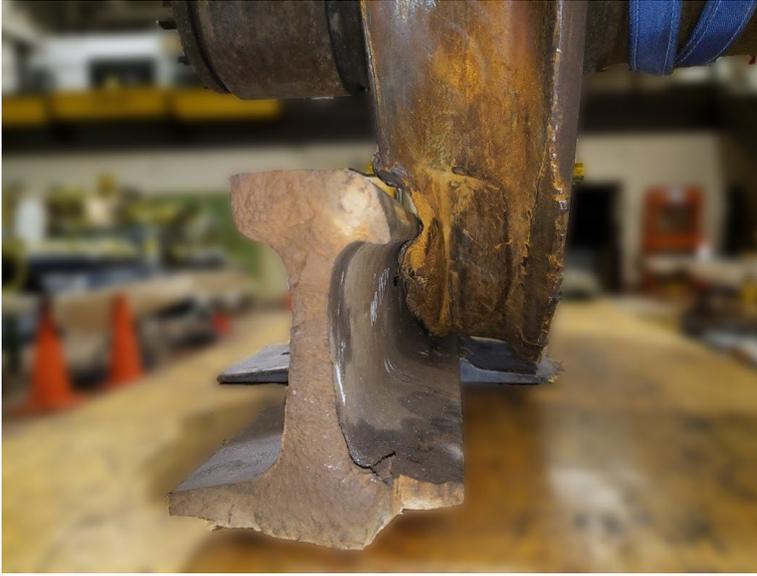
Figure 18. Second groove to L4 wheel (Source: TSB)

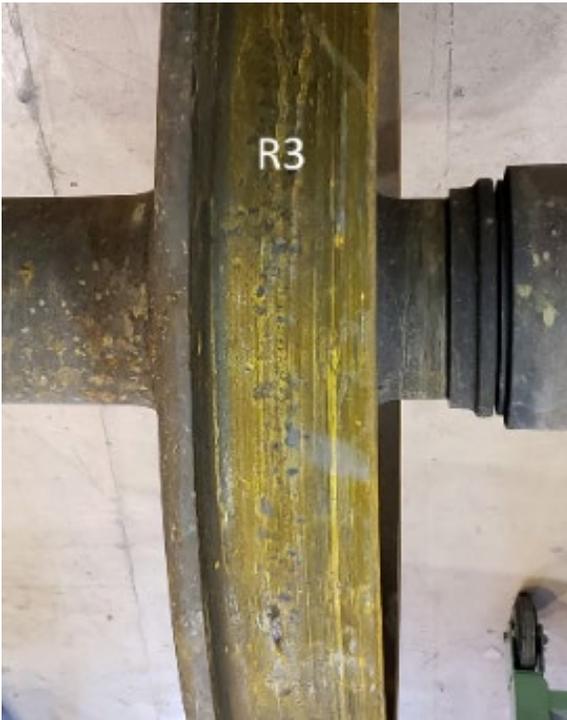
The R3 wheel had dents of varied size around the entire circumference, but concentrated on the portion of the tread that contacts the rail head (Figure 19). These dents were consistent with the wheel having been subjected to impact with debris from the R4 wheel.

Figure 19. Condition of the R3 wheel after the derailment (Source: TSB)

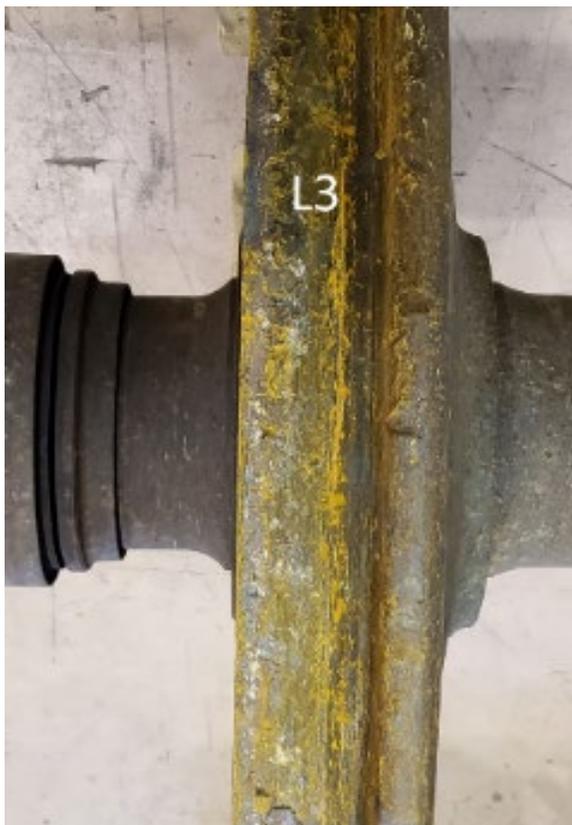
This damage indicates that the wheel dropped into gauge.

Figure 20. Condition of the L3 wheel after the derailment, with its rim width reduced by 1.75 inches (Source: TSB)

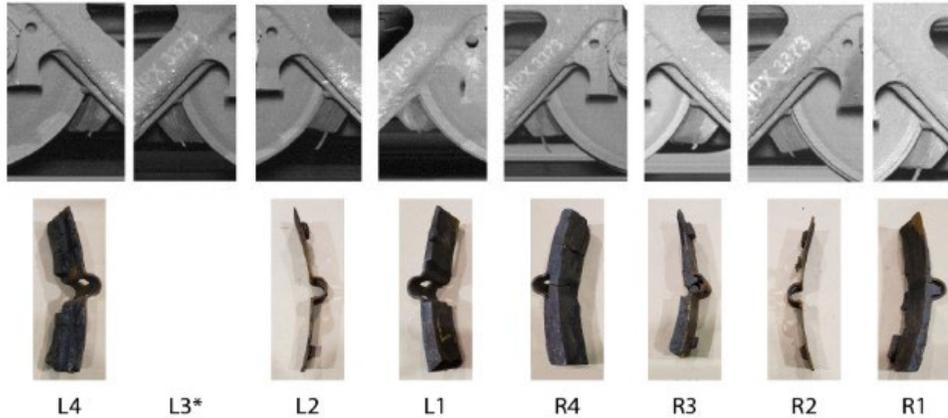
Figure 21. Photographs of the brake shoes on car CNPX 3373 taken by the train inspection portal system at Mile 85.6 of the Maple Creek Subdivision on 11 September 2020 (top row) and photographs of the same brake shoes taken after the derailment (bottom row) (Source: Canadian Pacific [top row] and TSB [bottom row])

As the figure shows, the brake shoes were significantly more worn when the derailment occurred, to an extent unusual for only 4 days of service. On average, brake shoes in potash service on this route last 8 to 10 months.

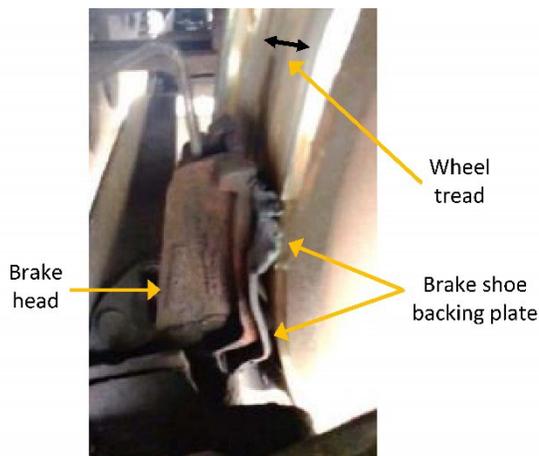
Figure 22. Condition of the brake shoe on the L3 wheel post-derailment (Source: Canadian Pacific, with TSB annotations)

The TSB laboratory examined the brake shoes recovered from car CNPX 3373 after the derailment. It found that the brake shoes in the R1 and L1 positions exhibited uneven wear from top to bottom. The top portions had been worn to the backing plate, while the bottom portions still had brake shoe material. The brake shoes in positions R2 and L2 had no brake shoe material left, and the metal backing plates had been blued. The brake shoe at position R3 had some remaining material but had a glazed appearance over the whole surface. The brake shoes from the R4 and L4 positions were the thickest and exhibited some glazing. The glazed appearance of the shoes indicates that the shoes experienced elevated temperatures due to prolonged contact with the wheel treads.
