Rail Transportation Safety Investigation Report R20V0005

MAIN-TRACK TRAIN DERAILMENT

Canadian National Railway Company
Freight train U79351-06
Mile 69.97, Bulkley Subdivision
near Kitwanga, British Columbia
07 January 2020

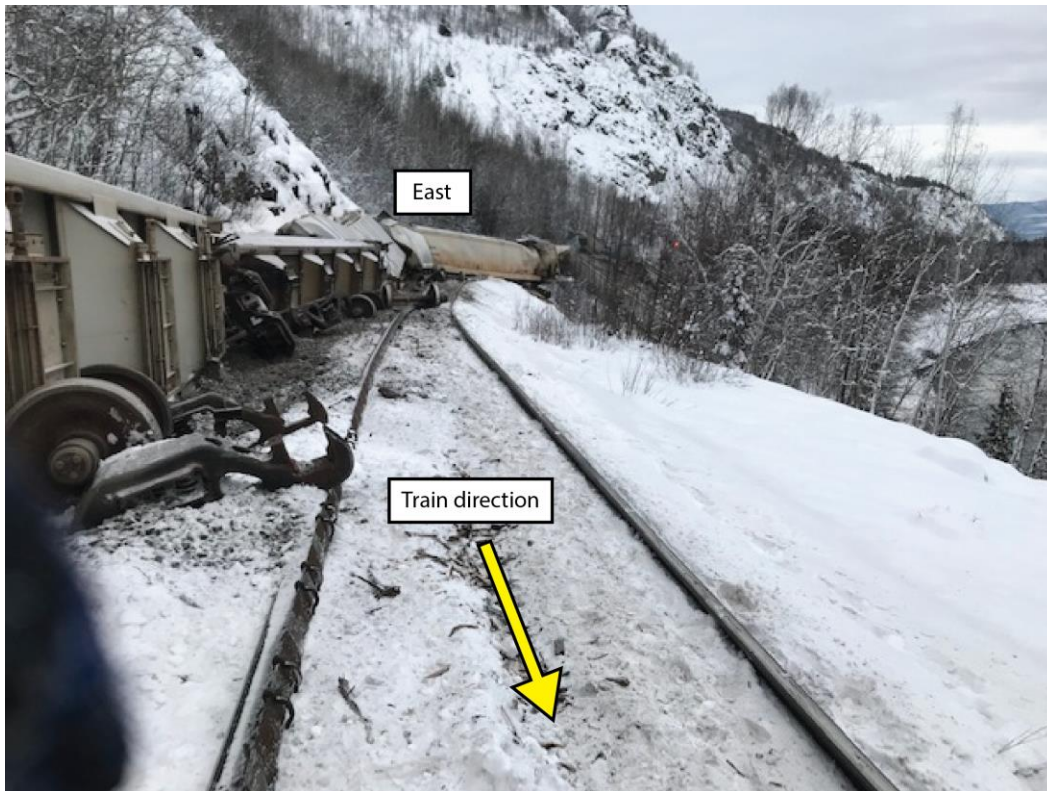
Post-derailment inspection revealed that the point of derailment was in the eastern spiral³ of a 6° LH compound curve at Mile 69.97. The 3rd through 36th cars behind the locomotives derailed. The 3rd car to the 8th car remained upright along the track. The 9th car struck a rock face and rotated laterally. The 10th through 36th cars piled up in jackknife pattern perpendicular to both sides of the track (Figure 2).

Figure 2. Derailed cars to the high (north) side of the eastern spiral of the 6-degree left-hand compound curve, looking east (Source: Canadian National Railway Company, with TSB annotations)

on the north wheel inner rims, suggesting that the backside of the wheels was not pressed up against the field side of the north rail. The first 6 cars derailed to the high side of the LH curve and the high (north) rail rolled over.

The video and audio recordings from the lead locomotive strongly suggest that a sudden track failure occurred. Given the annual tonnage on the Bulkley Subdivision and the frequency of loaded unit train operations, it is likely that bulk unit train traffic accelerated the development and deterioration of priority wide-gauge conditions in the 6° LH curve where the derailment occurred.

Emerging wide-gauge conditions can progress quickly, particularly on track where bulk unit trains operate, making increased inspection and timely repairs a necessity for safe railway operations.
