AIR TRANSPORTATION SAFETY INVESTIGATION REPORT A24Q0027

TOUCHDOWN SHORT OF RUNWAY

Air Inuit Ltd.

Boeing of Canada Ltd. de Havilland Division DHC-8-314, C-GAIW

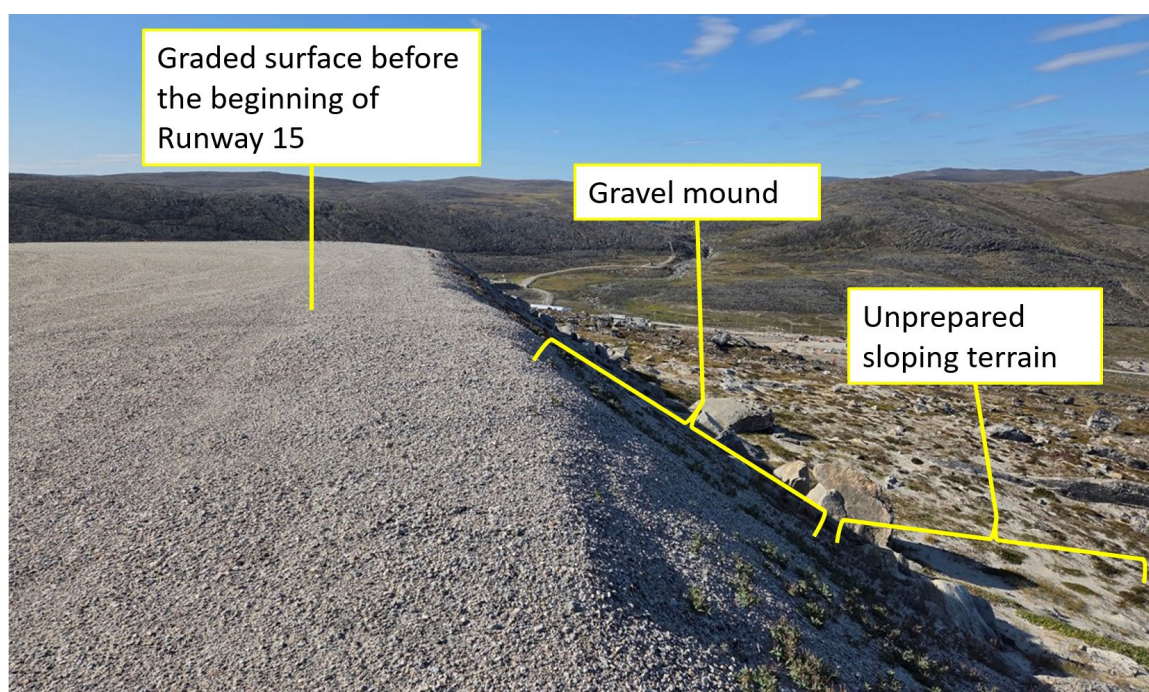
Figure 2. End of Runway 15, including the end of the levelled surface, the gravel mound (approximately 30 feet high), and the unprepared sloping terrain (Source: Third party, with permission, and with TSB annotations)

At 1554:33, the main landing gears touched down on the gravel mound that delineates the end of the runway, 220 feet before the threshold (Figure 2). The left wheel touched the ground approximately 5 inches below the runway, and the right wheel touched down approximately 4 inches below the runway.

At CYKG, when the runway was built, the uneven terrain needed to be levelled at the top of the hill, creating a mound of gravel approximately 220 feet before the threshold. When the aircraft struck this mound, the left wheel touched the ground approximately 5 inches below the runway level, and the right wheel, approximately 4 inches below this level. This contact resulted in an overstress fracture in the left landing gear strut, and the strut detached from the wheel assembly.

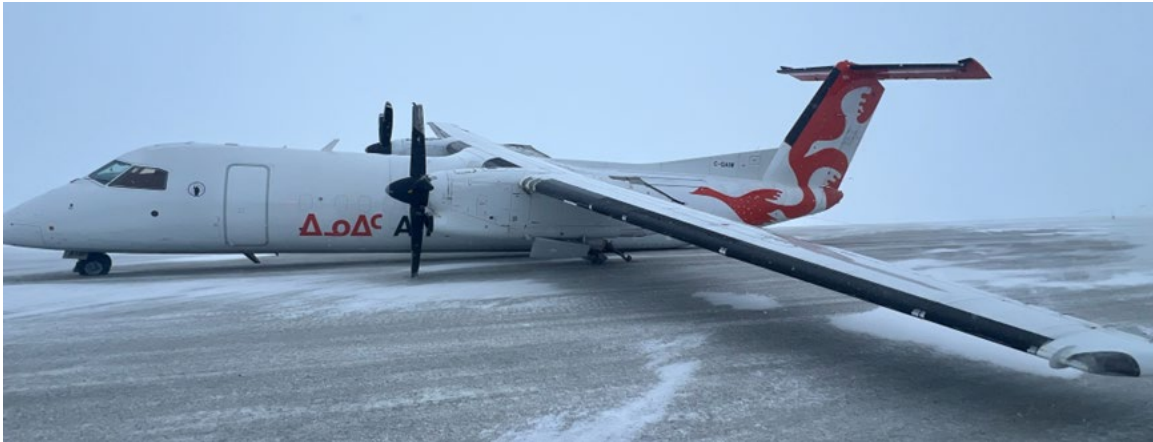
Figure 3. Occurrence aircraft stopped on the runway (Source: Aircraft captain)

The piston subassembly and wheels broke free from the left landing gear, unbeknownst to the flight crew. The aircraft bounced, and the captain landed the aircraft on the runway, while remaining in the centre of the runway. The aircraft came to a stop approximately 2100 feet beyond the threshold of Runway 15 (Figure 3).

During landing, the remaining part of the strut bent partially backward, and the propeller struck the surface of the runway. The aircraft came to a stop resting on the bent left landing gear and the other 2 intact landing gears. The left wing did not touch the ground (see Figure 3 in Section 1.1, *History of the flight*).

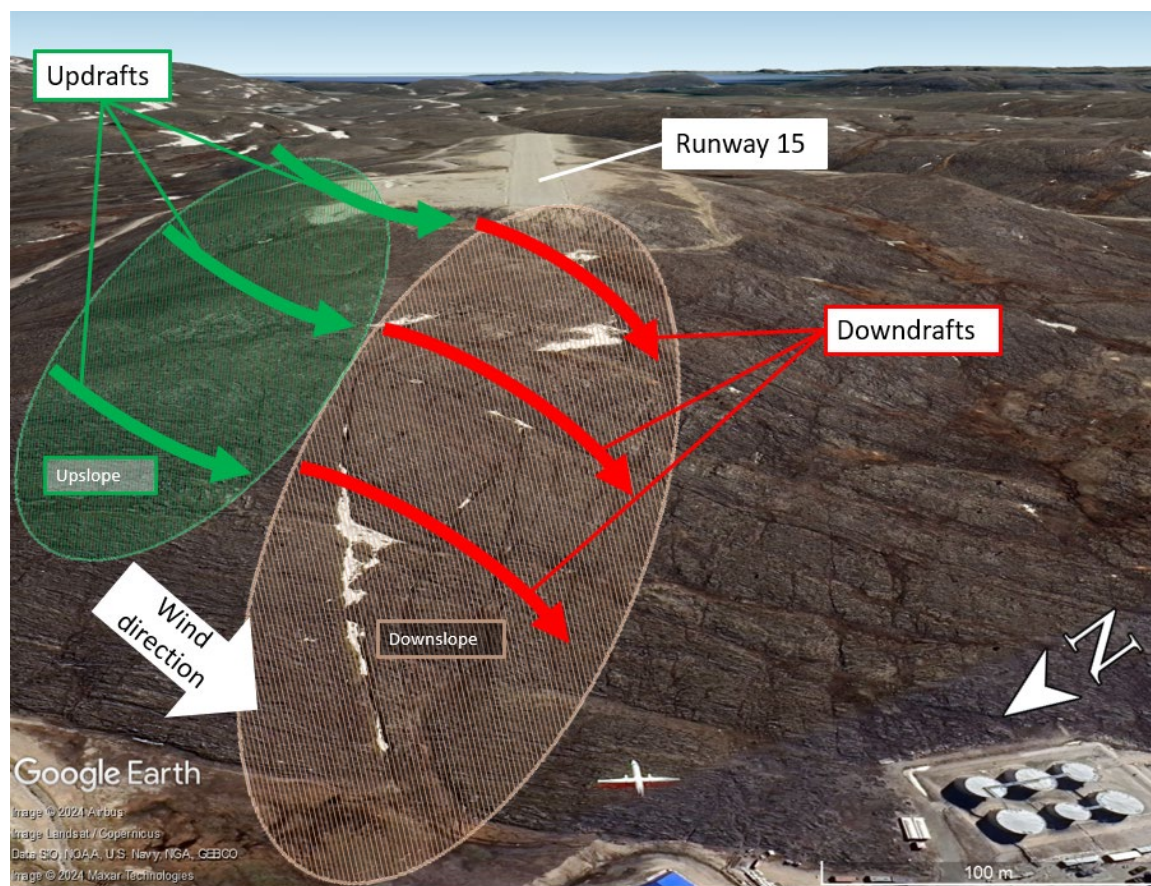
Figure 5. Illustration of the likely wind currents in the vicinity of CYKG at the time of the occurrence
(Source: Google Earth, with TSB annotations)

Taking into account the topography around CYKG and the winds present at the time of the occurrence, the investigation determined there were likely downdrafts in the final approach area for Runway 15 at that time (Figure 5).

According to the flight data, when the aircraft was in the final approach phase over the rising terrain, there was a negative vertical wind component. The maximum downward vertical wind was approximately 600 fpm about 0.25 NM from the runway threshold, 12 seconds before impact. The attitude then changed from 2.3° to 5.5° nose up. The purpose of this nose-up manoeuvre was to stop the descent so that the aircraft would not touch down before the beginning of the runway. During this manoeuvre, vertical wind effects were felt and the aircraft continued to descend.

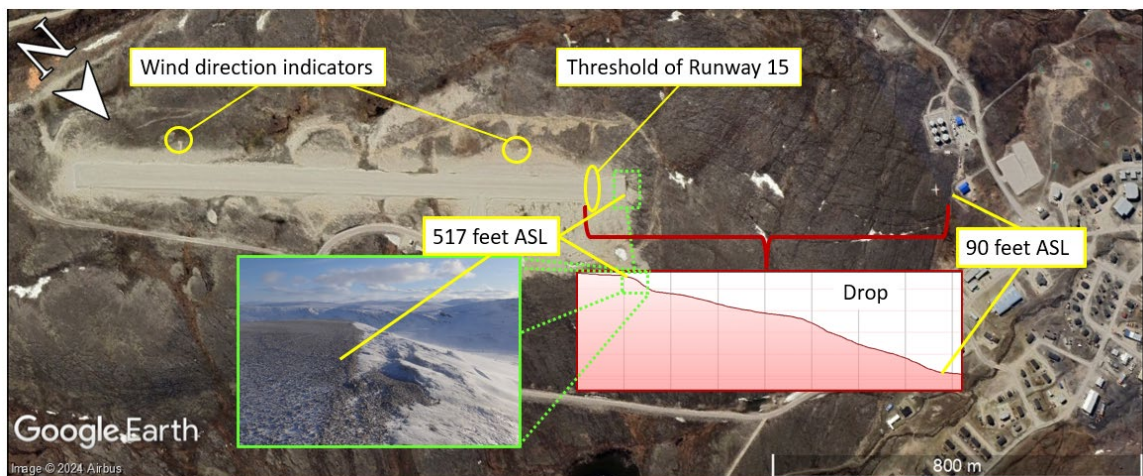
Figure 6. Aerial view of Kangiqsujaq (Wakeham Bay) Airport and the surrounding area, with overlays showing the difference in elevation on the final approach path for Runway 15 (Source of the main image: Google Earth, with TSB annotations. Source of the overlays: TSB)

Wind indicators are located beside the runway, approximately 200 feet from the edge of the runway and approximately 500 feet beyond each runway threshold. The runway was built on top of a rocky hill, and the 220 feet leading up to the threshold of Runway 15 have been levelled with gravel to be at the same elevation as the runway (Figure 6). The thickness of the gravel creates a mound that reaches the unprepared terrain, which then drops to 90 feet ASL approximately 2600 feet from the threshold of Runway 15 (see Figure 2 in Section 1.1, *History of the flight*).

The topography around the airport means that when winds are greater than 20 knots, there is a risk of turbulence and wind shear. The *Canada Flight Supplement* warns pilots of this situation.⁶

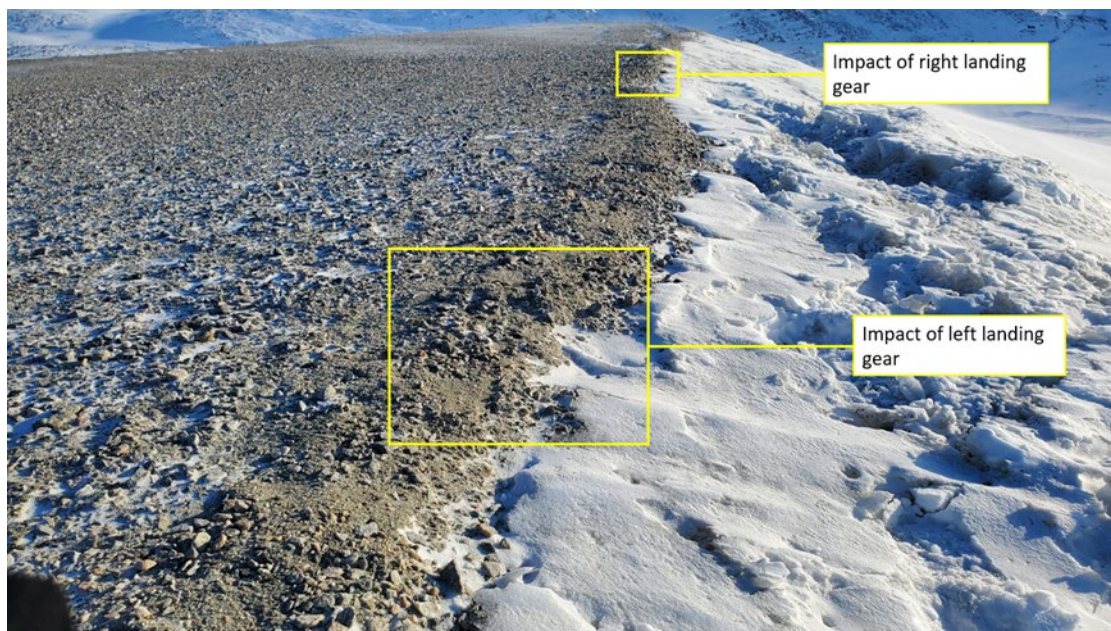
Figure 7. Impact of landing gears striking the mound at the beginning of the levelled runway surface (Source: TSB)

When the left landing gear struck the mound approximately 5 inches below the levelled part of the runway (Figure 7), the landing gear strut cylinder fractured (Figure 8), which led to the piston subassembly breaking off with the wheels attached.

Using an area just beyond the threshold as an aiming point placed the aircraft on a descent path leading to a touchdown before the runway threshold. The descent was not stopped owing to the effects of a downdraft. As a result, the touchdown occurred approximately 220 feet before the threshold, the wheels struck the mound below the runway level, and the left landing gear fractured.
