AIR TRANSPORTATION SAFETY INVESTIGATION REPORT A23W0039

LANDING GEAR COLLAPSE

Northwestern Air Lease Ltd.
British Aerospace P.L.C. Jetstream Model 3112, C-FCPE
Fort Smith Airport (CYSM), Northwest Territories
14 April 2023

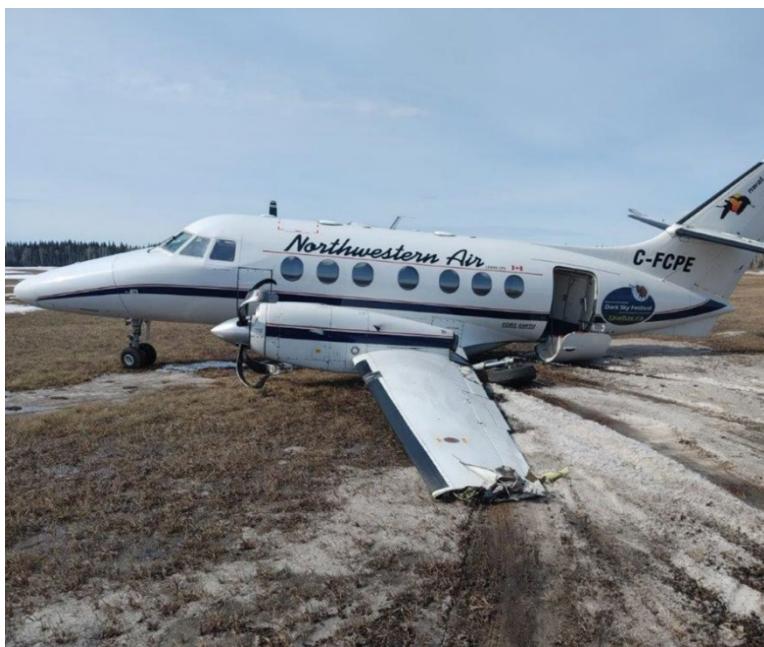
The aircraft remained upright during the landing but was substantially damaged (Figure 1) when the left MLG unit collapsed as a result of a failed spigot housing.³ The left MLG unit, wing tip, propeller, and engine were significantly damaged, as was the belly cargo pod.

Figure 1. View of the occurrence aircraft with damage shown, looking northwest (Source: Third party, with permission)

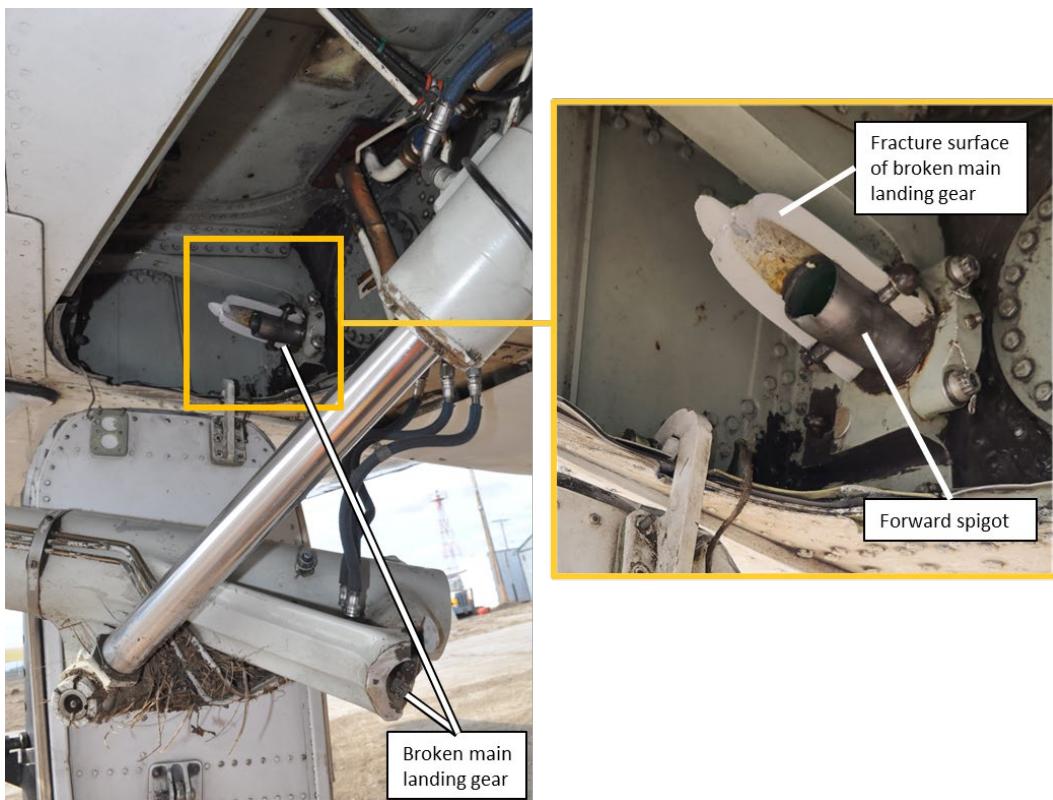
Each MLG unit is attached to the wing by half cap bearing housings mounted to the spigots through the spigot housing. During the landing of the occurrence flight, the spigot housing of the left MLG unit failed, resulting in the collapse of this MLG unit (figures 2, 3, and 4).

Figure 4. Main image showing a portion of the broken left main landing gear unit and the inset showing a close-up of the broken parts (Source: TSB)

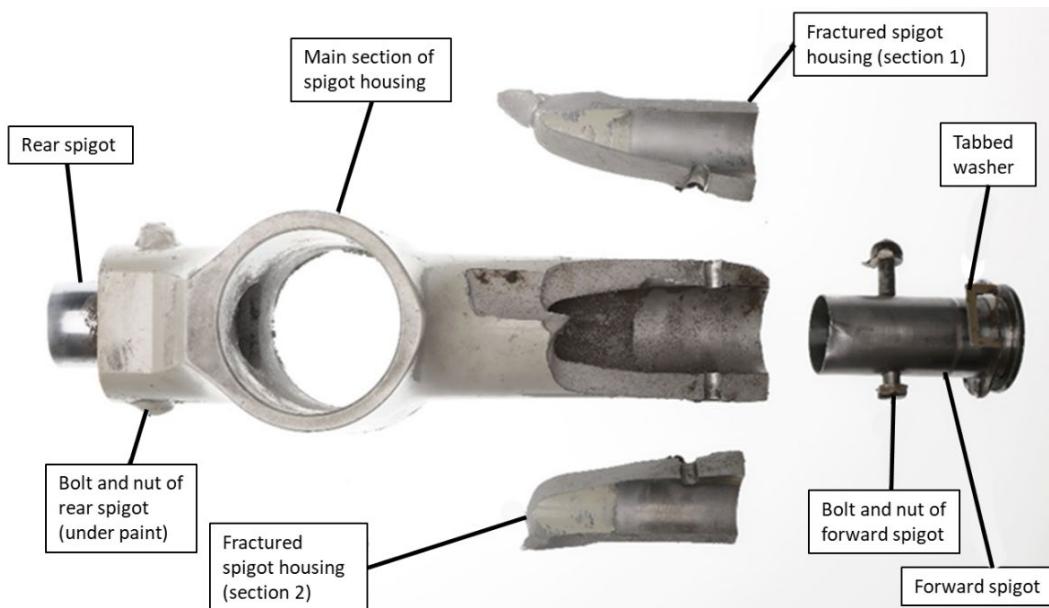
The forward end of the spigot housing fractured into 3 pieces (Figure 5), causing part of it to separate from the forward spigot and fall away. The spigot was retained by the half cap bearing housing that held the gear to the aircraft.

Figure 5. Parts of the fractured main landing gear unit (Source: TSB)

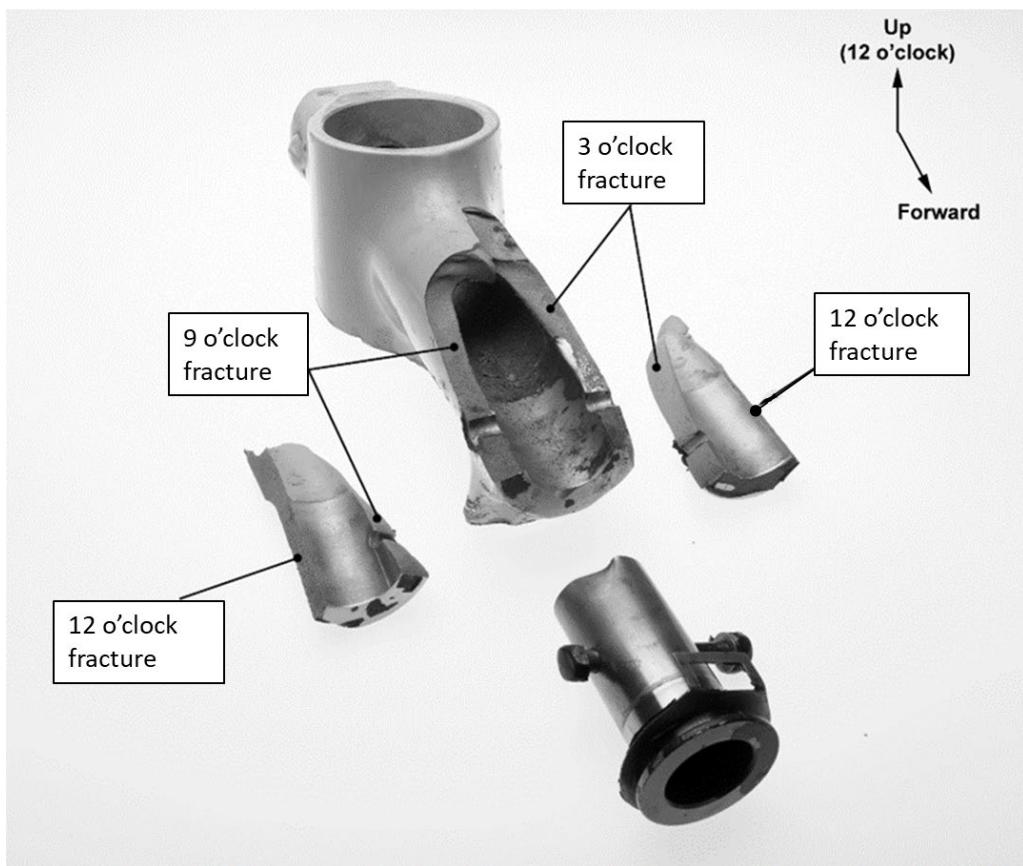
When the forward end of the MLG unit's spigot housing was visually examined and found to have broken into 3 pieces, fractures were observed at the 3 o'clock, 9 o'clock, and 12 o'clock positions (Figure 6).

Figure 6. Positions of the 3 fractures in the spigot housing (Source: TSB)

The 3 o'clock and 9 o'clock fractures each intersected a bolt hole, indicating that they each consisted of 2 independent fractures, 1 forward and 1 aft of the bolt hole (Figure 6). Sealant was observed on the edge of 1 of the mating fracture surfaces, adjacent to the forward face of the spigot housing. The forward face of the spigot housing (Figure 7) was also examined for evidence of corrosion protection. Some brownish and black sealant residue (likely Loctite 5188) remained on the forward face; however, there was no visual indication of a chemical conversion coating,¹⁵ such as Alocrom 1200 (golden in colour) or Tectyl 502-C (an amber-coloured wax compound). There was also no evidence of primer, paint, or a chemical conversion coating on the repaired area.

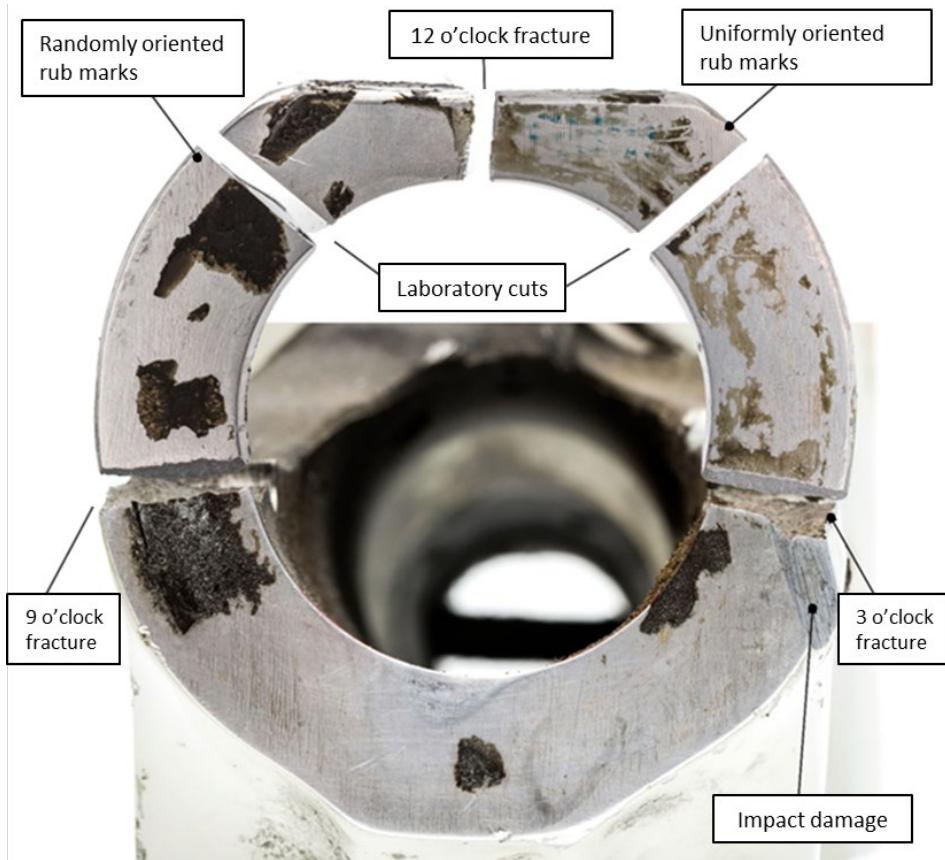
Figure 7. Forward face of the spigot housing, with residue visible (Source: TSB)

Although the EDS analysis confirmed that a chromium-based chemical conversion coating was present on the forward face of the spigot housing, other than at the repaired area at the 6 o'clock position, this coating could not be seen, as noted by the manufacturer.

Based on the fact that this coating is normally visible, it is likely that it had not been reapplied to the forward face during the last eddy current inspection. According to the overhaul manual for the MLG, Alocrom 1200 (or Alodine) must be applied on the forward face of the spigot housing during overhaul.¹⁹ In addition, a review of related SBs (SB 32-A-JA 851226,²⁰ SB 32-19,²¹ SB 32-JM7862,²² and SB 32-A-JA 140940²³) found that the reapplication of the chemical conversion coating is to be carried out on repaired areas on the forward face, where corrosion or wear marks (due to washer rotation) have been removed. There is no mention of reapplication of the chemical conversion coating according to visibility. Given that the zone from 7 o'clock to 5 o'clock was outside of the repaired area and that the cylinder was not being overhauled when the repair was performed, this zone did not have a requirement for recoating according to the SBs.

Even though the cracking occurred at the 12 o'clock location on the forward face of the spigot housing, the repair at the 6 o'clock position was also examined. It was found that the repaired area had not been coated with the coloured protective coating (chemical conversion coating), contrary to the instructions listed in SB 32-19. Although the absence of coating on the repaired area did not play a role in the failure of the MLG unit, if the coating omission is repeated during other MLG repairs, it could lead to pitting, stress corrosion cracking (SCC), and subsequent MLG failures.

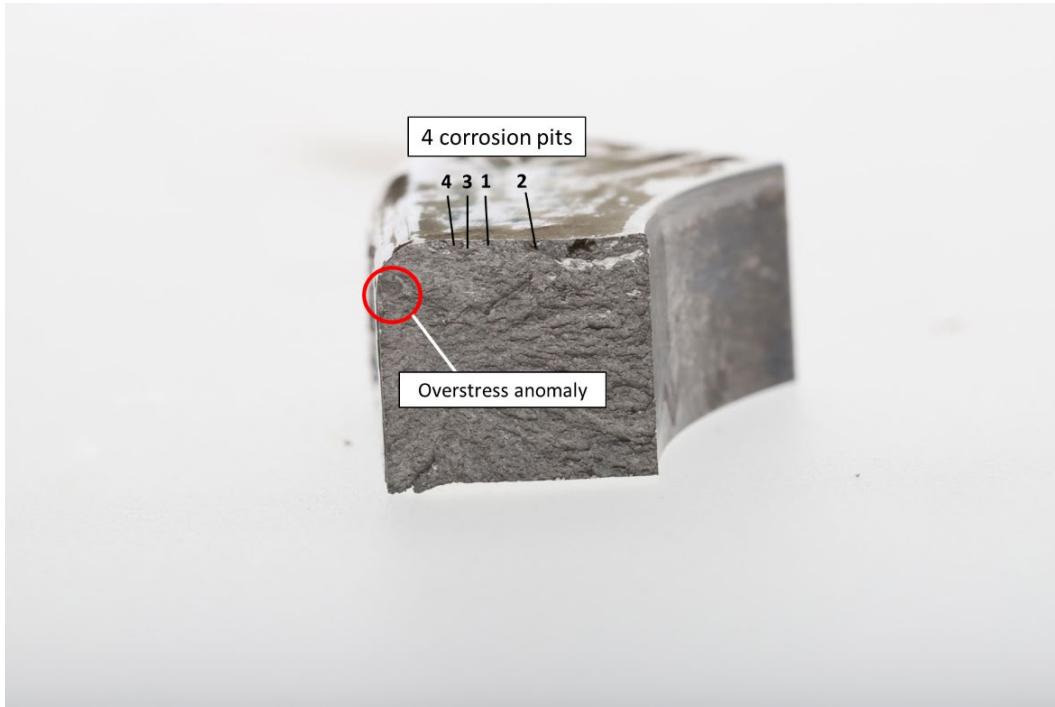
The features observed on the 12 o'clock fracture surface mainly consisted of rock candy¹⁶ fracture features (indicative of intergranular fracture) and ductile dimples (indicative of ductile overstress). These features initiated from 4 small corrosion pits and 1 overstress anomaly, the latter of which appeared as a dark circular feature (Figure 8). The 3 and 9 o'clock fracture surfaces also contained rock candy fracture features and ductile dimples. However, on those 2 fracture surfaces, there was no fatigue and very little corrosion pitting, and the origin of the intergranular cracking could not be determined from the features that were observed.

Figure 8. 12 o'clock fracture surface, with the overstress anomaly and corrosion pits shown
(Source: TSB)

crack length.^{17,18} The cause of the overstress anomaly is unknown, and the formation of corrosion pits indicated that the base material had been exposed to the environment at some point in time.

The TSB laboratory determined that it is likely that a corrosive environment entered the MLG unit's spigot housing at the overstress anomaly and the 4 corrosion pits and associated fatigue zones. These features are all well below the 6 mm critical crack length. In addition, there is metallurgical evidence of intergranular cracking at this location. Therefore, it is likely that the failure mode transitioned to SCC. SCC then propagated within the spigot housing, and the cracking likely progressed not only during landings, but also when the aircraft was parked. At some point, the amount of pre-failure cracking (a combination of the overstress anomaly, corrosion pits, fatigue cracking, and SCC) reduced the component strength to the point where the intact structure could not support the landing loads, and a final failure occurred in the form of ductile and intergranular fracture.
