AIR TRANSPORTATION SAFETY INVESTIGATION REPORT A24C0095

COLLISION WITH TERRAIN

KBM Forestry Consultants Inc.
Cessna U206F, C-FKZO
Lloydminster Airport (CYLL), Alberta, 7 NM SE
08 September 2024

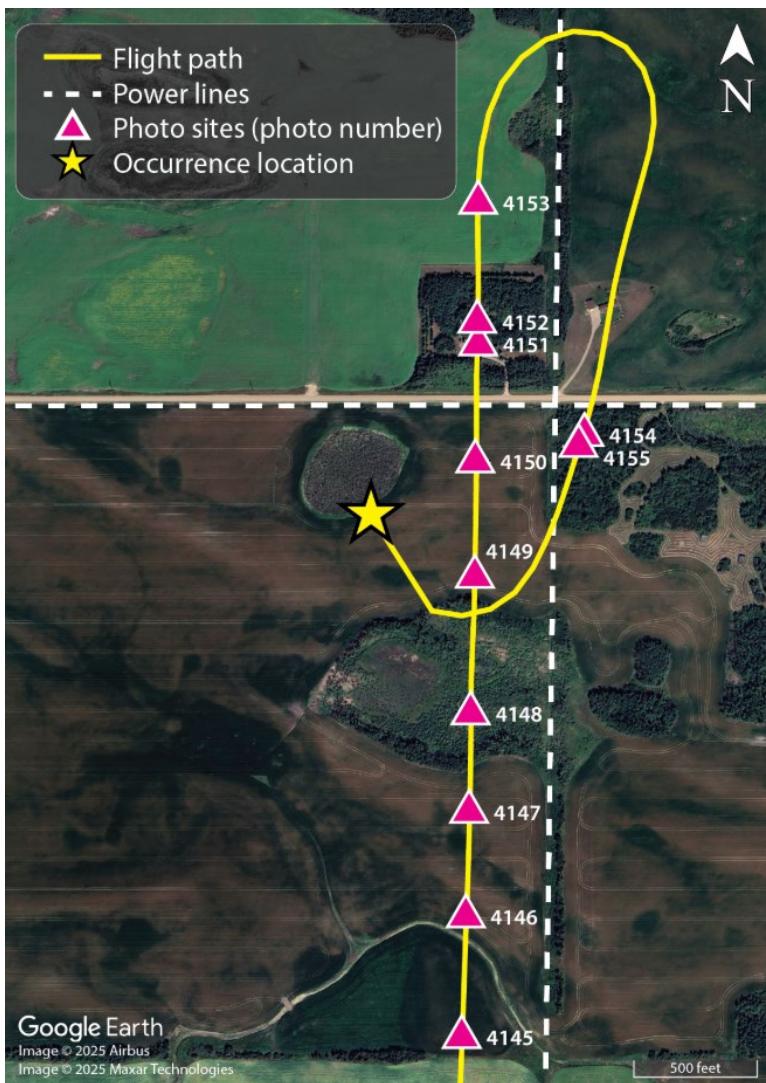
Figure 1. Occurrence flight path with photo sites and power lines
(Source: Google Earth with TSB annotations)

photographed twice (photos 4151 and 4152 in Figure 1). The next photo (photo 4153 in Figure 1) is of the next pole in the power line. The pilot then turned approximately 190° to the right to allow the observer to take 2 additional photos (photos 4154 and 4155 in Figure 1) of the intersection of power lines.

After the last photo was taken (photo 4155 in Figure 1), at 1753, the pilot started a right turn at a height of approximately 200 to 300 feet above ground level (AGL), likely to return to the original flight path to continue along the power line. During the turn, the aircraft stalled and its bank angle to the right increased. While the aircraft was descending at a rate of at least 3000 fpm, it began to roll to the left toward a wings-level attitude. Three seconds after the stall began, the aircraft impacted terrain (Figure 2).

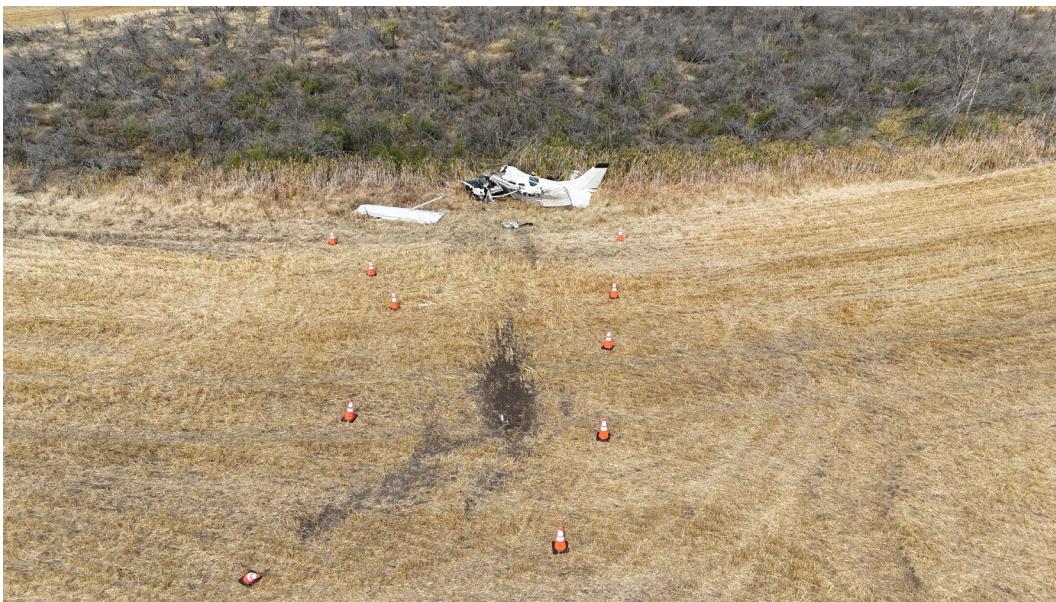
Figure 2. Occurrence site (Source: TSB)

The aircraft was destroyed. There was no indication of fire either before or after the occurrence.
