# AIR TRANSPORTATION SAFETY INVESTIGATION REPORT A24Q0027

## TOUCHDOWN SHORT OF RUNWAY

Boeing of Canada Ltd. de Havilland Division DHC-8-314, C-GAIW

Kangiqsujuaq (Wakeham Bay) Airport (CYKG), Quebec

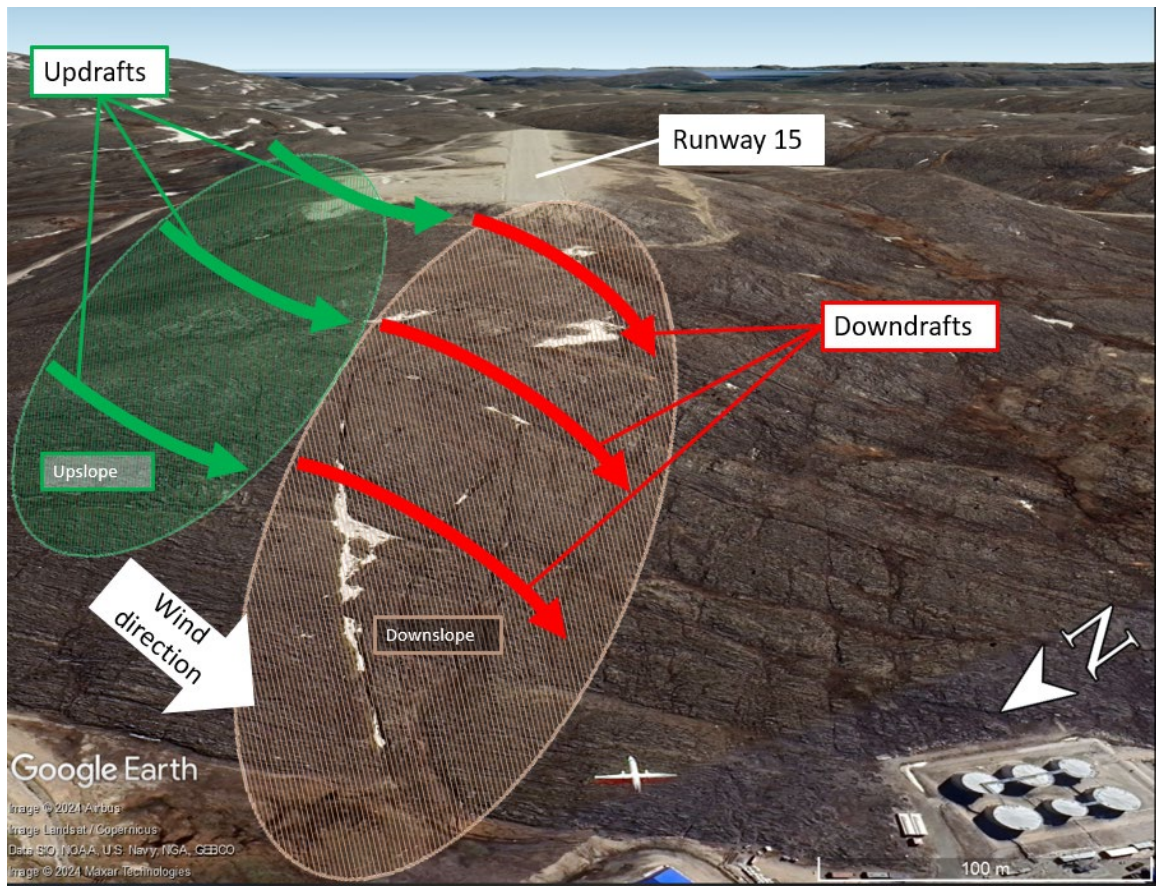
Taking into account the topography around CYKG and the winds present at the time of the occurrence, the investigation determined there were likely downdrafts in the final approach area for Runway 15 at that time (Figure 5).

Figure 5. Illustration of the likely wind currents in the vicinity of CYKG at the time of the occurrence  
(Source: Google Earth, with TSB annotations)

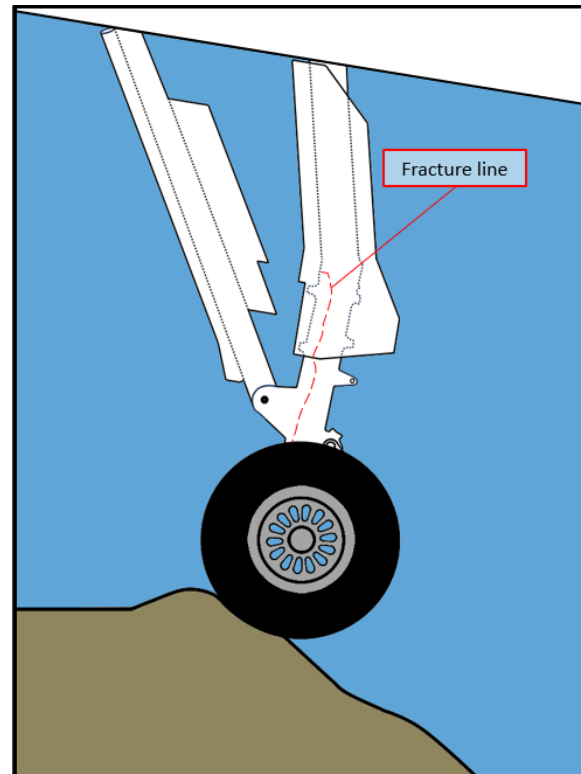
When the left landing gear struck the mound approximately 5 inches below the levelled part of the runway (Figure 7), the landing gear strut cylinder fractured (Figure 8), which led to the piston subassembly breaking off with the wheels attached.

Figure 8. Illustration showing the impact of the left landing gear striking the mound and the fracture line along the landing gear strut cylinder (Source: TSB)

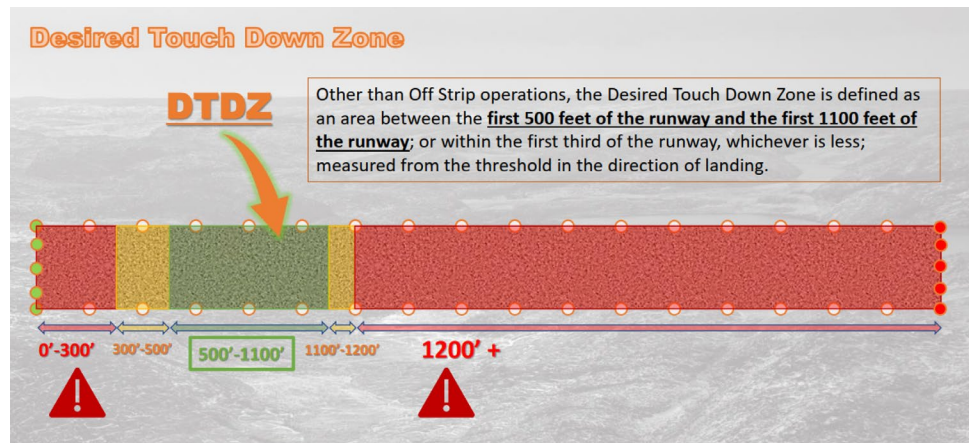
Figure 9. Diagram and definition of desired touch down zone (Source: Air Inuit Ltd. Landing Performance & Landing Geometry [training document])

That investigation found that company pilots had a tendency to attempt to land close to the runway threshold on gravel runways. The investigation also found that flight crews did not always fully understand landing performance calculations. More specifically, they did not understand how much of a safety margin was already included in the calculations and that the calculations were based on crossing the threshold at a height of 50 feet.

Air Inuit also made the following amendments to its training programs:

- detailed explanation of landing performance calculations based on various aiming points and approach angles;
- explanation of the eye-to-wheel height (EWH) and eye-to-wheel path height (EWPH) for DH8C aircraft, Boeing 737 aircraft, and Beechcraft 300 aircraft, depending on the pitch angle and approach angle;
- incorporation of the desired touchdown zone diagram in flight training and on the simulator for all aircraft operated by the company.
