# RAIL TRANSPORTATION SAFETY INVESTIGATION REPORT R24D0070

## MOVEMENT EXCEEDS LIMITS OF AUTHORITY

VIA Rail Canada Inc.

29 September 2024

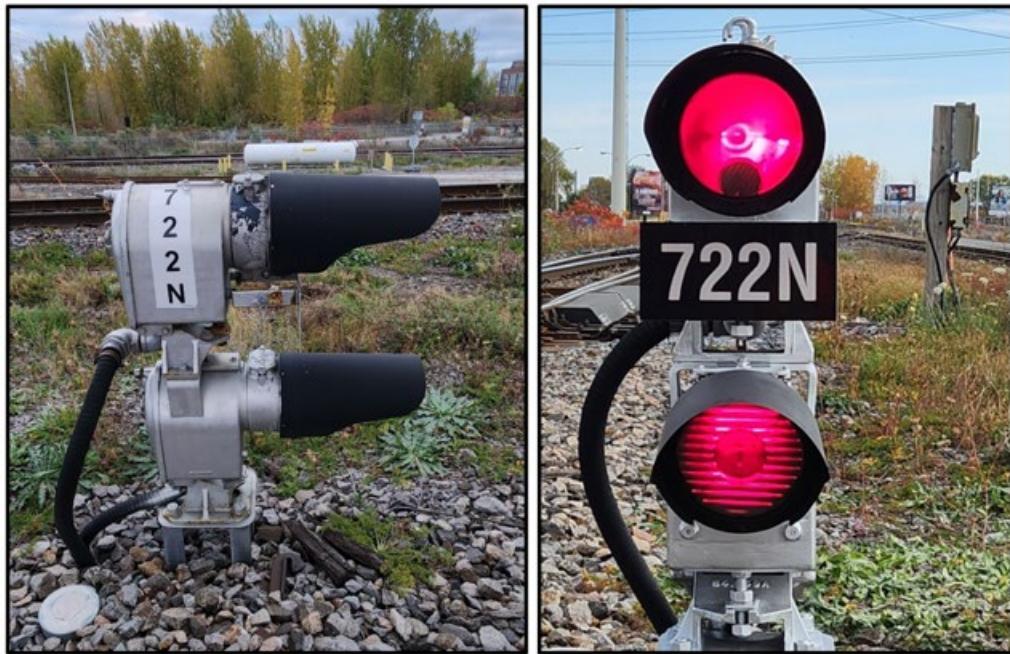
Figure 4. Side and front views of Signal 722N (Source: TSB)

The TSB also examined the components of the signalling system and Signal 722N. The examination revealed that the signalling system was operating as designed and that the optical, electrical, and mechanical components of Signal 722N were in good condition.

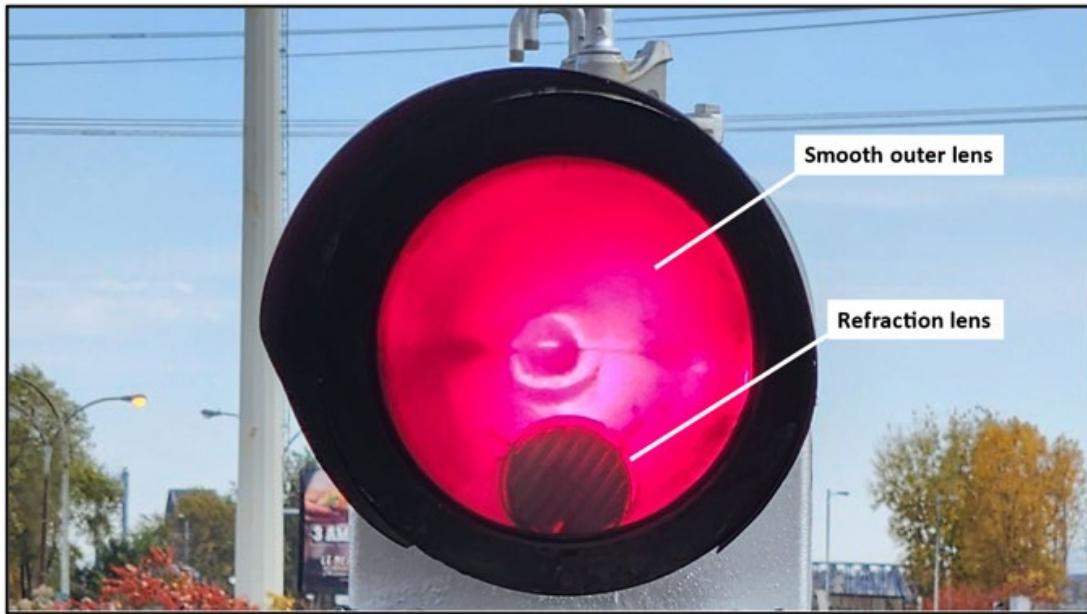
Figure 7. Top light of Signal 722N (Source: TSB)

VIA's internal investigation determined that, at the time of the occurrence, the sun was reflecting off the signal. A CN signal maintainer dispatched immediately to the scene confirmed that the top light of the signal had a yellowish tint despite the fact that the signal was displaying a Stop indication (red on red aspect). A VIA investigator determined that the sun's reflection on the outer lens may have caused the upper light to appear yellow. Following this incident, CN fitted the signal with extended hoods to reduce the risk of interference from sunlight reflecting off the signal lenses.<sup>29</sup>

The yellow colour of the top light of Signal 722N perceived by the ICLE was likely caused by the reflection of incident sunlight on the smooth lens surface.

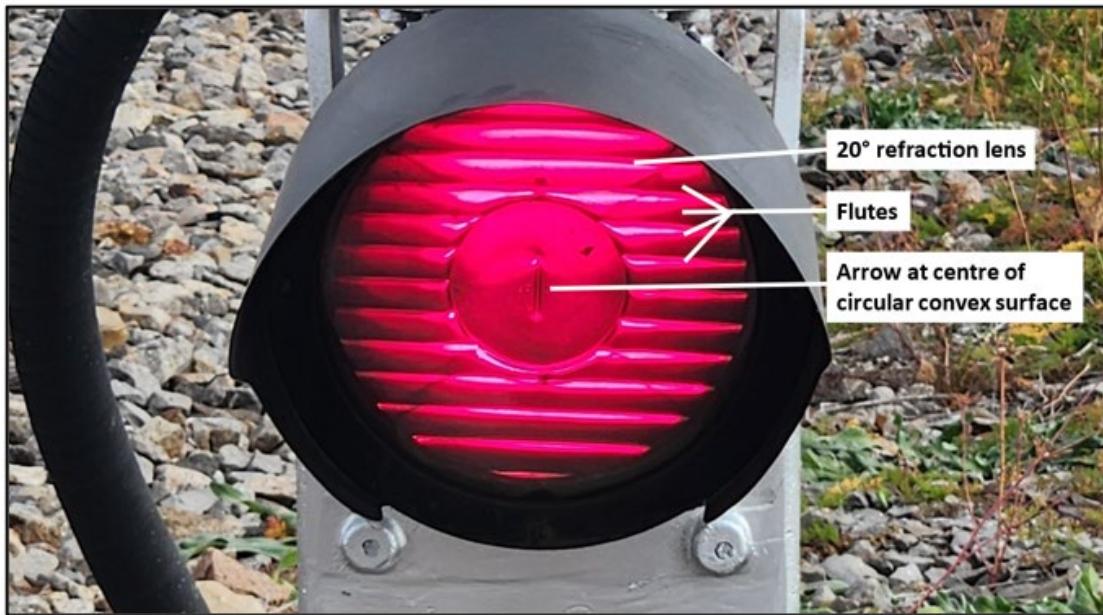
Figure 8. Bottom light of Signal 722N (Source: TSB)

The bottom light has a  $20^\circ$  external refraction lens, which is installed in a way that concentrates the light beam emitted by the light at an angle of  $20^\circ$  upwards. This type of lens has flutes and a smooth convex surface in the centre. An arrow in the centre of the smooth surface makes it possible to adjust the orientation of the lens and the light beam to suit the topographical conditions on the ground (Figure 8).

Signal 722N is the only signal in the interlocking limits that features 2 different types of lenses. Signal 722S, which is located at the same height on the south track, has 2 standard smooth lenses. The investigation was unable to determine why Signal 722N was equipped with different lenses.

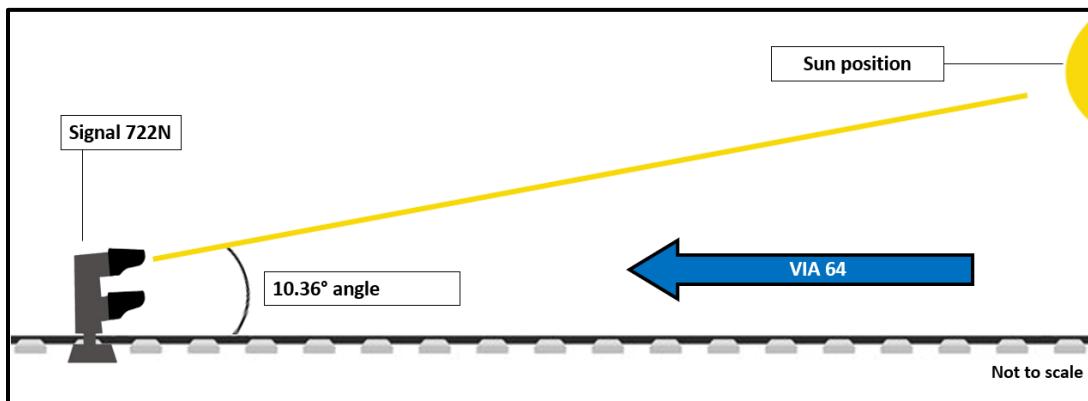
Figure 9. Effect of sunlight on Signal 722N (Source: TSB)

At the time of the occurrence, the sun was  $10.36^{\circ}$ <sup>30</sup> above the horizon and at a  $255.11^{\circ}$  azimuth at Signal 722N. According to data from the Ministère des Transports et de la Mobilité durable du Québec and REM surveillance cameras, as well as the forward-facing camera on the lead locomotive of VIA 64, the sky was clear and the sun was facing the signal and shining directly on its lenses (Figure 9).
