AIR TRANSPORTATION SAFETY INVESTIGATION REPORT A25W0077

HARD LANDING

Commercially registered
Bell Helicopter Textron Canada Limited Bell 206L-4, C-GKX
Hespero/Safron Residence Heliport (CTS6), Alberta
06 July 2025

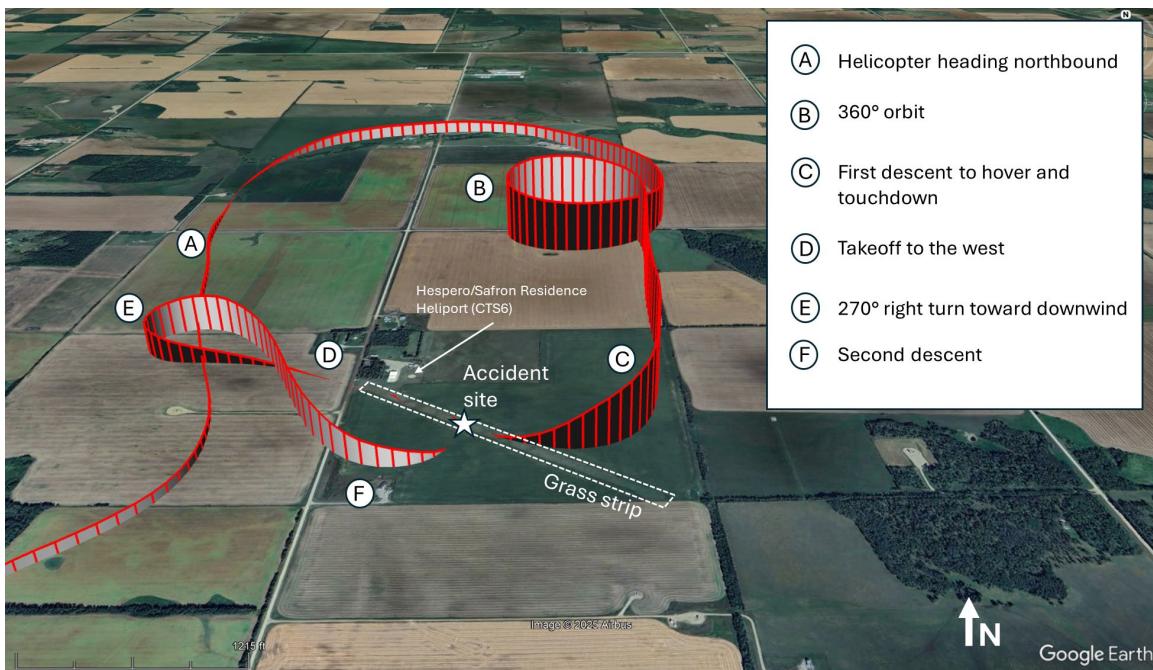
Figure 1. Map showing the occurrence helicopter's flight path (Source: Google Earth, with TSB annotations)

On 06 July 2025, the commercially registered Bell Helicopter Textron Canada Limited (Bell) 206L-4 helicopter (registration C-GKX, serial number 52387) was conducting a private visual flight rules (VFR) flight from The Lodge at Panther River, Alberta, to the Hespero/Safron Residence Heliport (CTS6), Alberta, with the pilot and 1 passenger on board. At 1213,¹ after a 34-minute flight, the helicopter overflowed the destination, heading north. The pilot conducted a 360° turn, and from a height of approximately 700 feet above ground level (AGL), commenced a turning approach consistent with an autorotation. The approach consisted of a 123° track change and a rate of

descent up to 3846 fpm. The pilot terminated the approach by conducting a power recovery² before landing in the middle of a grass strip, which was oriented on a heading of 290° magnetic (M).³ The pilot then departed along the grass strip, on a northwest heading and conducted a 270° turn to the right, eventually turning downwind on the southwest side of the grass strip. He levelled off at a height of approximately 300 feet AGL, at approximately 80 knots indicated airspeed (KIAS), and on a heading of 140°. At 1218:29, he started a left turn that increased to 43° of bank toward a heading of 351° in another descent consistent with an autorotation (Figure 1). At 1218:41, the maximum rate of descent in the turn was recorded to be 2362 fpm at a height of 100 feet AGL. In the next 5 seconds, the helicopter pitched up to 14° and the rate of descent slowed to 125 fpm at a ground speed of 30 KIAS while the helicopter banked 9° to the right. Over the next 6 seconds, the rate of descent increased, and the pitch fluctuated.

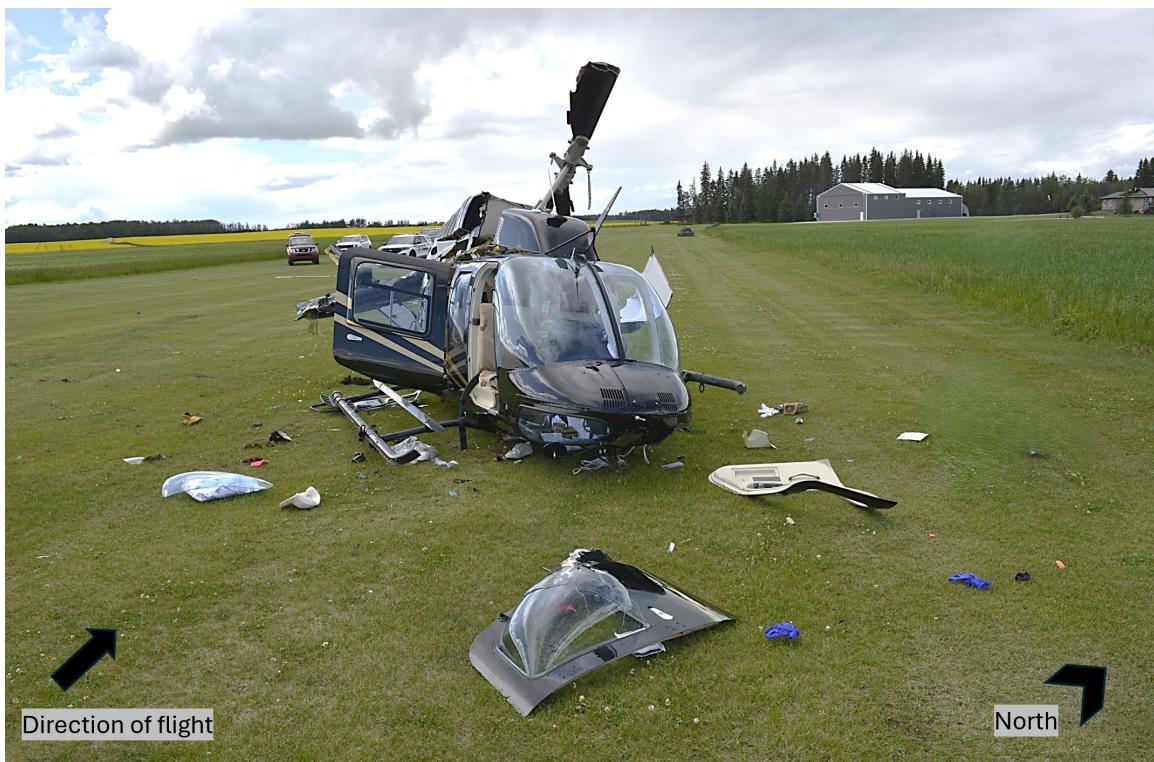
Figure 2. Occurrence site, looking west (Source: TSB)

The helicopter contacted the ground at 1218:50, the skid gear collapsed, and the helicopter came to rest facing the opposite direction of travel. One main rotor blade impacted the tail boom, and the tail rotor was separated from the fuselage. The 2nd main rotor blade was found clear of the wreckage, severed outboard of the blade doublers with evidence of contact with the upper wire cutter (Figure 2). There was no post-impact fire. The passenger was fatally injured, and the pilot was seriously injured.
