# RAIL TRANSPORTATION SAFETY INVESTIGATION REPORT R24C0012

## MAIN-TRACK TRAIN DERAILMENT

Canadian Pacific Railway Company, doing business as CPKC  
Freight train 119-02  
Mile 65.8, Brooks Subdivision  
Near Brooks, Alberta  
05 February 2024

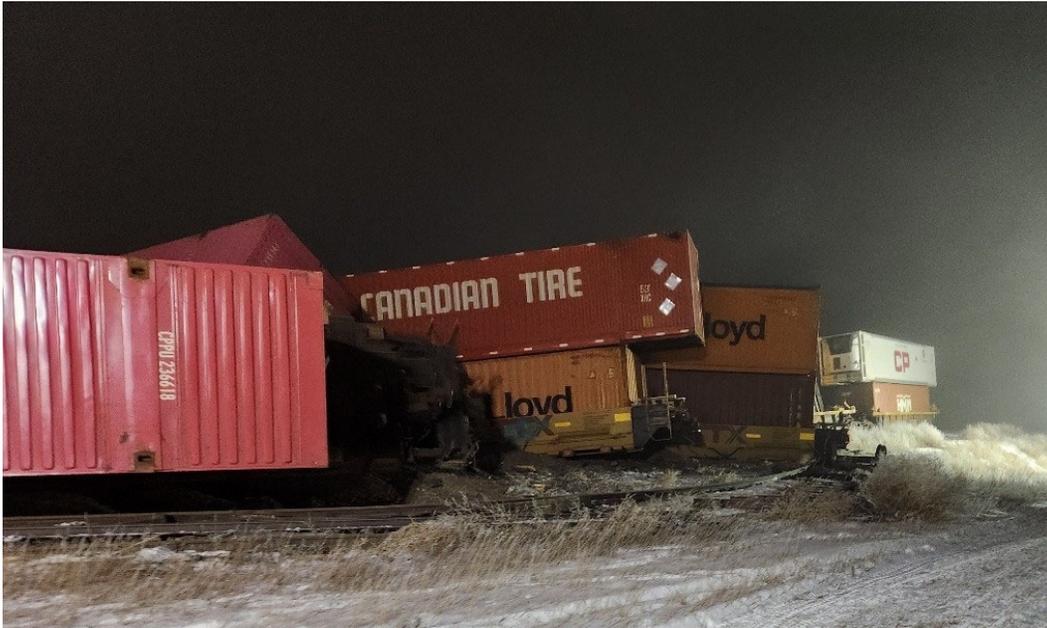
The cars had derailed in an accordion fashion (Figure 2).

Figure 2. Cars derailed in an accordion fashion (Source: TSB)

The investigation could not determine with certainty the derailment sequence. A number of broken rails were observed in the area where the train derailed. Inspection of about 3000 feet of track to the east of the derailment site revealed indications of wheels sliding on the rail head surface.

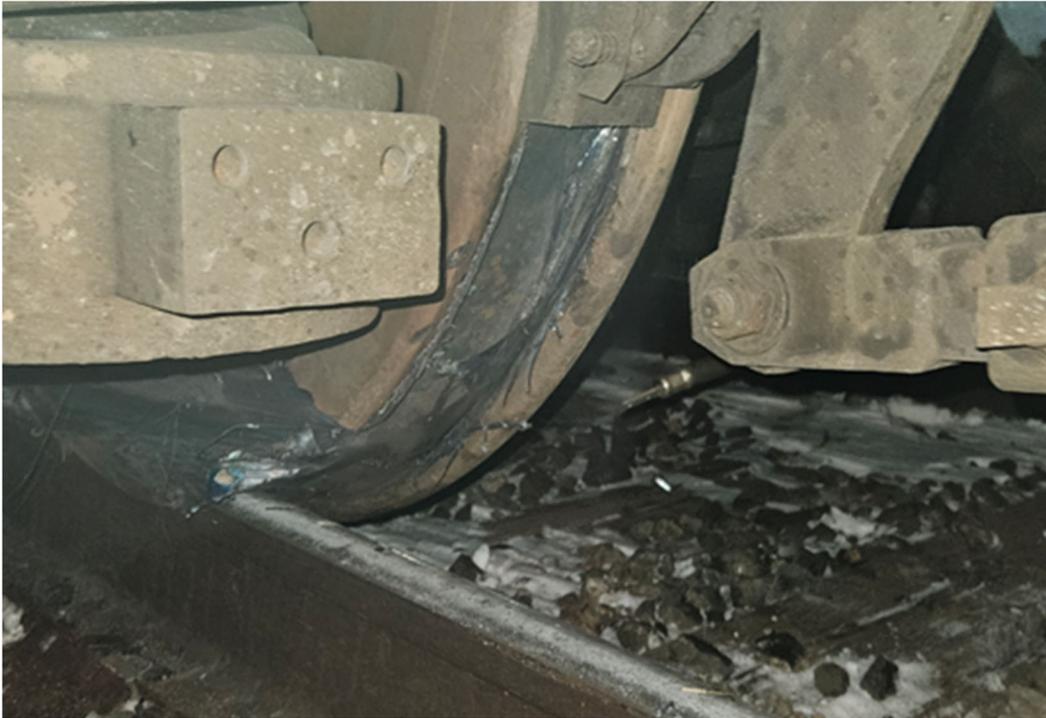
Further inspection of the train revealed that both wheels of the #4 wheel set on locomotive KCS 4767 had significant damage (Figure 3), consistent with an axle not freely rotating and intermittently locking up.

Figure 3. Damage to the L4 wheel on locomotive KCS 4767 (Source: TSB)

After the occurrence, it was determined that axle #4 of locomotive KCS 4767 had locked up, causing significant damage to the wheels, which led to a track failure and the derailment. Based on the site examination, the investigation could not determine with certainty the derailment sequence.

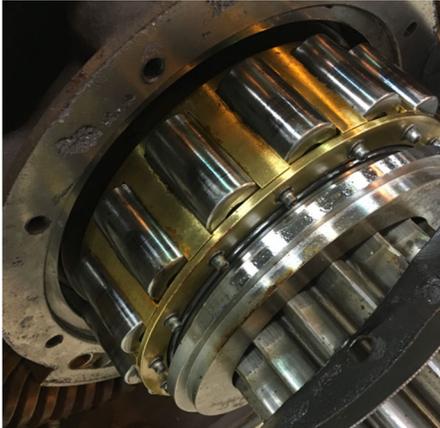
The gearcase on traction motor #4 was found to have little oil, with residue inside the bottom half of the gearcase. The pinion-end bore seal on the traction motor was also pinched. The pinched seal led to the gradual depletion of the gearcase oil, depriving the pinion-end bearing—a component that supports the rotor—of lubricant and eventually causing it to seize. Figure 4 shows a pinion-end bearing.

Figure 4. Pinion-end bearing (Source: CPKC)

Subsequent examination of the wheel set and traction motor assembly #4 determined that an incorrect bolt pinched the traction motor's pinion-end bore seal. The pinched seal led to the gradual depletion of the gearcase oil, depriving the pinion-end bearing from lubricant. This loss of lubrication eventually caused the bearing to seize, resulting in a locked axle condition. It could not be determined why an incorrectly sized bolt was installed.

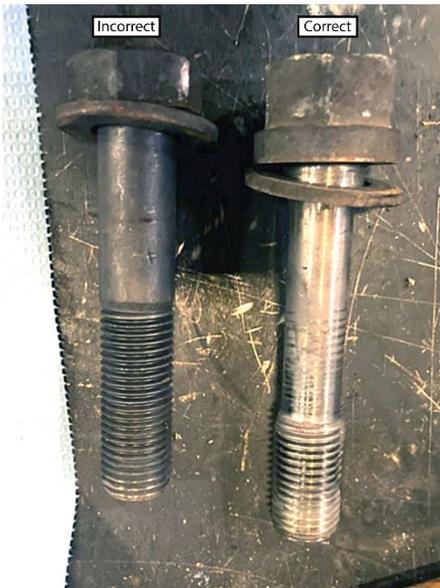
According to CPKC's report, there was an incorrectly sized gearcase mounting bolt on the traction motor (Figure 5), likely installed after a slow-speed (5.6 mph) derailment that occurred in Mexico in October 2023.<sup>8</sup> When the incorrectly sized bolt was installed, it pinched the seal and provided a path for the gearcase oil to leak.

Figure 5. Incorrect gearcase mounting bolt installed on traction motor #4 of locomotive KCS 4767 and the correct mounting bolt for comparison (Source: CPKC)

CPKC records do not indicate when the incorrect bolt was installed. However, in its conclusion, CPKC's report indicated that the installation of the incorrect bolt likely took place during repairs after the slow-speed derailment in October 2023.

A review of the locomotive's repair history revealed that it had been involved in a slow-speed derailment at CPKC in Mexico in October 2023. It is likely that an incorrectly sized bolt was installed on traction motor #4 during the repairs made after this derailment. After these repairs, the locomotive was released into unrestricted service. It underwent its annual inspection a few days later. Although the inspection was performed in accordance with requirements, the incorrectly sized bolt was not identified or replaced.
