AIR TRANSPORTATION SAFETY INVESTIGATION REPORT A24P0074

COLLISION WITH TERRAIN

Privately registered
Cessna 421C, N264DC
Tofino/Long Beach Airport (CYAZ), British Columbia
18 July 2024

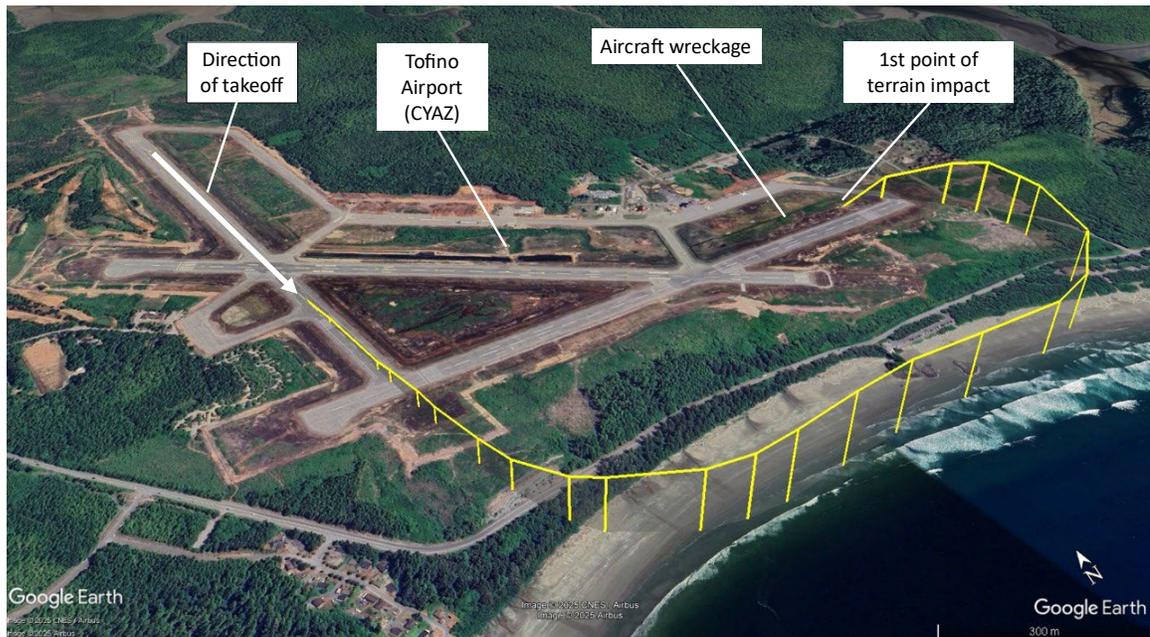
The aircraft departed Runway 16 at approximately 1242.¹ Shortly after takeoff, the aircraft occupants observed flames coming from the top of the right engine cowling. The aircraft turned east,² joined the left downwind leg for Runway 25, and levelled off at approximately 320 feet above ground level (AGL) (Figure 1).

Figure 1. Flight path of occurrence flight based on radar data (Source: Google Earth, with TSB annotations)

The aircraft subsequently performed a descending steep turn toward the threshold of Runway 25 but overshot the runway centreline to the north. During this turn, the aircraft's rate of descent increased significantly.

At 1243, approximately 1 minute after takeoff, the aircraft impacted the ground north of Runway 25 in a wings-level attitude with the landing gear extended and the flaps partially extended.³ The initial point of impact was approximately 206 feet past the runway threshold and 157 feet north of the paved surface of Runway 25.

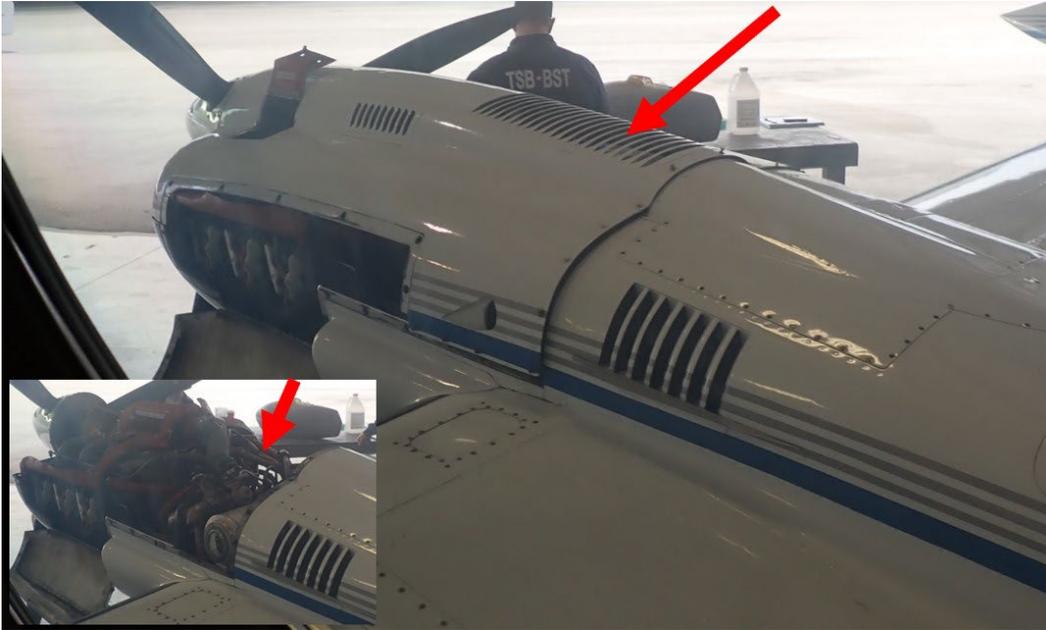
The aircraft’s right engine was examined by TSB investigators and laboratory personnel at an engine repair and maintenance facility in Kamloops, BC. The right engine turbocharger was sent to the TSB Engineering Laboratory in Ottawa, Ontario, for further analysis. During examination of the turbocharger components, it was noted that the 1-piece V-band clamp, which connects the engine turbocharger to its exhaust pipe, exhibited wear. This indicates that it may have been either improperly installed or misaligned.

An in-flight fire, located in the right engine nacelle (Figure 3), occurred just after takeoff. The fire characteristics were consistent with a turbocharger exhaust fire resulting from a disconnected turbocharger exhaust pipe. It is unknown if the aircraft fire warning system activated.¹⁶

Figure 3. Approximate location of the in-flight fire indicated by arrows, with inset image showing the approximate fire location with the upper engine cowling removed. The pictured aircraft is a Cessna 421B, which has the same engine and nacelle as the Cessna 421C (Source of main image and inset: TSB)

The turbocharger exhaust for the right engine was found disconnected from its turbocharger, whereas the same components for the left engine were found connected.

Failures of turbocharger exhaust-to-tailpipe V-band clamps and couplings can result in engine fires. Therefore, V-band clamps on aircraft turbochargers must be installed, maintained, and inspected in accordance with the published guidance. Additionally, many of these V-band clamps and couplings are subject to ADs. Compliance with ADs is the responsibility of aircraft owners and lessees.

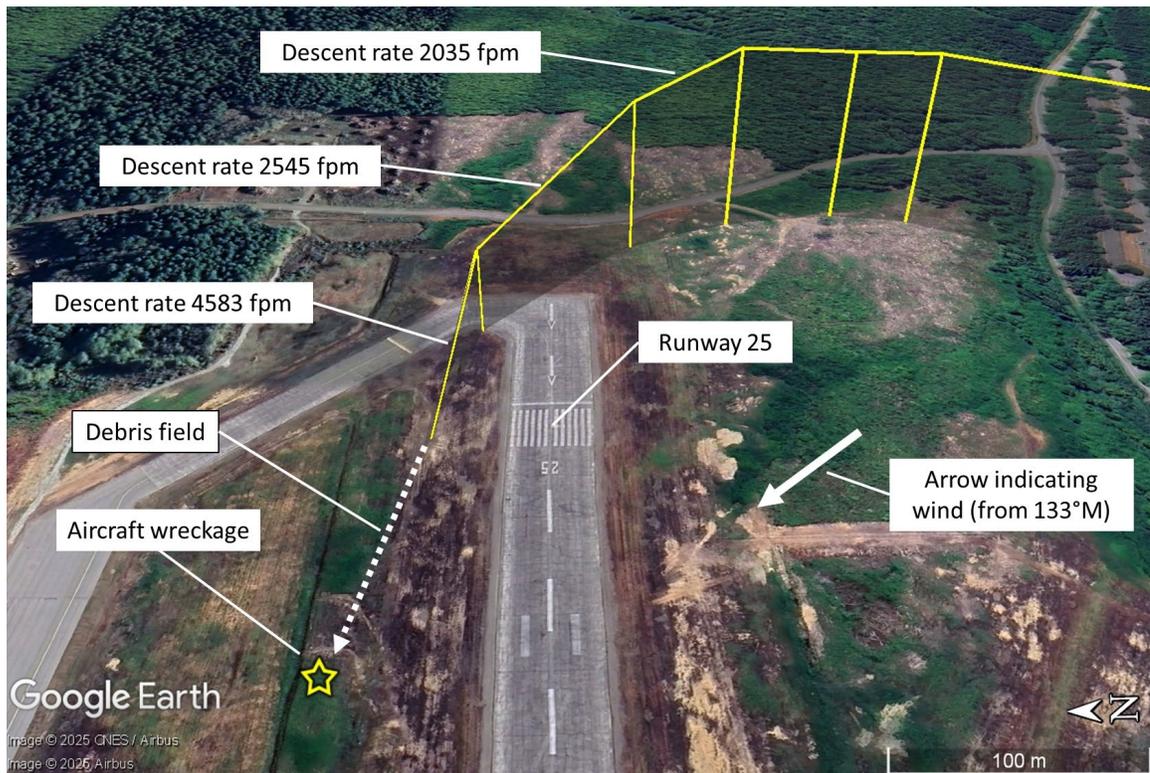
The aircraft's stall warning system¹⁸ activated while the aircraft was performing the descending turn toward the threshold of Runway 25 (Figure 5). The descent rate for a normal approach to landing in the Cessna 421C is approximately 500 fpm.¹⁹ Between the last 2 recorded data points during the turn, the aircraft's rate of descent averaged approximately 4583 fpm. The maximum bank angle during the turn was calculated to be 57°, and the lowest true airspeed was calculated to be 110 knots.

Figure 5. Detail of the occurrence aircraft's turn to final, based on radar data (Source: Google Earth, with TSB annotations)
