Transportation  
Safety Board  
of Canada

# AIR TRANSPORTATION SAFETY INVESTIGATION REPORT A24W0008

## CONTROLLED FLIGHT INTO TERRAIN

British Aerospace P.L.C. Jetstream Model 3212, C-FNAA

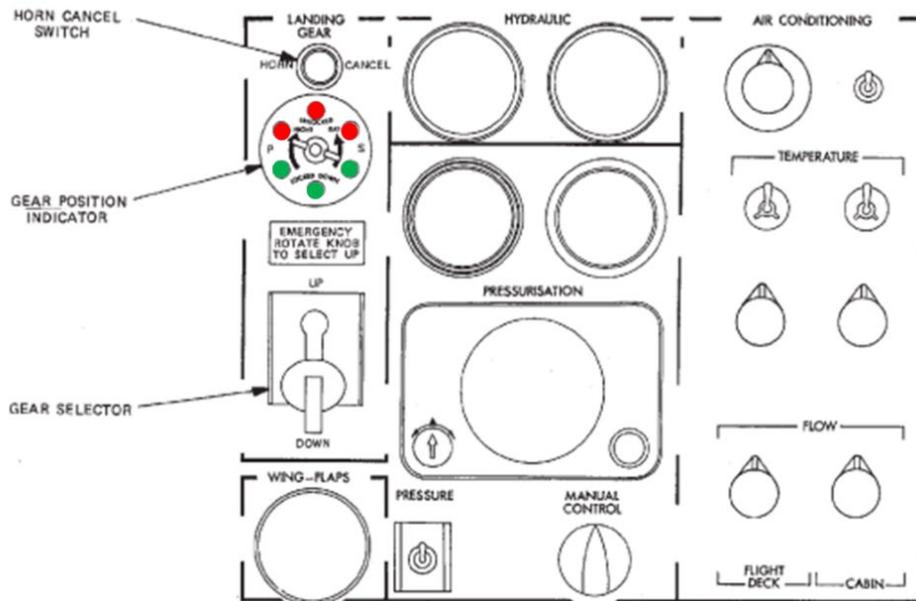
Figure 2. Low centre instrument panel, showing the landing gear position indicator with its red (top) and green (bottom) indicator lights (Source: BAE Systems, Jetstream 3200 Series Aircraft Maintenance Manual, Revision 35 [28 September 2023], 32-60-00: Position and Warning Description and Operation, p. 2, with TSB annotations)

The investigation determined that there had been an intermittent issue with the left main landing gear unit, in that it did not fully retract when outside temperatures were colder than approximately  $-20^{\circ}\text{C}$  and when the landing gear was under air load at indicated airspeeds exceeding approximately 140 KIAS. However, this information was not found recorded in any of the aircraft's technical records. The investigation determined that the Jetstream pilots within Northwestern Air Lease had developed an informal procedure to address the issue. According to this informal procedure, the PF increases the pitch angle of the aircraft to bleed off airspeed down to approximately 140 KIAS, at which point the landing gear locks in the retracted position, the landing gear position indicator lights extinguish, and the pilots can then continue the flight as usual.

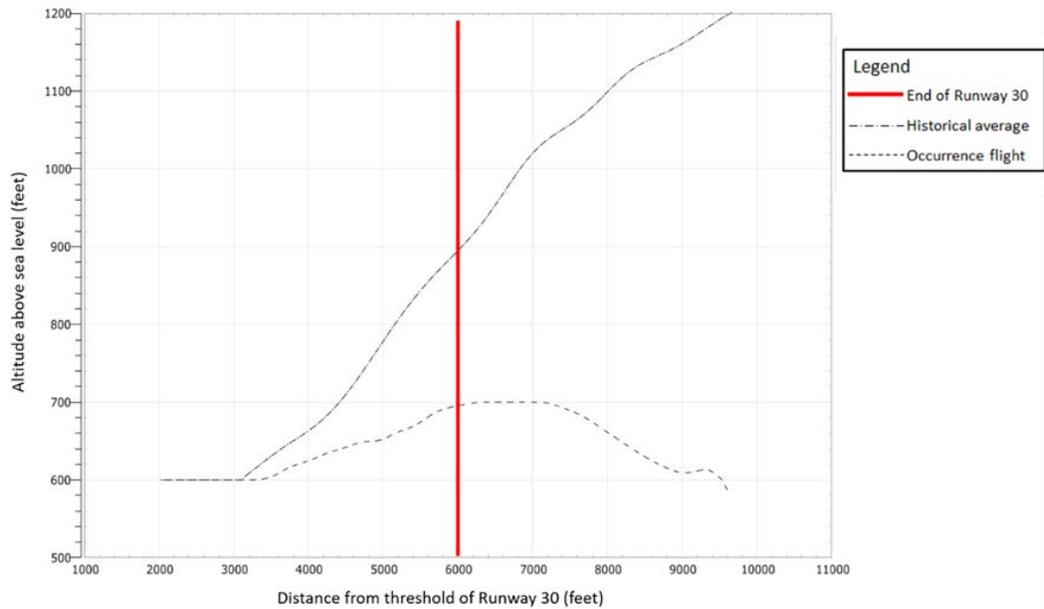
Figure 3. Comparison of height on initial climb between the historical average and the occurrence flight (Source: TSB)

During the occurrence flight, the aircraft departed Runway 30 with an approximate headwind of 2 to 3 knots. During the takeoff, by the time the aircraft reached the end of Runway 30 it had reached a height of approximately 100 feet AGL (700 feet above sea level

[ASL]) and a ground speed of 145 knots. By comparison, the average height reached by the end of the runway, based on 3 of the occurrence aircraft's previous takeoffs, is 280 feet AGL (880 feet ASL), with an average ground speed of 128 knots.

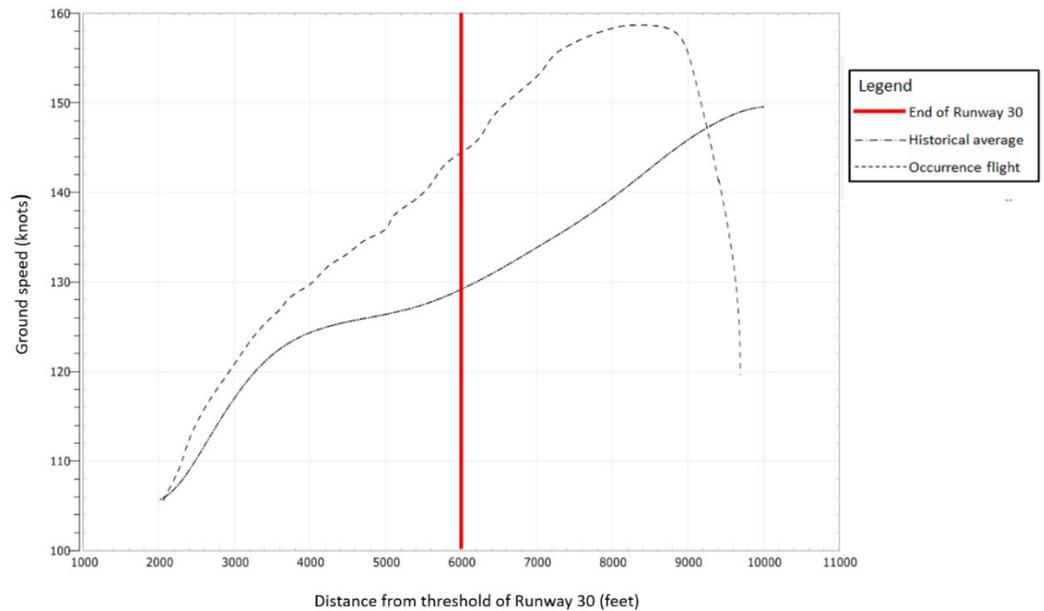
Figure 4. Comparison of ground speed on initial climb between the historical average and the occurrence flight (Source: TSB)

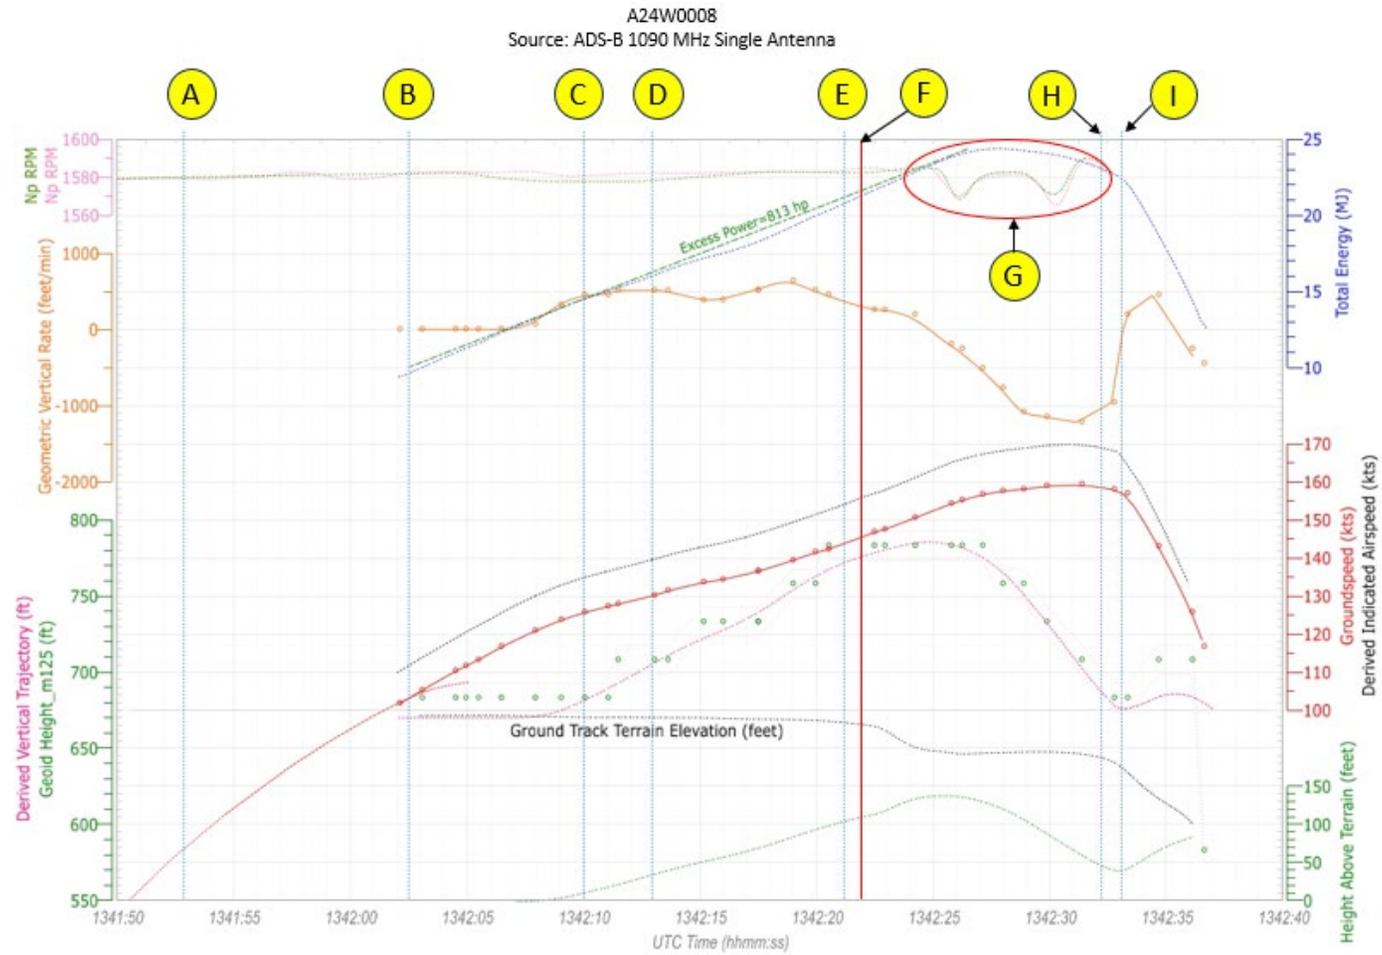
Figure A1. Time history plot of occurrence takeoff

Eight seconds later, and at a height of approximately 100 feet above ground level (AGL), the FO observed an abnormal landing gear indication and notified the captain. Two seconds later, the FO called for the captain to reduce the speed; the captain acknowledged, and 2 brief changes in propeller rpm occurred within 6 seconds. During the initial climb, the captain maintained a shallow climb angle and attitude, the aircraft's speed increased to approximately 165 knots indicated airspeed (KIAS), and the aircraft reached a maximum height of approximately 140 feet AGL (Appendix A, Figure A1). At this point, the aircraft

Event	Local time	Elapsed time (seconds)	Event description
A	0641:53	0	"70 knots" call
B	0642:03	10	"V <sub>1</sub> " and "Rotate" calls
C	0642:10	17	"Positive rate" call
D	0642:13	20	First officer (FO) makes continuous ignition query
E	0642:21	28	FO observes abnormal gear indication and calls for speed reduction
F	0642:22	29	Aircraft passes the end of Runway 30
G	0642:25	32	Engine rpm fluctuations
H	0642:32	39	Terrain awareness and warning system alert, "Descending" call made by FO
I	0642:33	40	Initial impact sounds at the end of the runway clearway (end of cockpit voice recorder recording)

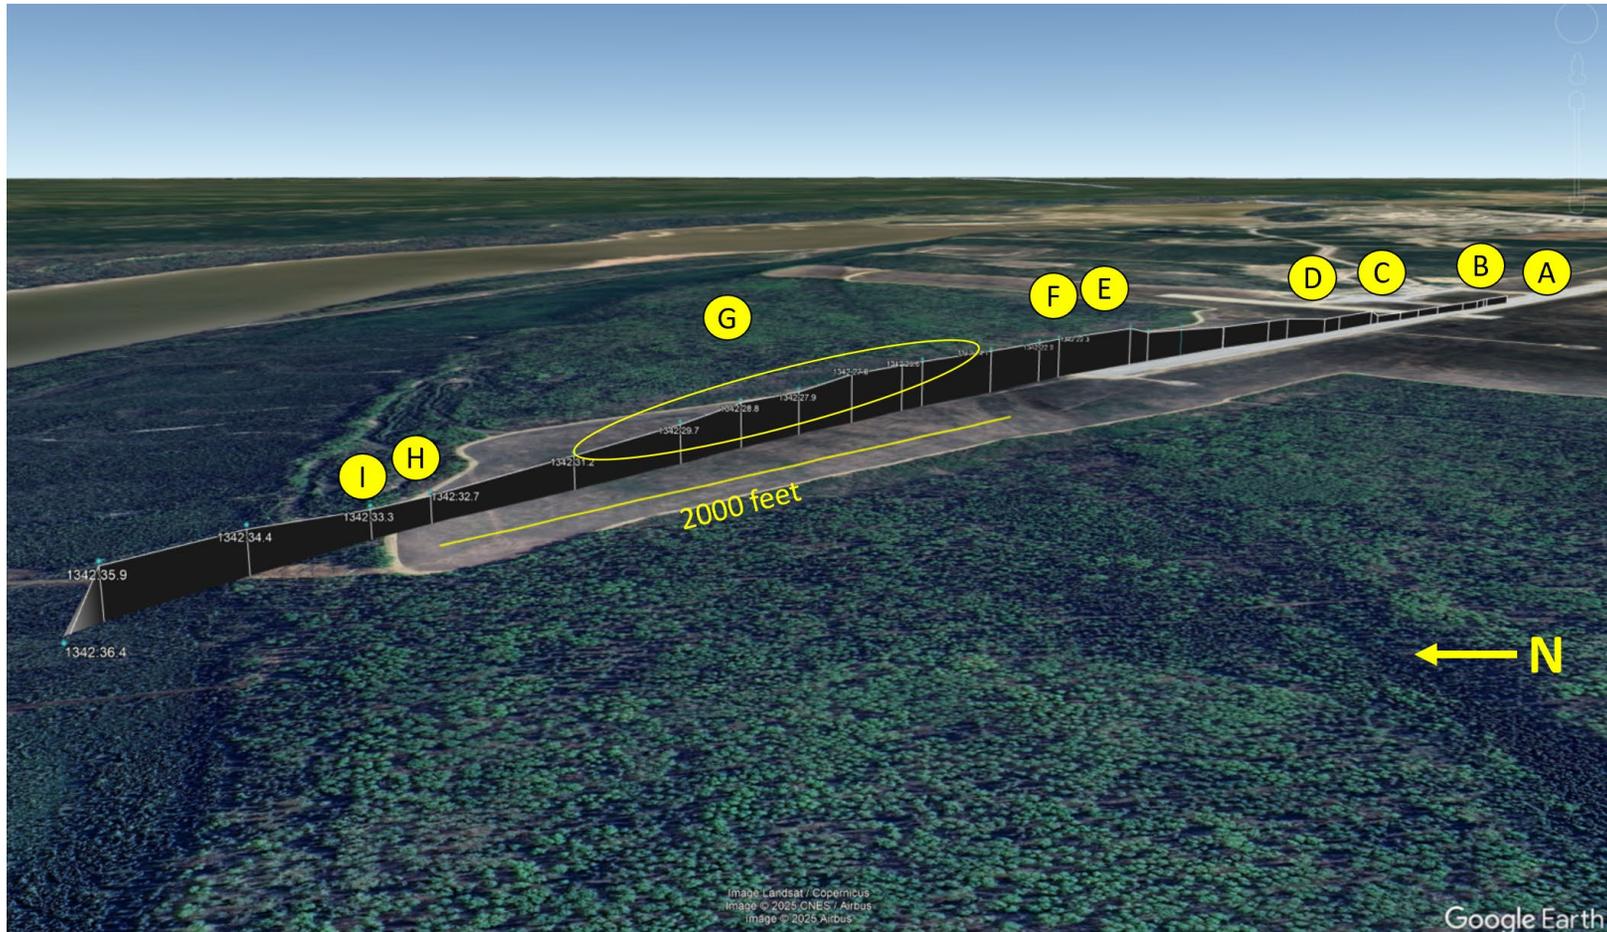
The aircraft impacted the tops of trees located 0.5 NM (3050 feet) beyond the end of Runway 30, at a height of approximately 40 feet. The broken treetops indicated that the aircraft was in a wings-level attitude at the time of the initial impact. Fuel was smelled at this location by ground search personnel early in the search effort, and several pieces of the aircraft, primarily consisting of aircraft fairings and propeller spinner pieces, were found.

After the initial impact with the trees, the aircraft continued to travel on a heading of 300°T before impacting terrain 680 feet past the edge of the cleared area and coming to rest. Following this impact, the fuselage and empennage remained together, but both the left and right wings broke away from the fuselage and travelled forward of the fuselage location. The engines were still partially attached to their respective wings; however, some of the engine mounting structures were broken. All propeller blades from both propellers were broken at the hubs.

Figure A2. Occurrence aircraft's flight path, with the location of events indicated
