# AIR TRANSPORTATION SAFETY INVESTIGATION REPORT A24P0092

## COLLISION WITH TERRAIN

West Coast Helicopters Maintenance and Contracting Ltd.  
American Eurocopter an EADS Company AS350 B2 (helicopter), C-GWCT  
Brooks Peninsula, British Columbia  
15 August 2024

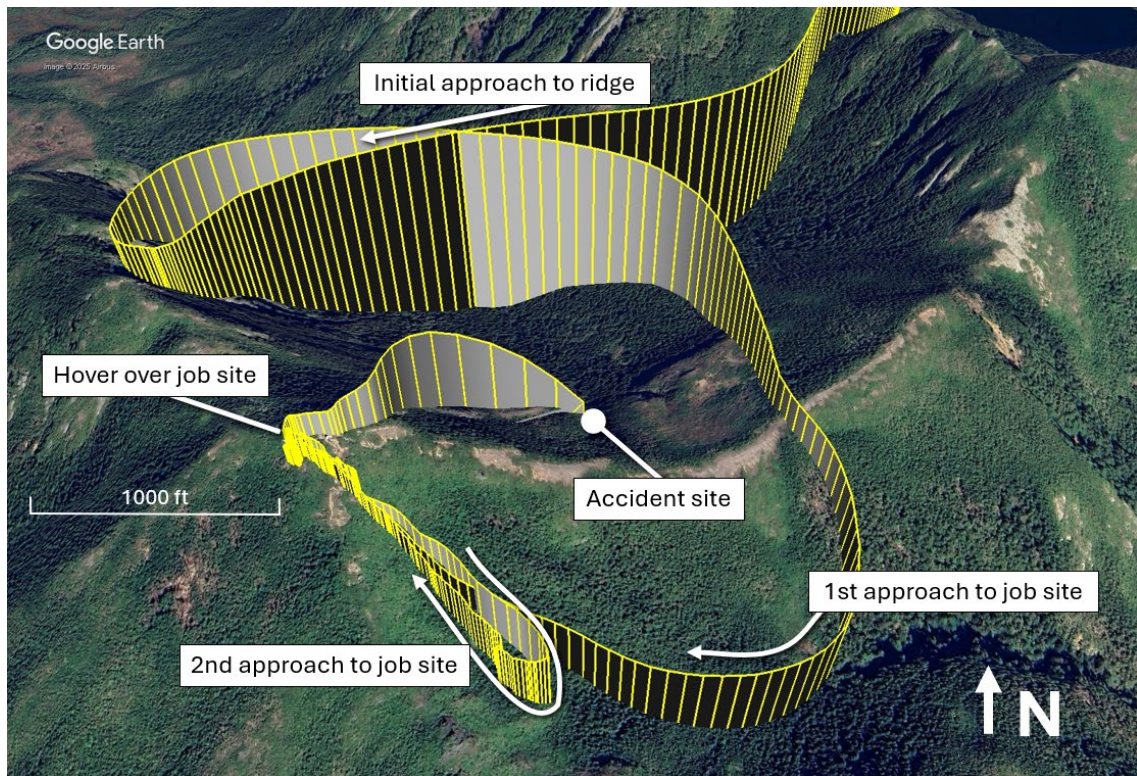
The helicopter hovered over the job site for 3 minutes, at a height<sup>8</sup> of approximately 100 feet above ground level (AGL) (approximately 2500 feet above sea level [ASL]). At 0952, the helicopter departed to the northeast and initiated a shallow climb. Approximately 20 seconds later, the final recorded global positioning system (GPS) position indicated that just before the accident, the helicopter was on a northeast track, travelling at approximately 60 knots ground speed (Figure 3). Its final descent rate exceeded 9000 fpm.

Figure 3. Map showing the occurrence flight path (Source: Google Earth, with TSB annotations)

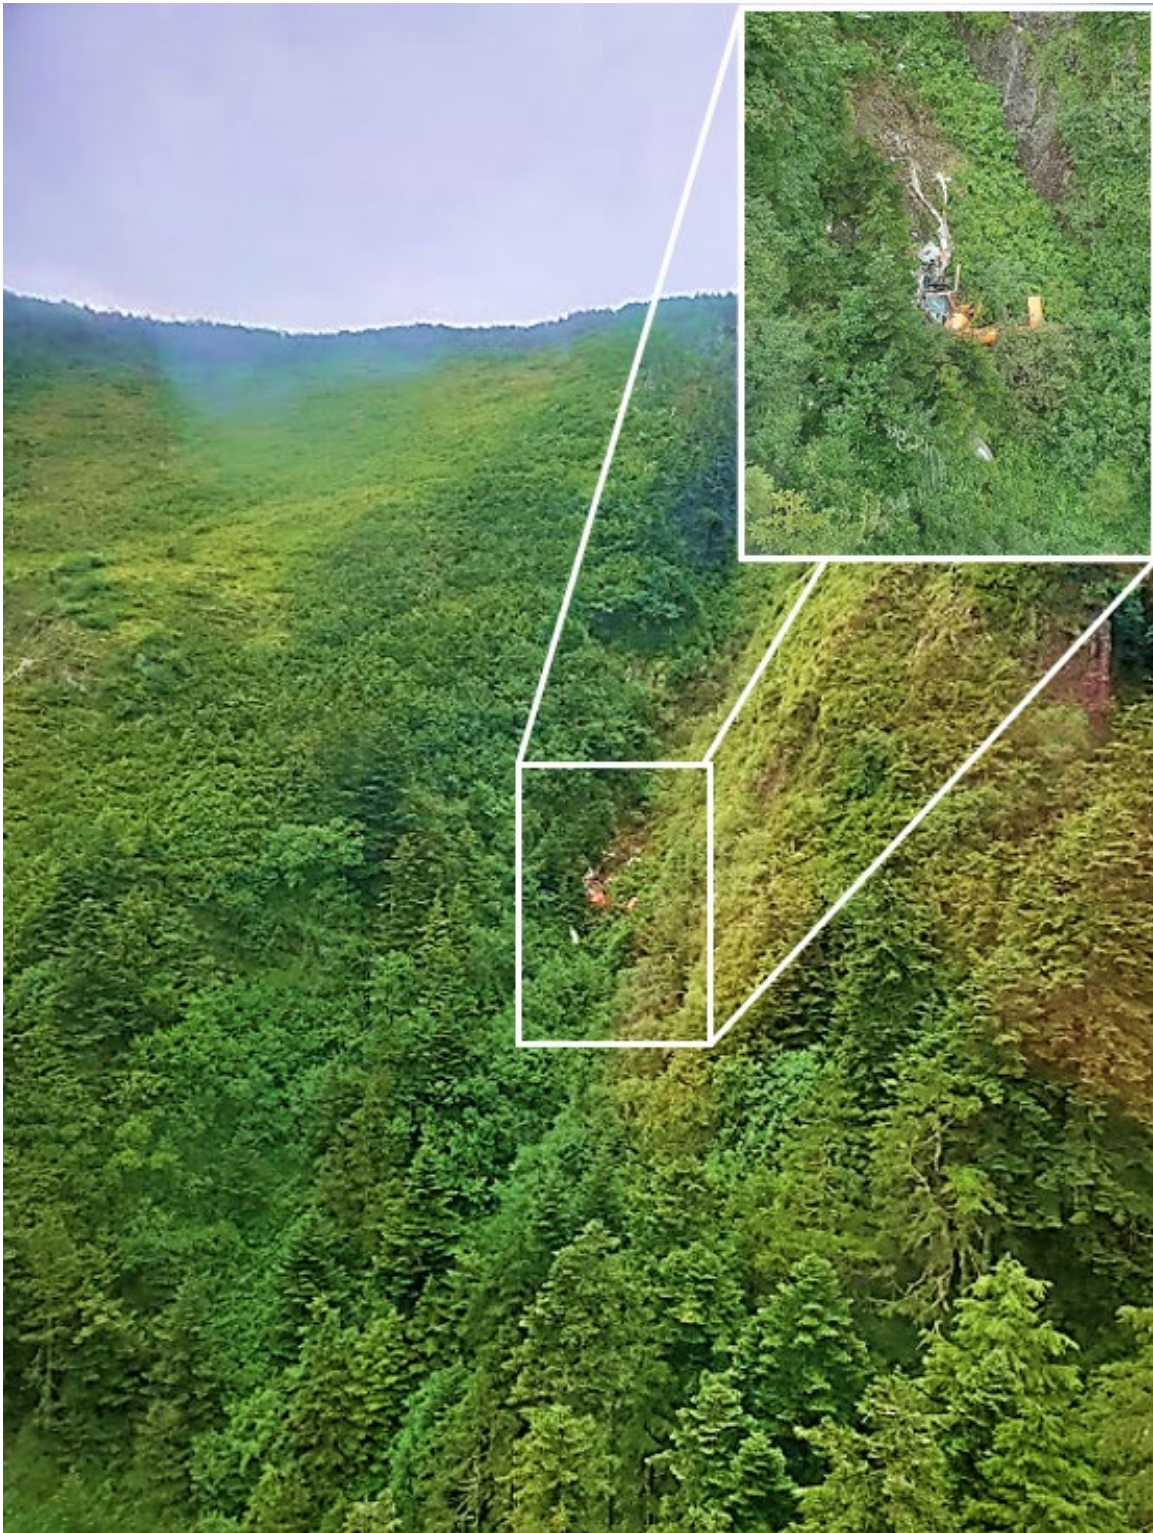
The helicopter had impacted terrain in a nose-down attitude and was destroyed (Figure 4). There was no post-impact fire. The pilot was the sole occupant and was fatally injured.

Figure 4. Occurrence site, looking south, with close-up view in inset (Source of both images: Joint Rescue Coordination Centre)

There was an impact scar on the ground approximately 450 feet west of the helicopter impact site, which is consistent with the load having impacted terrain after being released in flight. The load appears to have then rolled 125 feet downhill and come to rest approximately 325 feet from

the helicopter impact location. The longline was still connected to the load, which is consistent with the load being intentionally released from the helicopter belly hook attachment point. The investigation did not discover any damage to the longline or hook assemblies. There was no indication that the load came into contact with trees or terrain before being released by the pilot.
