# RAIL TRANSPORTATION SAFETY INVESTIGATION REPORT R23V0205

## MAIN-TRACK TRAIN COLLISION AND DERAILMENT

BNSF Railway Company  
Freight trains R-NWE8041-18I and M-VBCEVE1-18T  
Mile 133.54, New Westminster Subdivision  
Delta, British Columbia  
19 November 2023

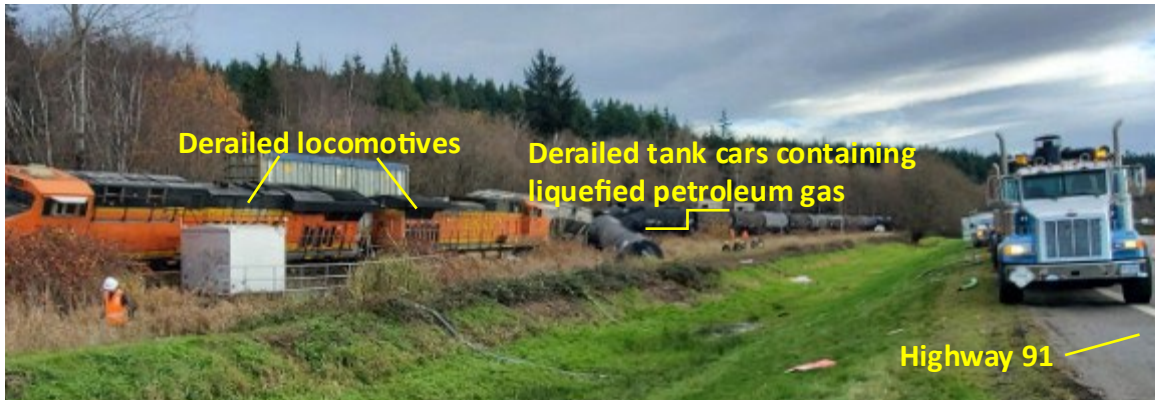
As a result of the collision, 2 multi-platform intermodal cars on train 118 (positions 8 and 9) derailed and sustained damage. This included the 2nd and 3rd platforms of the 3-platform car DTTX 620860, and the first 2 platforms of the 3-platform car BNSF 230028. On train 804, 2 locomotives and 5 cars derailed upright, including 2 tank cars loaded with liquefied petroleum gas (LPG, UN1075) and 1 residue tank car last containing LPG. Figure 3 shows the derailed rolling stock after the collision.

Figure 3. Derailed rolling stock after the collision (Source: TSB)

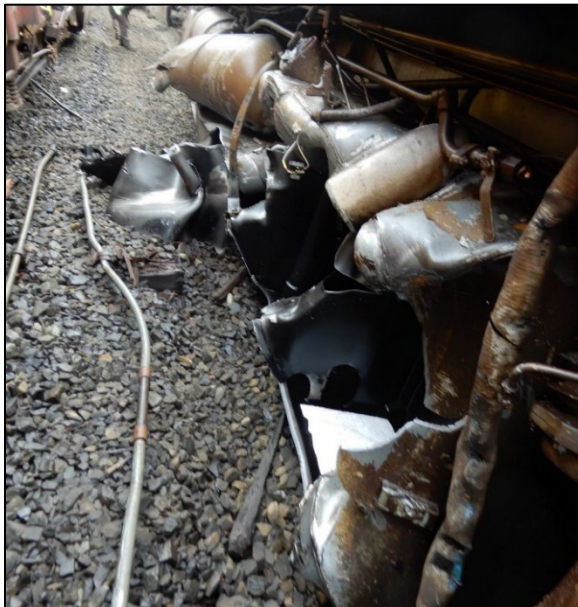
None of the derailed tank cars released product. However, the fuel tank on the east side of the lead locomotive on train 804 was extensively damaged (Figure 4), resulting in the release of approximately 8000 litres of diesel fuel. There were no injuries.

Figure 4. Severely damaged fuel tank on the lead locomotive of train 804 (Source: TSB)

A site survey was performed, and it was confirmed that 1 of the fuel tanks on the lead locomotive of train 804 had ruptured during the collision, releasing its contents. Evidence of fuel contamination was also observed on the surface of the water in a nearby drainage ditch and liquid containment booms were deployed on the water surface. Vacuum trucks were used to begin the recovery of spilled diesel and contaminated runoff.
