# AIR TRANSPORTATION SAFETY INVESTIGATION REPORT A23P0040

## LOSS OF CONTROL ON GROUND

Mustang Helicopters Inc.  
Airbus Helicopters AS 350 B3 (helicopter), C-GUXR  
Smithers Airport (CYYD), British Columbia  
06 May 2023

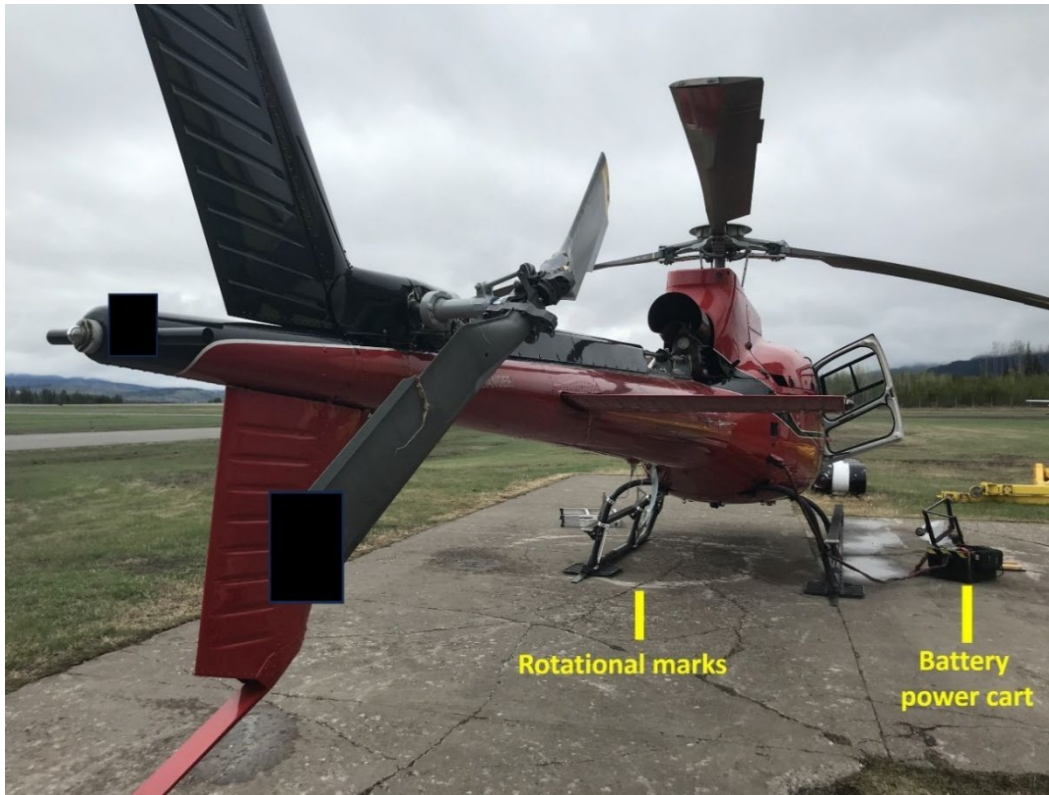
The helicopter came to rest after having rotated approximately 540° (Figure 1). During the rotation, both maintenance staff members had attempted to distance themselves from the spinning helicopter, but they were struck multiple times by the tail rotor.

Figure 1. The occurrence helicopter shortly after the loss of control (Source: Smithers Royal Canadian Mounted Police [RCMP], with TSB annotations)
