RAIL TRANSPORTATION SAFETY INVESTIGATION REPORT R24T0064

MOVEMENT EXCEEDS LIMITS OF AUTHORITY

GO Transit commuter train 1028

Mile 34.4, Canadian National Railway Company Oakville Subdivision

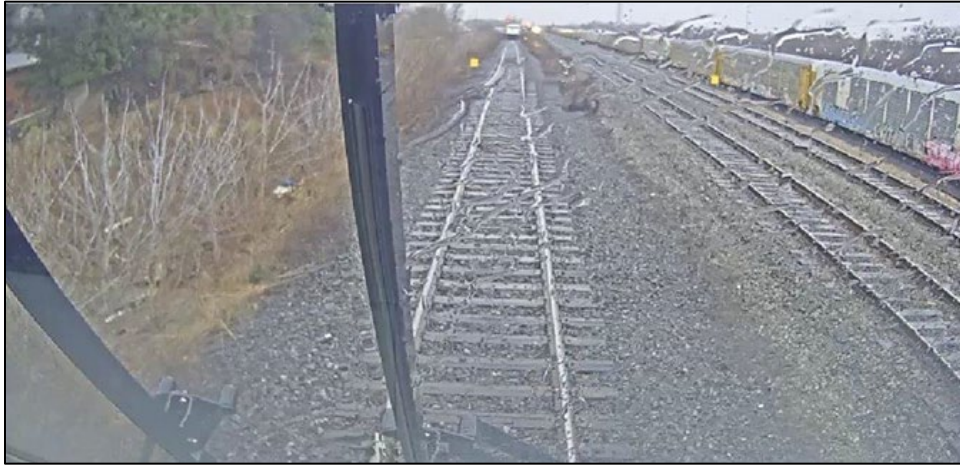
Figure 2. Head end of train GO 1028, as seen from the cab car of GO 1775, after both trains had stopped (Source: Metrolinx)
