# AIR TRANSPORTATION SAFETY INVESTIGATION REPORT A23O0122

## LOSS OF CONTROL AND IMPACT WITH RUNWAY

Perimeter Aviation LP  
Fairchild SA227-DC Metro 23, C-GJVW  
Detour Lake Aerodrome (CDT9), Ontario  
07 September 2023

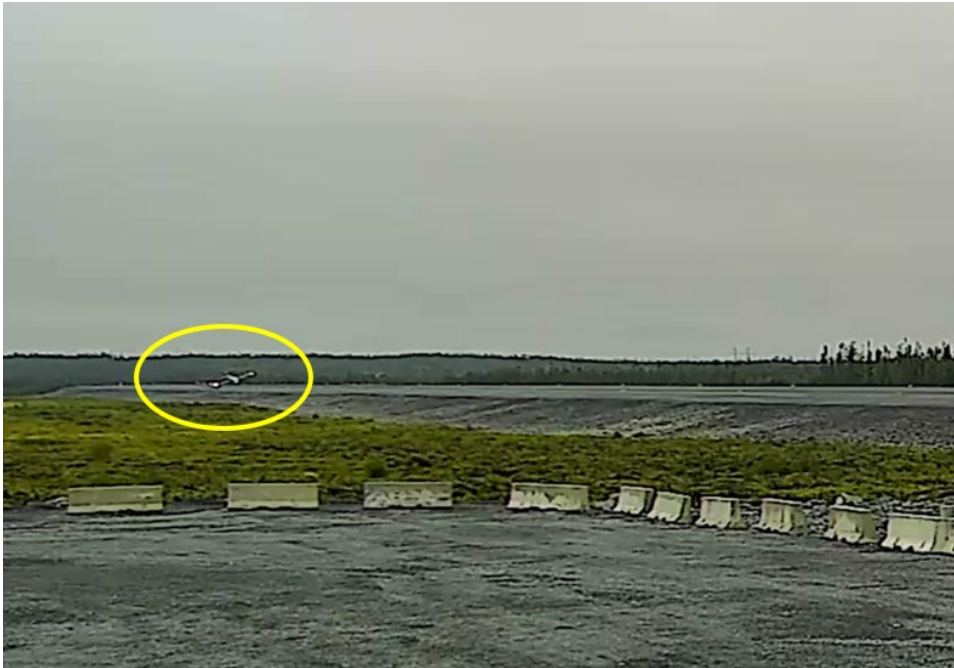
Figure 2. Occurrence aircraft impacting the runway (Source: Third party with permission and with TSB annotations)

The aircraft veered to the right (south) of the runway centreline, leaving the runway surface laterally and sliding down an embankment. The left main landing gear collapsed, and the aircraft came to rest in an upright position approximately 47 m (154 feet) from the runway, facing south-southwest on a heading of 210°M (Figure 3).

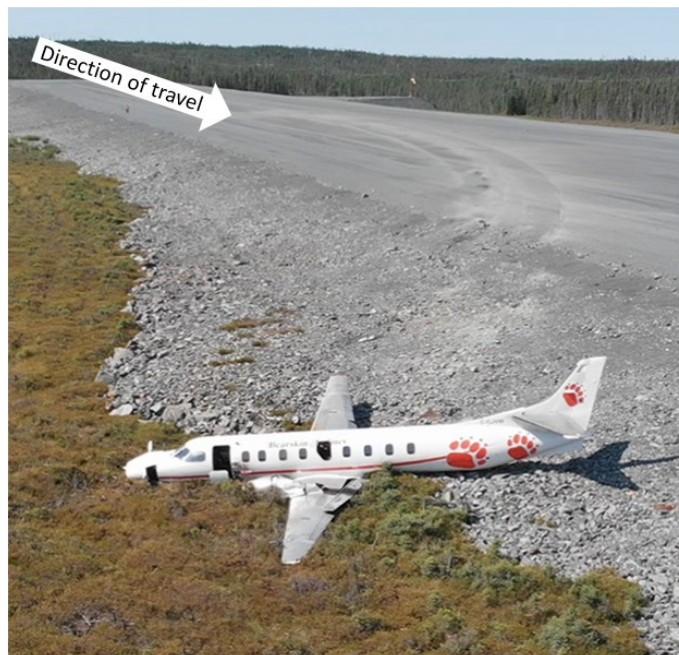
Figure 3. Occurrence aircraft at rest following impact with Runway 10 (Source: TSB)

Neither the aircraft's cabin nor cockpit was compromised. However, the fuselage's underside was wrinkled and punctured at numerous places along its length, including the wing centre structure. The aircraft fuel tanks were damaged from the impact with loose rock off the side of the runway. The nose landing gear and the left main landing gear were completely detached, while the right main landing gear was displaced but remained attached.

Both propellers shed all composite blades and exhibited damage to each hub. Both engines received significant damage from ingesting runway surface material and propeller blade particles.

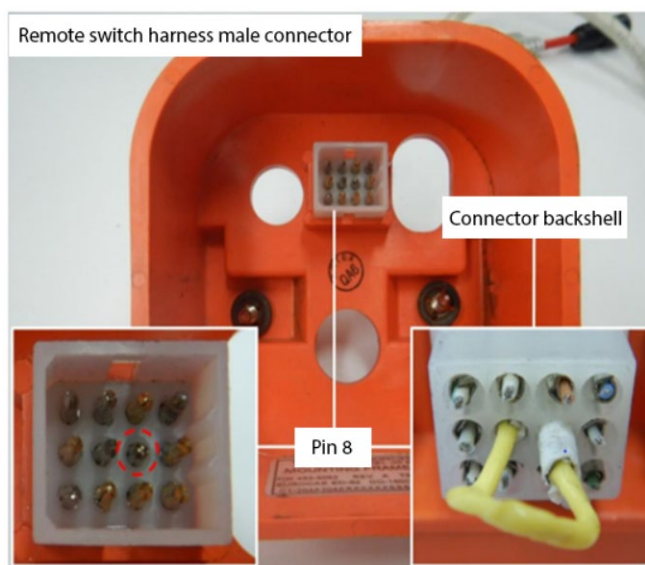
The ELT was then tested in conjunction with the remote switch harness 12-pin male connector. The ELT did not activate in this configuration during the activation performance test. It should be noted that this is how the unit was configured when installed in the aircraft. Visual inspection of the connector backshell of the remote switch harness revealed that Pin 8 was retracted from its normal position (Figure 6). Pin 8 was manually pushed back in place and the test reinitiated. The ELT activated and the performance test was positive.

Figure 6. Mounting frame cap assembly with Pin 8 retracted (Source: TSB)

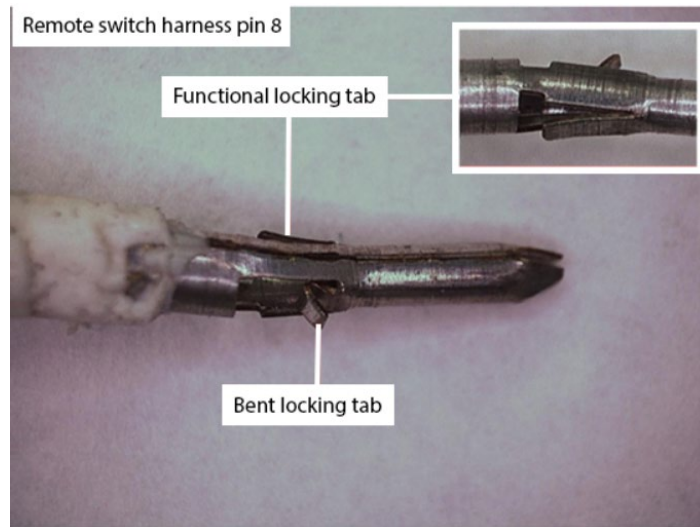
The locking pin mechanism of Pin 8 consisted of 2 locking tabs on opposite sides of the pin. One of the locking tabs was found bent forward. The other one was found functional. Pin 8 was also found deformed in a curved shape (Figure 7). The ELT manufacturer does not supply wiring or prefabricated switch harnesses for installation. Fabrication and installation of the switch harness was carried out by the airframe manufacturer or a maintenance organization. The investigation could not determine what caused the damage to Pin 8.

Figure 7. Deformed remote switch harness Pin 8 locking tabs, with close-up in inset (Source of main image and inset: TSB)

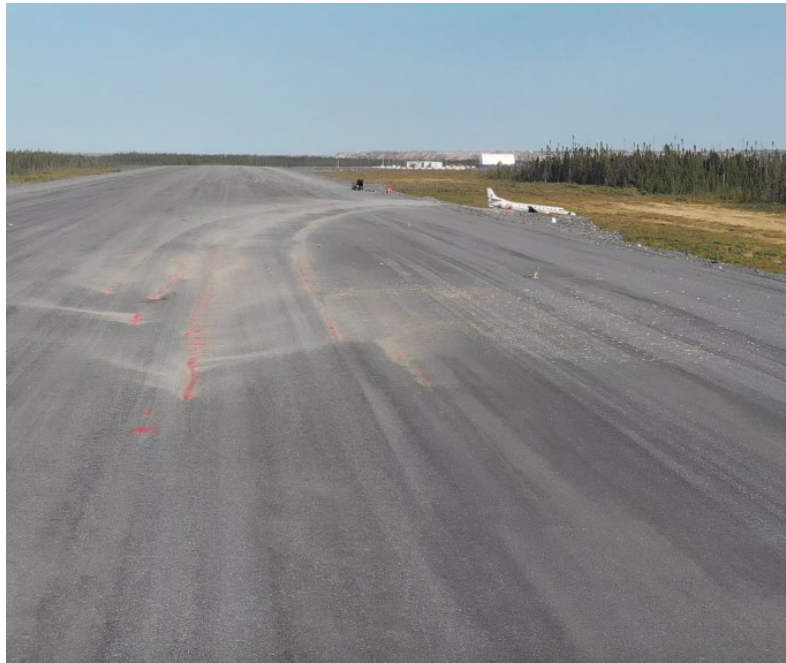
Figure 8. Occurrence aircraft at rest following impact with runway (Source: TSB)

Various components of the left and right main landing gears as well as debris from the nose wheel steering system were also found on the runway. The nose cone, right main landing gear, and the damaged edge lights were within 60 m (197 feet) of the aircraft's final resting position.

The occurrence aircraft's fuselage pressure vessel was punctured in multiple sections due to impact damage by the loose rock.

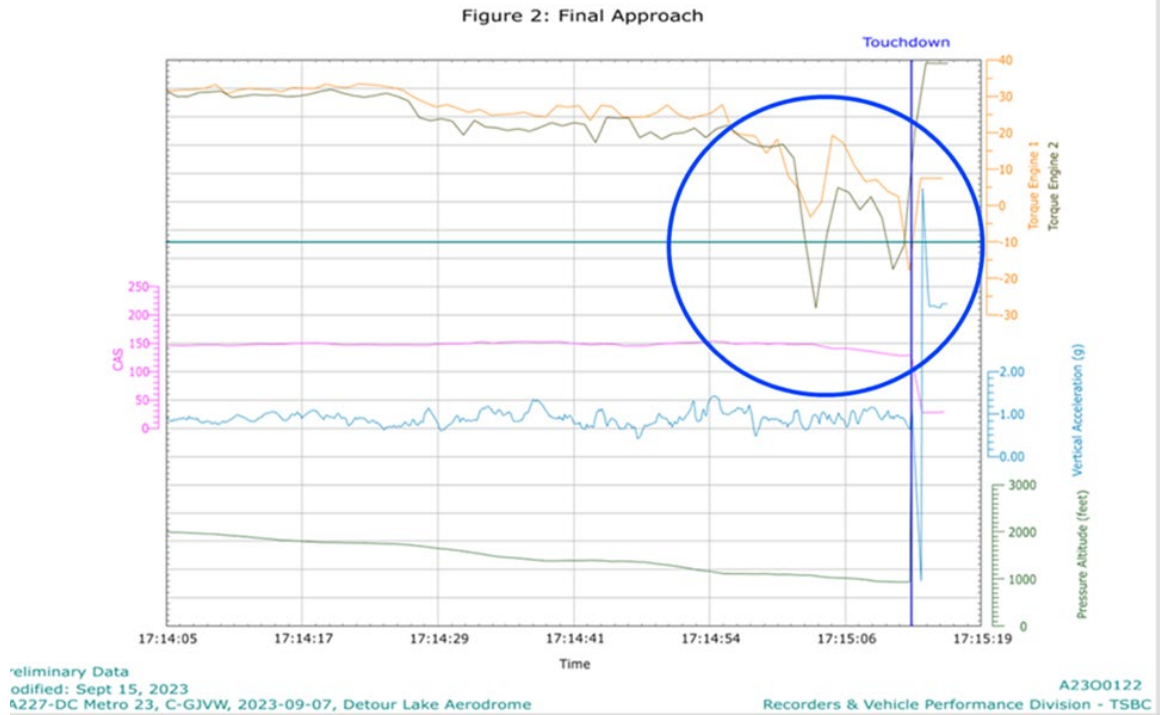
## Appendix E – Flight data recorder plot at time of short final to landing, indicating when the negative torque values were recorded (circled)
