# RAIL TRANSPORTATION SAFETY INVESTIGATION REPORT R25Q0097

## MAIN-TRACK DERAILMENT

Quebec North Shore and Labrador Railway  
Ore train PL676D  
Mile 37.7, Wacouna Subdivision  
Near Nicman Station, Quebec  
28 December 2025

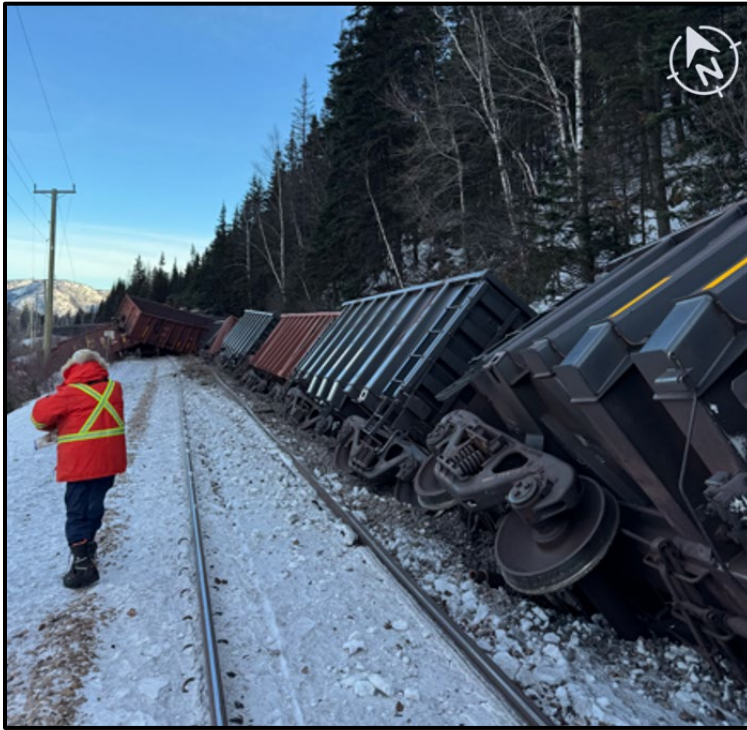
At approximately 1920,<sup>1</sup> near Mile 36.8, as the train was proceeding at about 29 mph, a train-initiated emergency brake application occurred, and the train came to a stop. After contacting the rail traffic controller (RTC) to report the situation, the locomotive engineer (LE) secured the train and proceeded to inspect it on foot. Upon reaching the 137th car, he observed that the coupler knuckle on the north end of the car was broken.<sup>2</sup> It was dark, and the LE could not see the remaining cars in the train. He therefore continued walking northward alongside the train, and after a few hundred feet, upon exiting a curve, noticed that the next car (IOCC 11430) had derailed across the rails at Mile 37.7. The next 6 cars had also derailed and were leaning against the rock face on the east side (Figure 2). Twenty-two other cars and the DP locomotive had also derailed in various orientations. They all sustained extensive damage.

Figure 2. Some of the derailed cars (Source: Quebec North Shore and Labrador Railway, with TSB annotations)

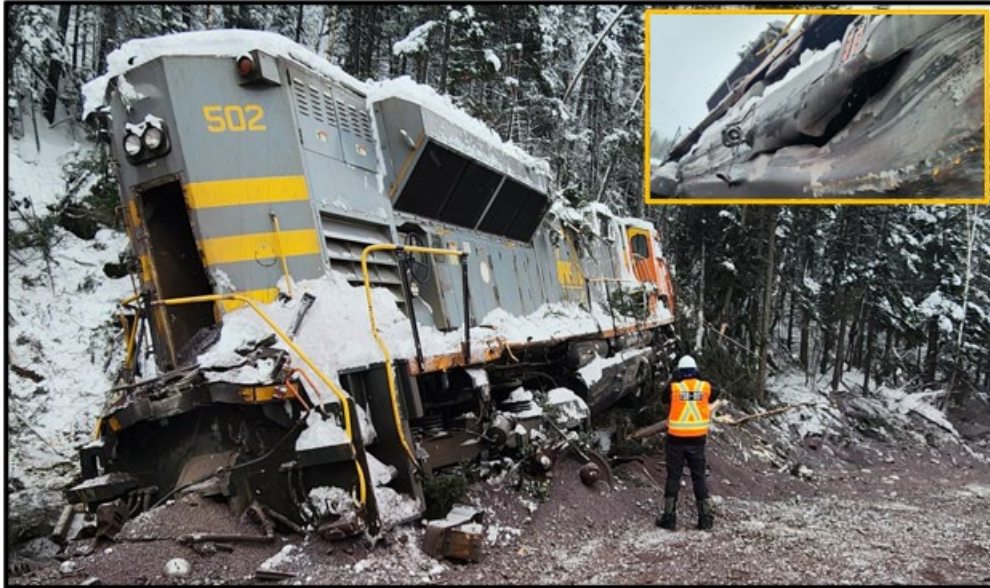
The fuel tank on locomotive QNSL 502 was punctured in the derailment (Figure 3), resulting in the release of approximately 1000 L of diesel fuel. The spill was limited to the area directly beneath the locomotive. Recovery operations for the remaining fuel in the locomotive, as well as other fluids it contained, were completed before the locomotive was moved. Most of the spilled fuel was subsequently recovered.

Figure 3. Derailed locomotive QNSL 502 with inset showing its punctured fuel tank  
(Source of main image: TSB. Source of inset image: TSB)

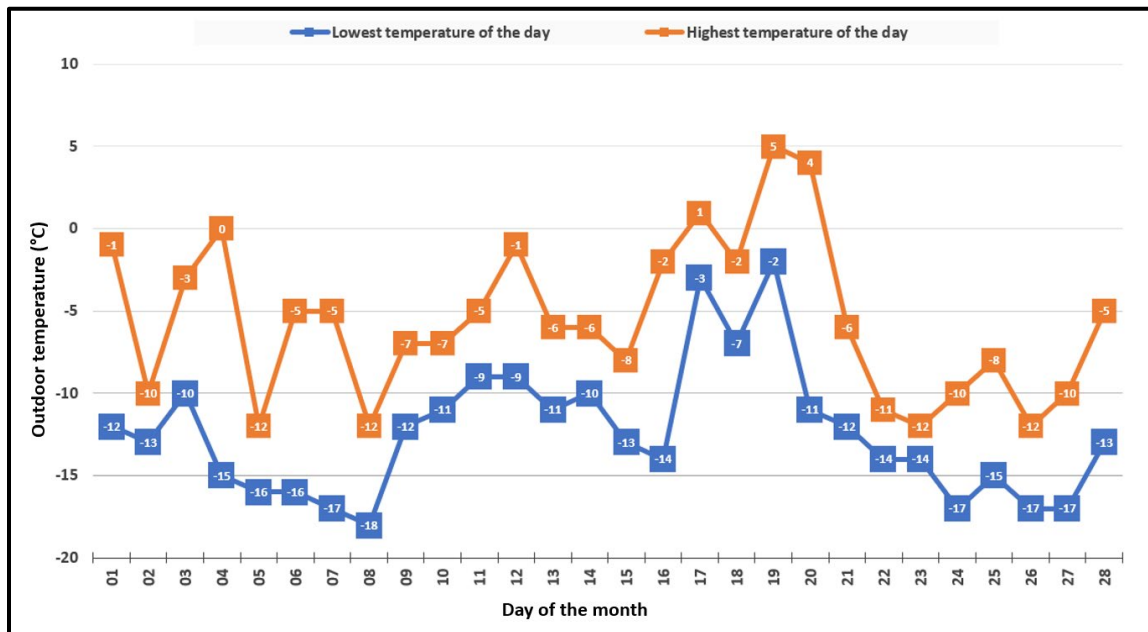
During December 2025, significant outdoor temperature fluctuations were recorded in the Sept-Îles area (Figure 4).

Figure 4. Temperatures recorded in Sept-Îles from 01 to 28 December 2025 (Source: Environment Canada)

Before the occurrence, the coldest day of the month had been 08 December, with a low of  $-18^{\circ}\text{C}$ , and the warmest day had been 19 December, when the recorded temperature rose to as high as  $5^{\circ}\text{C}$ . In the days leading up to the derailment, the outdoor temperature had dropped to near the previously recorded lows.

Significant temperature fluctuations over a relatively short period, particularly at the start of the cold season, place heavy stresses on the rails. Cold weather causes the steel to contract, generating tensile forces in the rail. Conversely, a rise in outdoor temperature causes the material to expand, resulting in compressive forces. The forces generated in the rails by these repeated cycles can cause internal defects to form and spread. Continuous welded rail is then more susceptible to failures, such as breaks, particularly at the welds joining rail sections together.
