# AIR TRANSPORTATION SAFETY INVESTIGATION REPORT A24W0016

## **COLLISION WITH TERRAIN**

Hanley Heli Service Inc.  
Bell Helicopter Textron 206L (helicopter), C-GCHM  
Fort Chipewyan Airport (CYPY), Alberta, 4 NM ESE  
12 February 2024

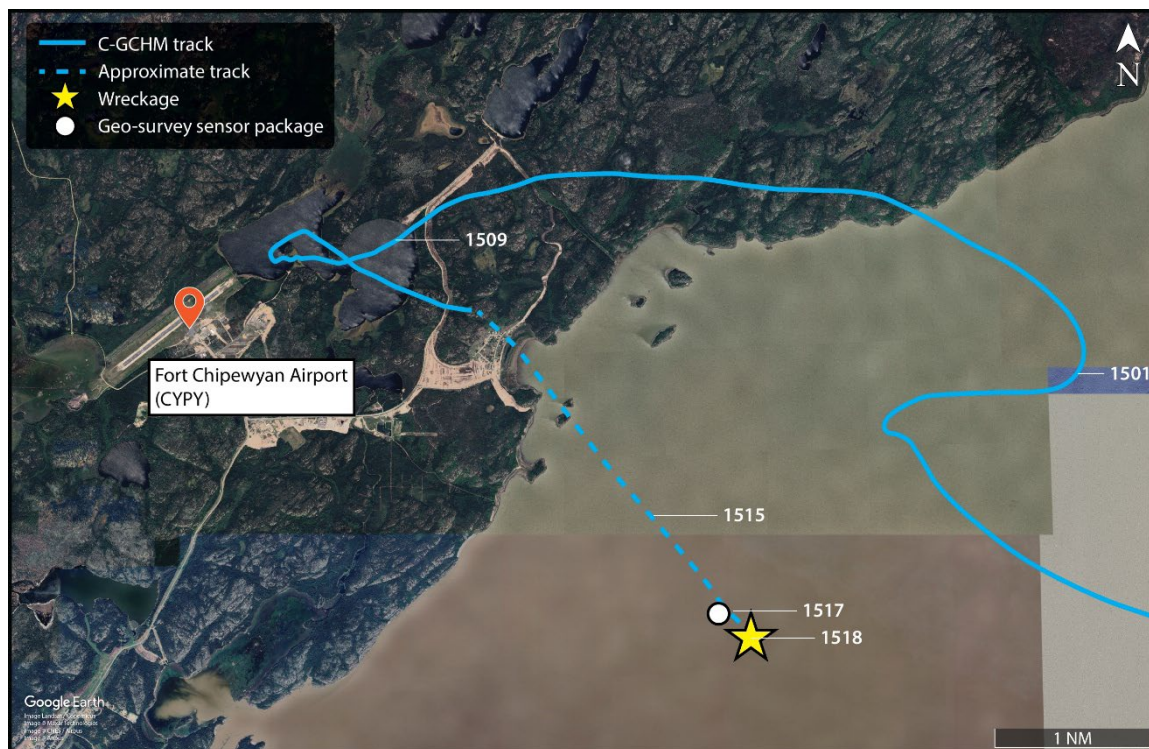
Shortly after, the occurrence helicopter's track began deviating right (i.e., to the north) of the direct track to CYPY (Figure 2). When the helicopter was approximately 5 NM east of CYPY, it turned right 90° toward the east and proceeded eastward for approximately 1.5 NM before commencing a gradual left turn that eventually brought the helicopter back toward CYPY. During that gradual turn, at approximately 1501, the occurrence pilot called the 2nd pilot and indicated that visibility was poor but that he was trying to arrive from the north.

Figure 2. Composite depiction of the final minutes of the occurrence flight, based on available data with times and the approximate track (Source: Google Earth, with TSB annotations)

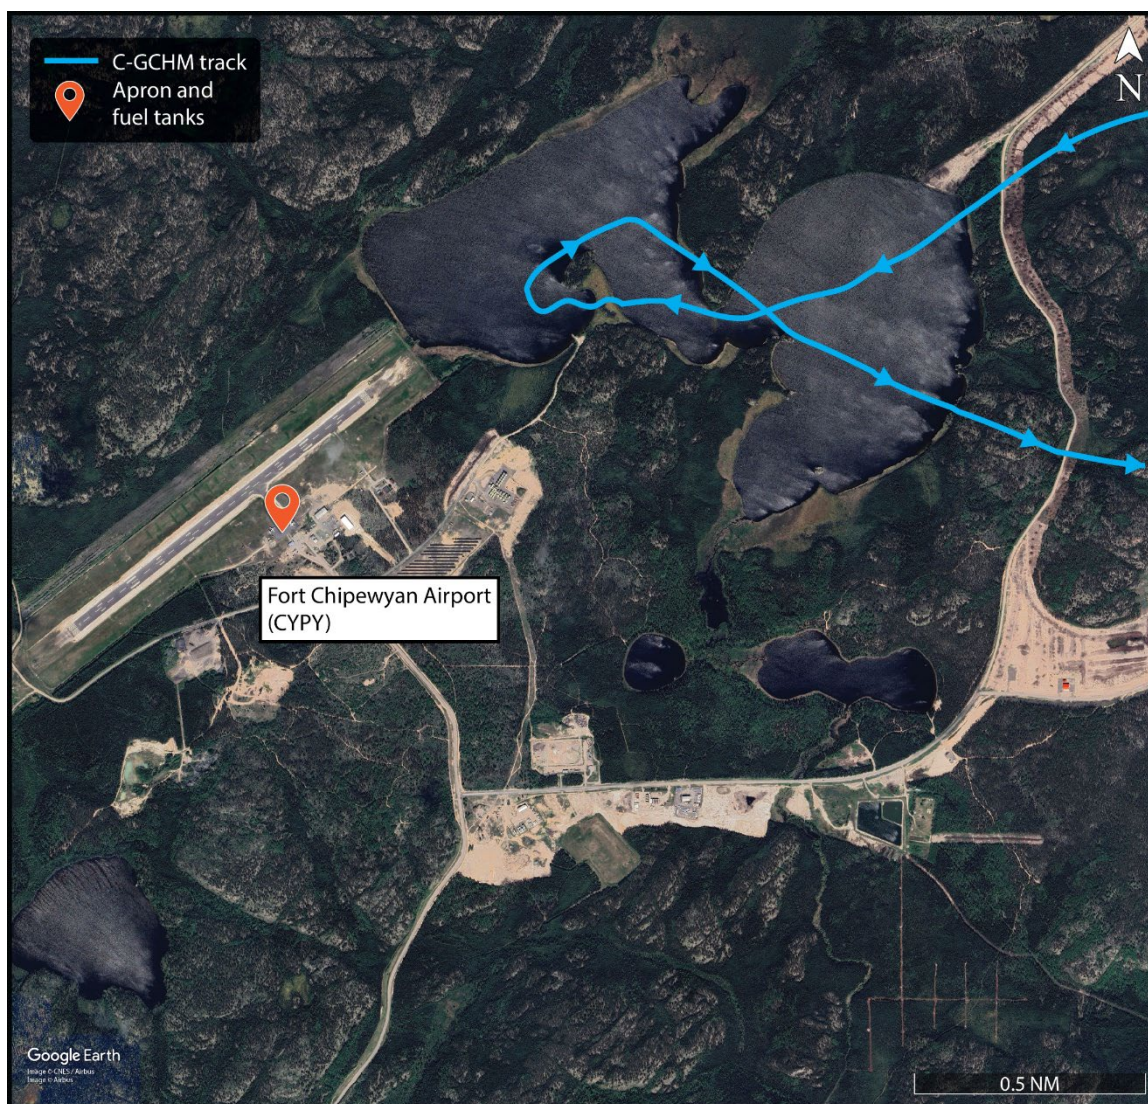
reported losing all visual references, and that he was unsure of the helicopter's position. At that point, the shore was approximately 0.33 NM horizontally to the right and 0.25 NM in front of the helicopter's ground track. The occurrence pilot made a 180° turn to the right over the frozen lake and continued in that direction for approximately 0.25 NM. After the turn, the shore was less than 100 m horizontally to the right. While the helicopter was reversing course, the 2nd pilot suggested that the occurrence pilot fly toward Lake Athabasca, approximately 2 NM east of CYPY, in the hopes of re-acquiring visual references, and to possibly land along the shore.

Figure 3. Track showing occurrence helicopter's aborted attempt to land at Fort Chipewyan Airport and then altering course toward Lake Athabasca (Source: Google Earth, with TSB annotations)

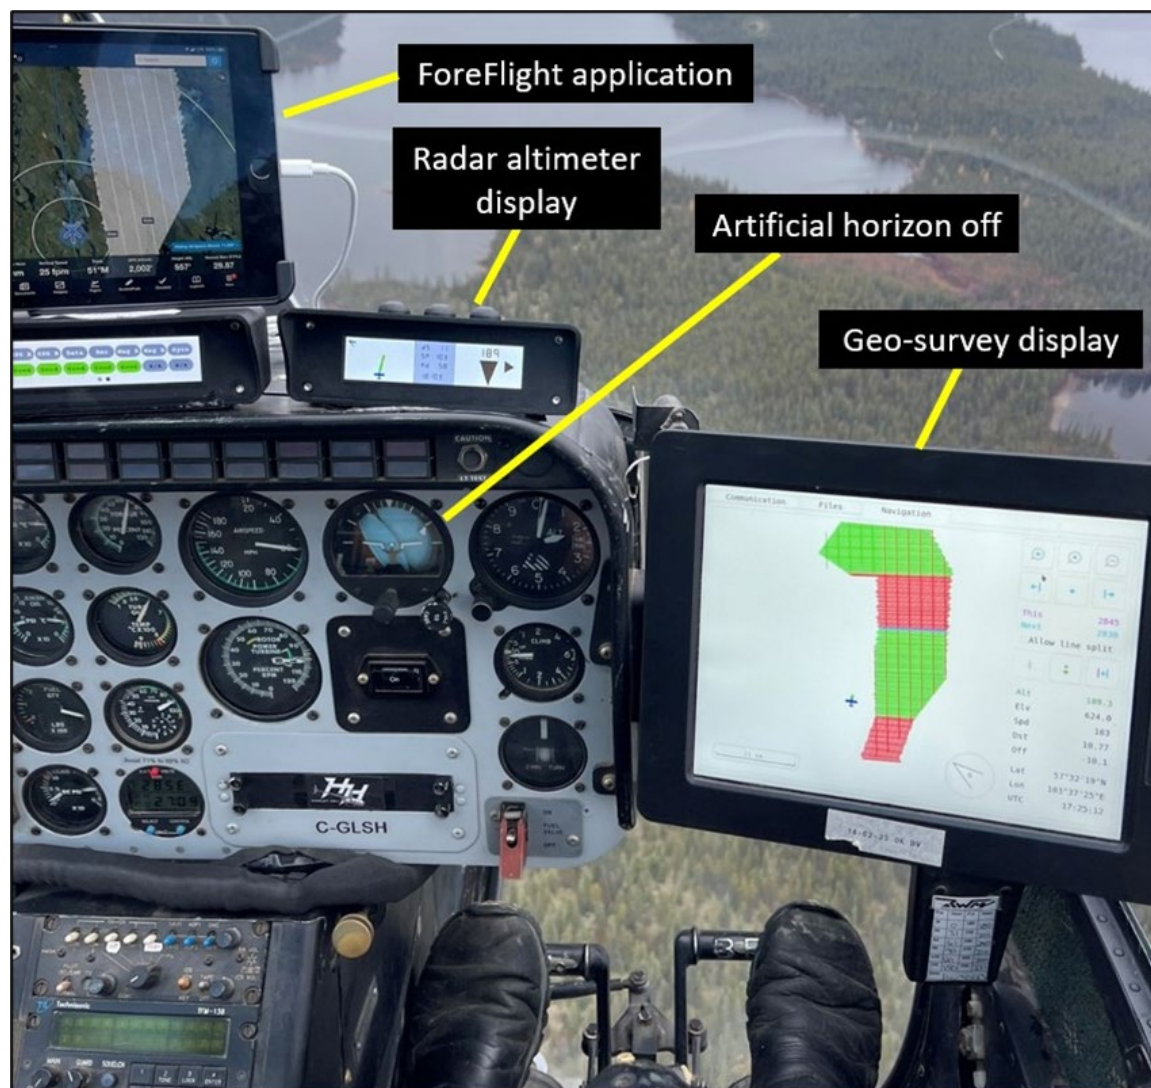
Figure 5. A Hanley Bell 206L in-flight during geo-survey operations, with artificial horizon in OFF position (Source: Hanley Heli Service Inc.)

To the right of the instrument panel was a geo-survey display showing the planned and actual track lines. As seen in Figure 5, the combination of the geo-survey equipment, along with the tablet, restricts the pilot's vertical field-of-view, looking forward. This makes it hard for a pilot to see references that fall beneath the pilot's sightline and the top of the equipment on or near the instrument panel. (The geo-survey sensor package installation will be discussed further in Section 1.6.3 *Geo-survey sensor package installation*.)

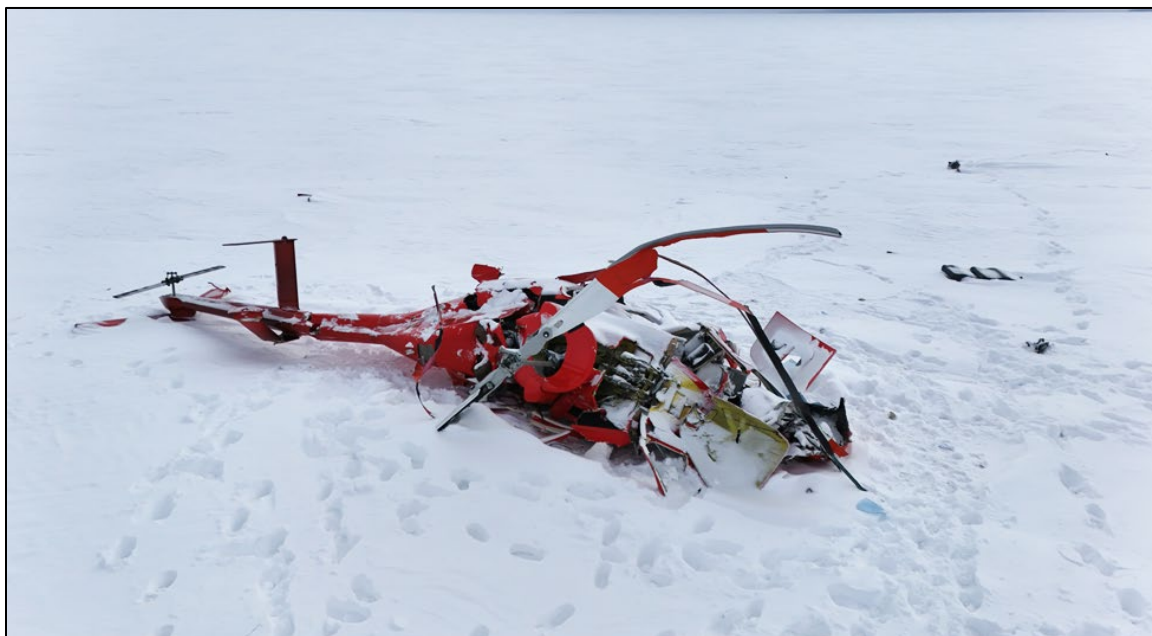
The helicopter impacted the frozen surface of Lake Athabasca in a nose-down, right-banked attitude (Figure 7). The helicopter was oriented approximately 100° right of its track from where the bird came to rest on the ice. With the exception of a few pieces of the main-rotor blades, most of the wreckage was located within approximately 50 feet of the fuselage. Other than at the location of the fuselage, there were no other indications of impact scars in the snow.

Figure 7. Occurrence helicopter (Source: TSB)

The extent of the damage, combined with the relatively contained accident site, suggests that the helicopter impacted the ice with high vertical g-forces and with little-to-no forward ground speed. Damage to the main-rotor blades was consistent with a significant amount of power being applied at the point of impact.

When search personnel first arrived on site, some snow was present on the wreckage; however, there was no indication of icing observed on the helicopter's rotor blades or other leading edge surfaces. Icing was not considered a factor in this occurrence.

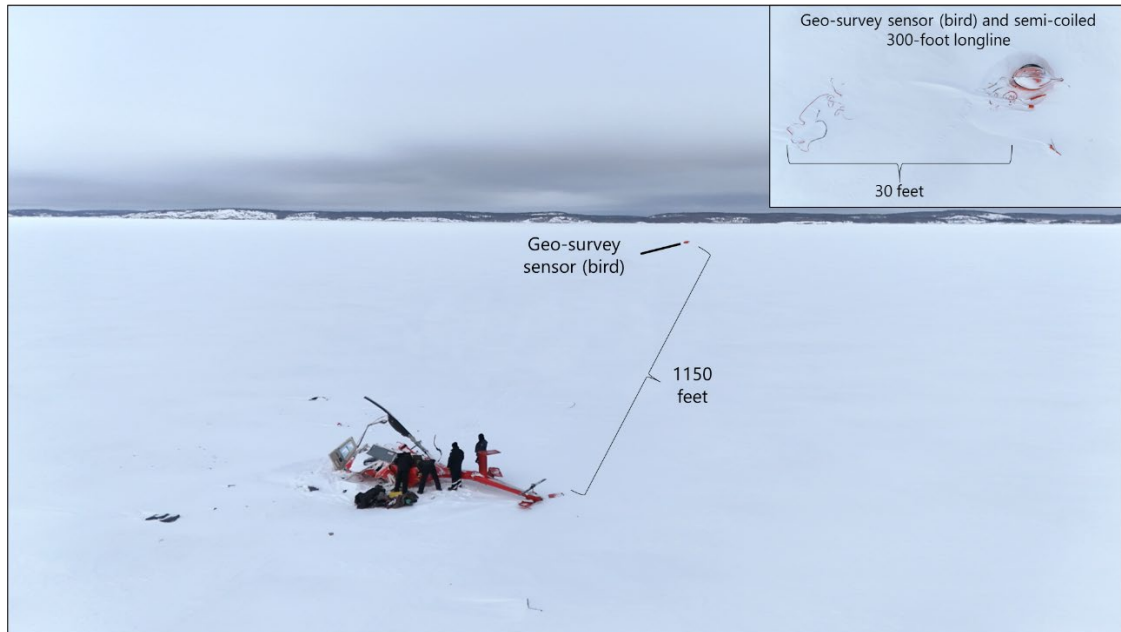
The bird was approximately 1150 feet to the northwest of the main wreckage. The 300-foot longline was found, in a semi-coiled fashion, within approximately 30 feet of the bird, and oriented 90° to the right of the track between the bird and the main wreckage (Figure 8). This suggests that the external load was released at a low ground speed while the helicopter was moving/drifting right of the track between the external load and the main wreckage.

Figure 8. Image of the accident site with inset image showing bird and semi-coiled 300-foot longline (Source: TSB drone image, edited by the TSB to remove snowmobiles and snowmobile tracks)
