AVIATION INVESTIGATION REPORT

A00P0244

CONTROLLED FLIGHT INTO TERRAIN – ON APPROACH

PIPER AEROSTAR 602P N88AT

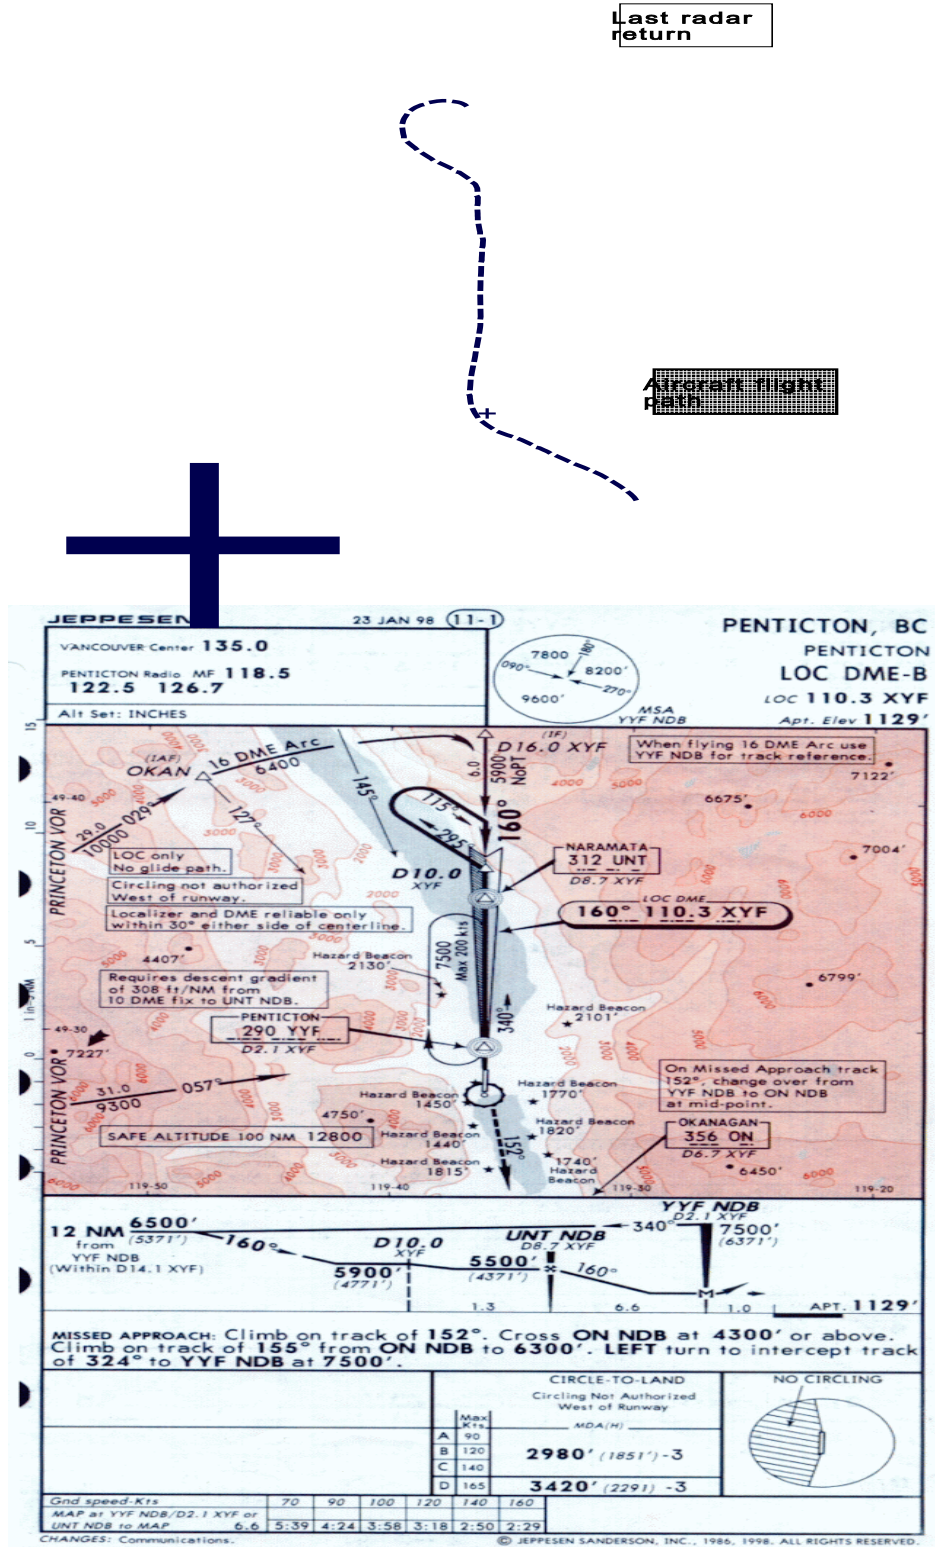
Appendix A - Penticton Approach Chart

As shown in Appendix A, the LOC DME-B approach at Penticton, a non-precision approach, commences at the Penticton non-directional beacon (YYF NDB) at a minimum altitude of

7500 feet. A pilot carrying out this approach is expected to then do the following:

- track outbound on the localizer, past the UNT (Naramata) NDB until 10 DME;
- make a left procedure turn at a minimum altitude of 6500 feet, completing the turn within 14.1 DME [using DME from XYF 110.3];
- proceed inbound on the localizer at a minimum altitude of 5900 feet until 10 DME;
- descend to a minimum of 5500 feet at the UNT NDB; and
- descend to a minimum of 2980 feet to the YYF NDB, the missed approach point.

The pilot tracked outbound on the localizer for one minute from the UNT NDB, and his procedure turn commenced at 13 DME. This was 3 nautical miles (nm) past the 10 DME turning point depicted on the approach chart and already at the controller / pilot agreed limit. The delay in starting the procedure turn resulted in the aircraft reaching 16 DME before the turn was completed, 1.9 nm past the chart limit. The aircraft was 1000 feet below the minimum altitude for the procedure turn, and as the aircraft turned to intercept the localizer, it was 400 feet lower than the minimum safe altitude for that area, which is 5900 feet asl.

1. For reasons not determined, the pilot did not adhere to the procedures depicted for the LOC DME-B approach to runway 16 at Penticton. As a result, the aircraft did not remain within the confines of protected airspace, was below the minimum safe altitude for the procedure turn, and struck the tower.
