AVIATION INVESTIGATION REPORT

A02P0299

RISK OF COLLISION

VANCOUVER CONTROL TOWER

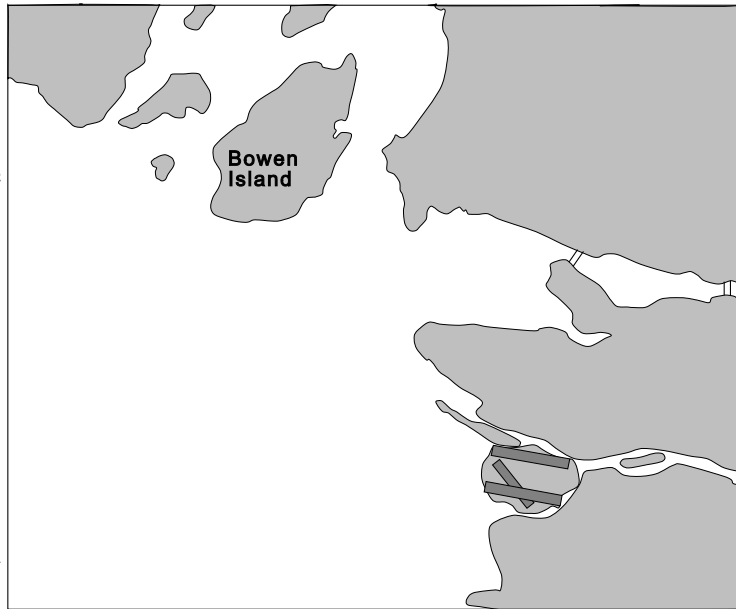
PCO361 was a visual flight rules (VFR) flight from Comox to Vancouver. The pilot contacted the tower advisory controller at 1147 at the GOWER reporting point (Figure 1), squawking 4500² and indicated that the aircraft was in descent out of 2000 feet above sea level. The tower advisory controller identified PCO361, cleared it for the Point Grey arrival for Runway 12 and issued traffic information on a de Havilland DHC-8 that was conducting a visual approach to Runway 12. PCO361 was instructed to follow the DHC-8. The tower advisory controller also passed additional traffic information on two helicopters, flying toward Point Grey, that were to remain east of the approach path for Runway 12. He then instructed PCO361 to contact the tower south controller at Point Grey. There was no coordination between the tower advisory controller and the tower north controller for Runway 12 arrivals: local procedures did not require such coordination.

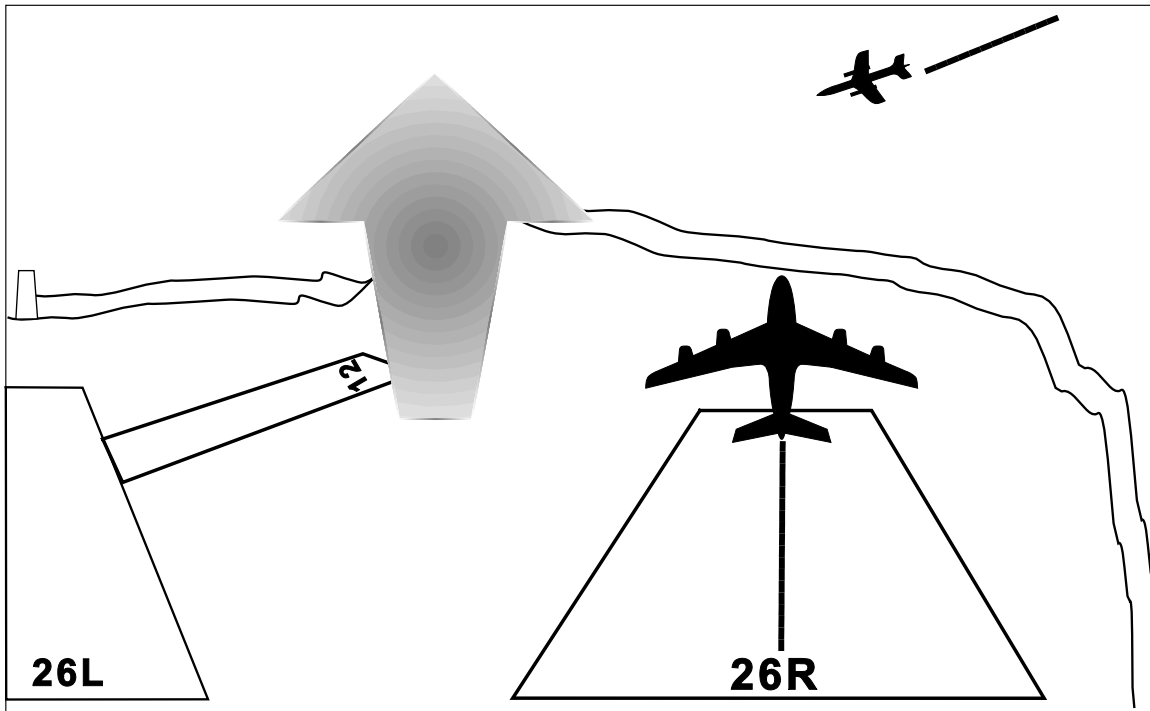
After the tower north controller cleared JAL17 for take-off, he attempted to manipulate the electronic flight progress strip on the extended computer display system to show that the aircraft had departed. This system is linked to all Vancouver tower positions and the terminal control unit and cuts down on verbal communications. While JAL17 was still on the take-off roll, the tower north controller saw an aircraft inbound from the northwest. He queried the tower south controller, who advised that it was a Pacific Coastal flight inbound for Runway 12. The tower south controller asked the tower north controller what action to take. The tower north controller recommended instructing the inbound aircraft to keep the speed up, because it now appeared that the inbound aircraft would cross the departure path of Runway 26R ahead of JAL17 (Figure 2).

At 1153, the tower south controller advised PCO361 to keep the speed up and that there was traffic rolling on Runway 26R. Both pilots of PCO361 observed the Boeing 747 coming toward them and just lifting off Runway 26R. They immediately banked the aircraft to the right, increased the rate of descent and increased the engine power settings. As soon as the pilots observed that they were clear of the departing traffic, they turned toward Runway 12 again and landed the aircraft without further incident. PCO361 had crossed the Runway 26R departure path 0.5 nm in front of and about 100 feet below the take-off profile of the departing JAL17. There was no indication that the crew of JAL17 saw the other aircraft.
