**AVIATION INVESTIGATION REPORT
A07O0264**

IN-FLIGHT FIRE

**CANADIAN FLIGHT ACADEMY LIMITED
CESSNA 152 C-GCSJ
OSHAWA, ONTARIO
24 SEPTEMBER 2007**

Report Number A07O0264

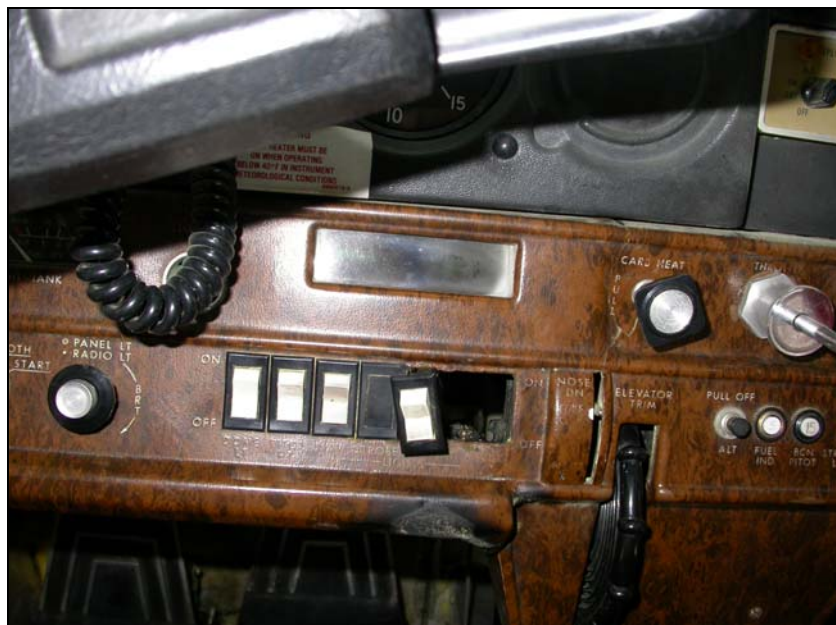
As the aircraft flew by Bowmanville, the pilot and passenger detected an electrical burning odour. Approximately 10 seconds later, sparks were observed coming from underneath the lower left instrument panel. The pilot immediately turned back towards the Oshawa Airport and contacted the tower to advise them of their situation. The tower controller requested that the pilot call the tower at a recognizable landmark near the airport. After completing the transmission, the pilot switched off all of the electrical switches including the master switch. The pilot and passenger then observed small flames emanating from the bottom of the lower left instrument panel. The flames ignited the plastic instrument panel (see Photo 1).

Photo 1. Front of instrument panel

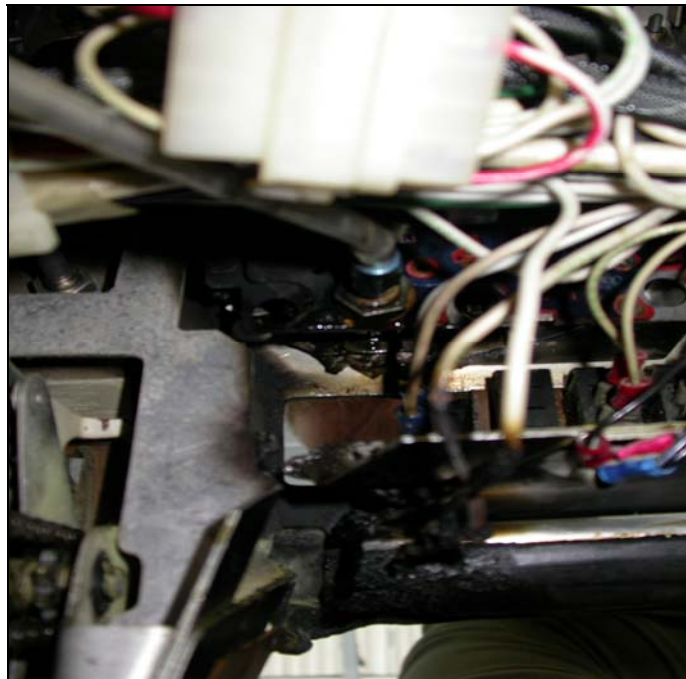
The landing light switch showed evidence of melt damage beginning at the base and progressing upward on both sides. The same damage was evident on the interior of the switch. The switch exterior had a thick coating of dust and an oily residue that was also found inside the switch. A scanning electron microscope (SEM) and energy dispersive spectroscopy (EDS) analysis of the residue indicated that it may have been engine oil. Due to the nature of the tests, positive identification of the residue could not be determined.

The rocker switch's common contact was the only metallic part recovered. It appeared to have been extracted from the switch casing as the casing was melting. The landing light circuit wires remained attached to the contact but showed evidence of fire damage near where the contact enters the switch. The contact was coated with the plastic casing material and showed evidence of repeated arcing which severely eroded the contact's surface (see Photo 2).

Photo 2. Rear of instrument panel

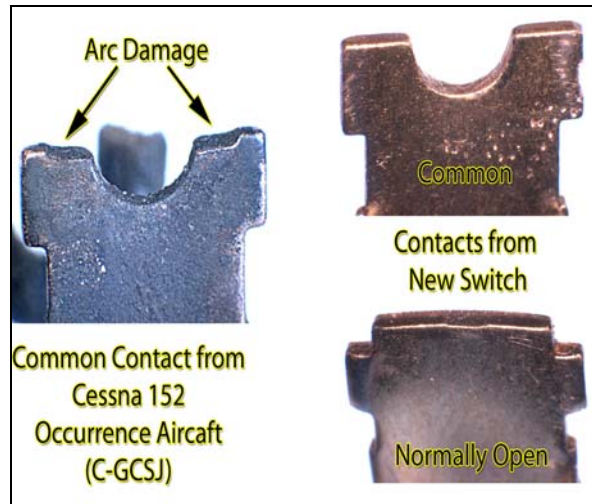
Arcing produces very high temperatures and is dependent upon the applied voltage and current. Typically, switch arcing, a phenomenon common to most switches, is of limited duration and isolated to small areas. The occurrence switch was wired such that it directly controlled the 250-watt incandescent lamp. According to the United States Federal Aviation Administration (FAA) Advisory Circular 43.13-1B (pages 11-16), this type of lamp can have an initial current up to 15 times the continuous current needed to remain on. This is because the cold filament has a lower resistance than a hot filament, thus the initial current could be as high as 134 amps, resulting in intense arcing. The only restriction would be the current limitations of the power source. Every time the landing light switch was selected to ON, the electrical current would produce an arc that, with repeated use, would erode the areas where the arc contacted the switch's copper components (see Photo 3). The fit between those components would be affected to the point where continuous arcing could occur even under normal loads.

Photo 3. Arc damage

The heat produced by arcing also promotes oxidization of the copper components, thus increasing their resistivity and producing even more heat. The heat produced would reach a level where the internal lubricant used to prevent oxidation and provide for smooth switch operation would deteriorate, thus leading to more oxidation. The cycle could continue until the heat produced would be sufficient to melt the switch casing. The switch's contacts, which are supported in place by the casing, could become dislodged or be pulled free from the switch and result in a live wire being exposed.

In January 2008, Cessna issued Temporary Revision Number 4 to Cessna 152 “1978 through to 1985 service manuals” that includes Special Inspection No. 26 which requires the inspection and replacement of the landing and taxi light switches. Such inspections and replacements are to take place at the next 100-hour or annual inspection and every five years thereafter.

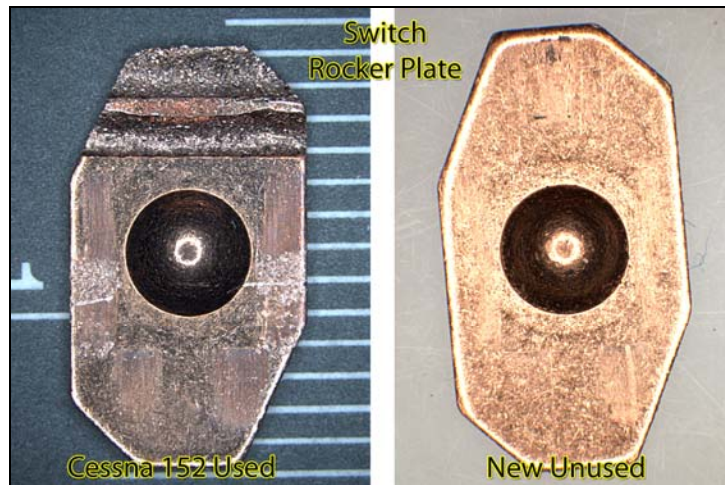
A used landing light switch removed from another aircraft when it was faulted as difficult to toggle was sent to the TSB Engineering Laboratory for examination. It was identical in composition and structure to the occurrence switch. Although it required extra effort to toggle, it was functional. A subsequent internal examination of the switch revealed a lack of lubricant within the switch which may have explained the stiffness of operation. The copper rocker plate showed evidence of erosion due to arcing and rubbing (see Photo 4). There was also evidence of severe oxidation around the areas where arcing damage was evident. The used switch was provided to determine what the temperature value of the exposed switch contacts was when continuous electrical power was applied over a period of time. An electrical load similar to the 250-watt lamp, connected to a 28 VDC power supply, was used and after a period of three hours the temperature reading at the contacts was an acceptable 53.5°C.

Photo 4. Switch rocker plates comparison - used and new
