**AVIATION INVESTIGATION REPORT  
A12O0030**

**LOSS OF SEPARATION AND RISK OF COLLISION**

**NAV CANADA – TORONTO AREA CONTROL CENTRE  
LONDON, ONTARIO, 20 NM NW  
08 MARCH 2012**

Report Number A12O0030

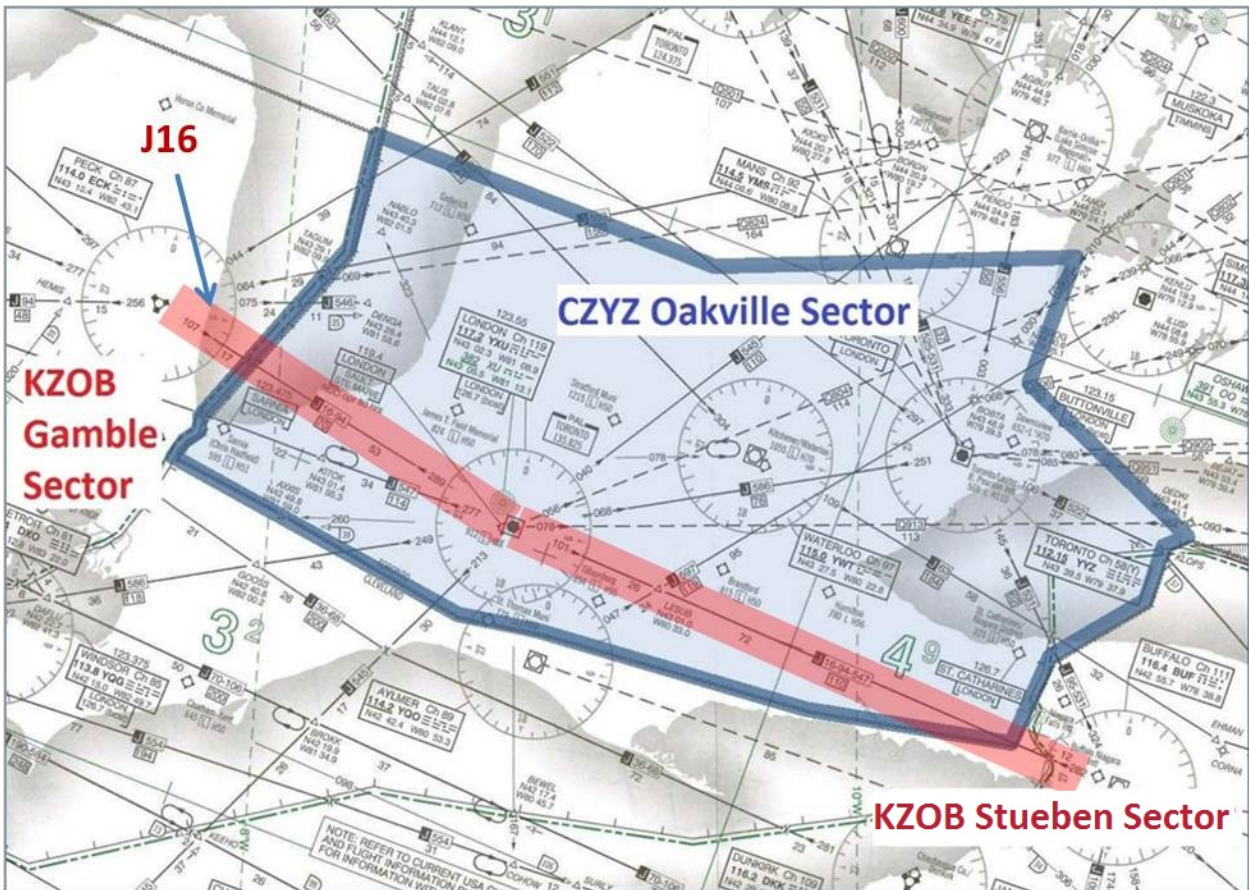
The portions of J16 on either end of this segment are controlled by the Cleveland Air Route Traffic Control Center (KZOB ARTCC, hereinafter referred to as KZOB), Gamble sector to the west, and Stueben sector to the east (Figure 1). At the time of the occurrence, both Gamble and Stueben sectors were staffed by 2 controllers.

Figure 1. Responsibility for control at FL 430 at the time of the occurrence

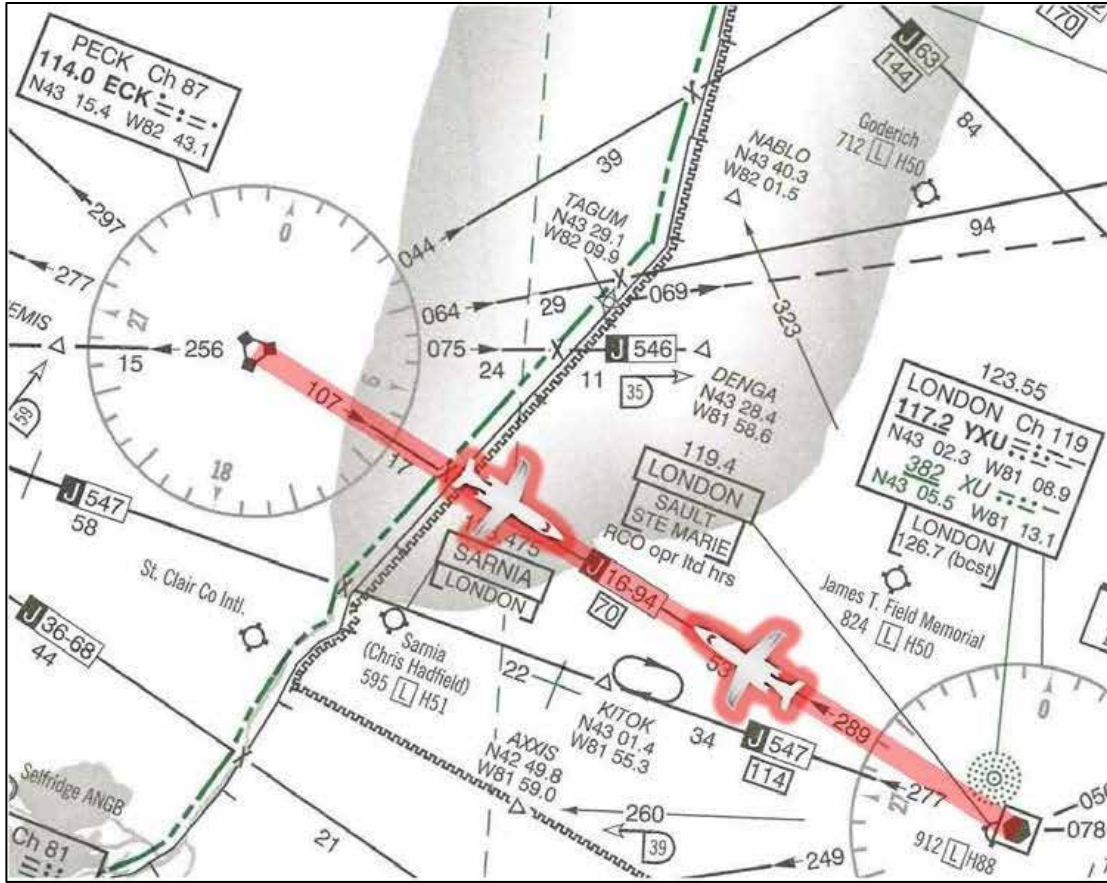
- 1339:55 N128GV was overhead YXU VOR, having previously established communications with Toronto Centre.
- 1340:54 The controller occupying the radar position in Oakville was relieved by another controller. A handover briefing was completed, and both N217AL and N128GV were pointed out at FL 430; however, there was no mention that N217AL's altitude was an IAFDF, or that the 2 aircraft were in conflict (Figure 2).

- 1342:52 N217AL and N128GV crossed paths, separated by 900 feet vertically and 1 nm laterally. The minimum required separation is 2000 feet vertically, or 5 nm laterally.

Figure 2. Two aircraft on reciprocal tracks on J16 Airway
