AVIATION OCCURRENCE REPORT

**VFR FLIGHT INTO IMC -
LOSS OF CONTROL**

**SOUTHERN INTERIOR FLIGHT CENTRE LTD.
CESSNA 172M C-GIWX
HOPE SLIDE, BRITISH COLUMBIA
24 APRIL 1994**

REPORT NUMBER A94P0074

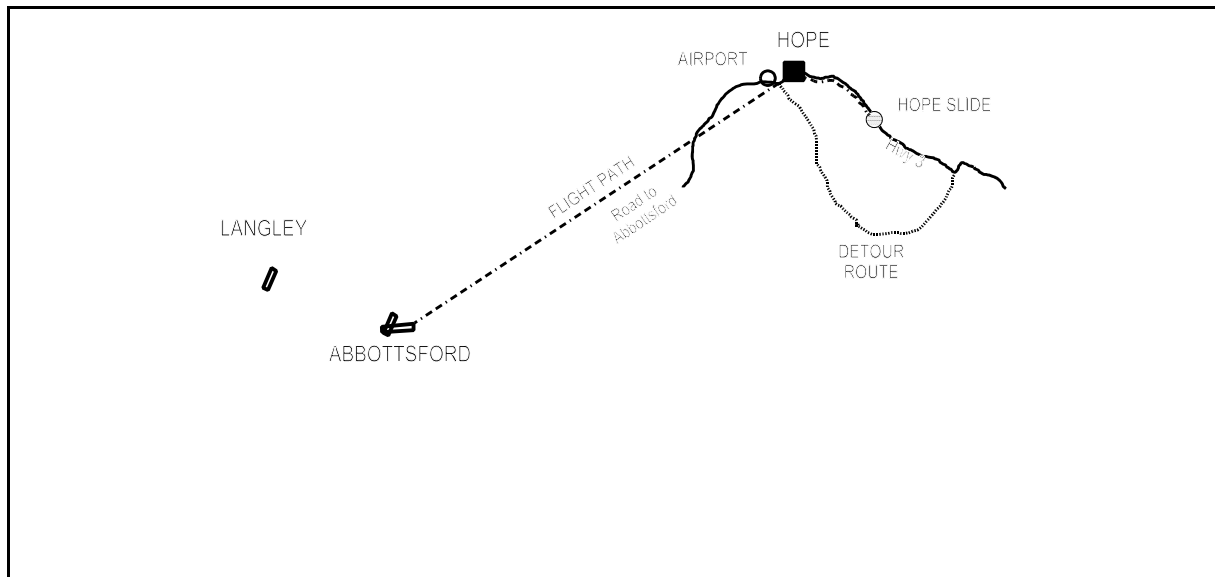
Figure 1 - Flight route

The eastbound aircraft was subsequently seen flying at about 600 feet over the town of Hope. A few minutes later, the aircraft was observed flying adjacent to, and just above, Highway 3 in the narrow and steep mountain valley that leads over the Hope Slide. The pass was obscured by low clouds at about 2,100 feet above sea level (asl). The aircraft entered the clouds and then re-appeared in a steep, nose-down attitude. It then crashed to the ground and burst into flames. The pilot and the two passengers were fatally injured; the aircraft was destroyed.
