MARINE INVESTIGATION REPORT (AMENDED)

M98W0245

UNCONTROLLED DESCENT OF A LIFEBOAT

BULK CARRIER "IOLCOS GRACE"
ANCHORAGE "K", VANCOUVER HARBOUR
BRITISH COLUMBIA
9 NOVEMBER 1998

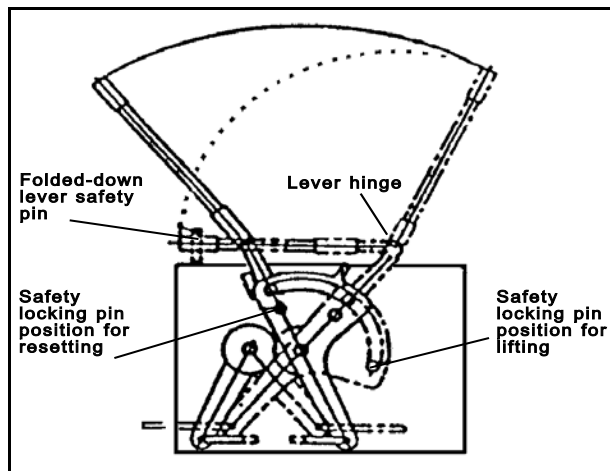
Single Point Hook Release Mechanism

The lifting hooks at the end of the lifeboat are fitted in brackets such that, when the hooks are unconstrained, the weight of the boat will cause the hooks to pivot open. Cams and pawls make up the locking mechanism that secures the hooks when in the lifting mode. The setting of the cams and pawls is controlled by bowden cables that lead to the release mechanism located alongside the engine casing, below the coxswain's seat. The actuating mechanism consists of a quadrant that pivots about its mid-length, pulling the bowden cables which, in turn, at bow and stern, retract a cam lever allowing the pawl piece to drop away from the hook. There are two holes in the quadrant into which a safety locking pin may be inserted to

lock the quadrant in either the lifting position or the position for resetting the lifting hooks. The quadrant is moved by a lever that extends above the cabin sole but which is hinged so that it may be folded down to the cabin sole when not in use. The safety locking pin that secures the quadrant in the lifting position has to be removed before the lever can be pulled to release the hooks; the long arm of the operating lever is held in the folded-down position by another safety pin.

The inner bowden cables are adjusted at the quadrant end by means of a left- and right-hand threaded rod connecting two yokes that link the inner cable and quadrant by way of clevis pins. The outer bowden cables can be adjusted by releasing its end clamps and moving the outer cable in the desired direction.

In the lifeboats on the “IOLCOS GRACE”, the release mechanism does not have a hydrostatic interlock for preventing premature release of the hooks, nor was there a requirement to have such a release. Later Shigi lifeboats have such an interlock, as required by SOLAS in 1994.

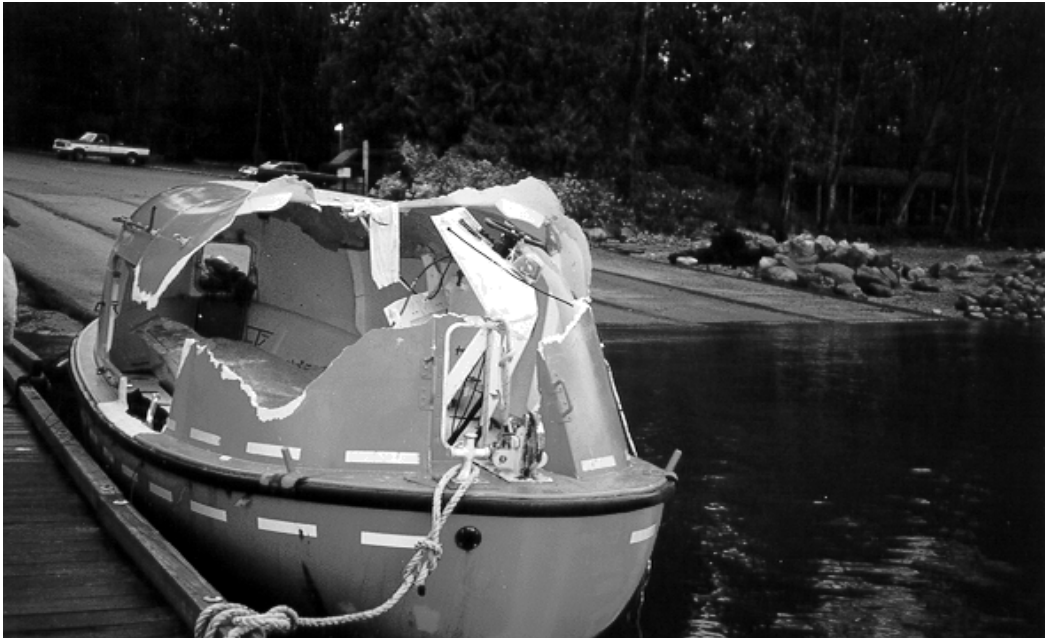
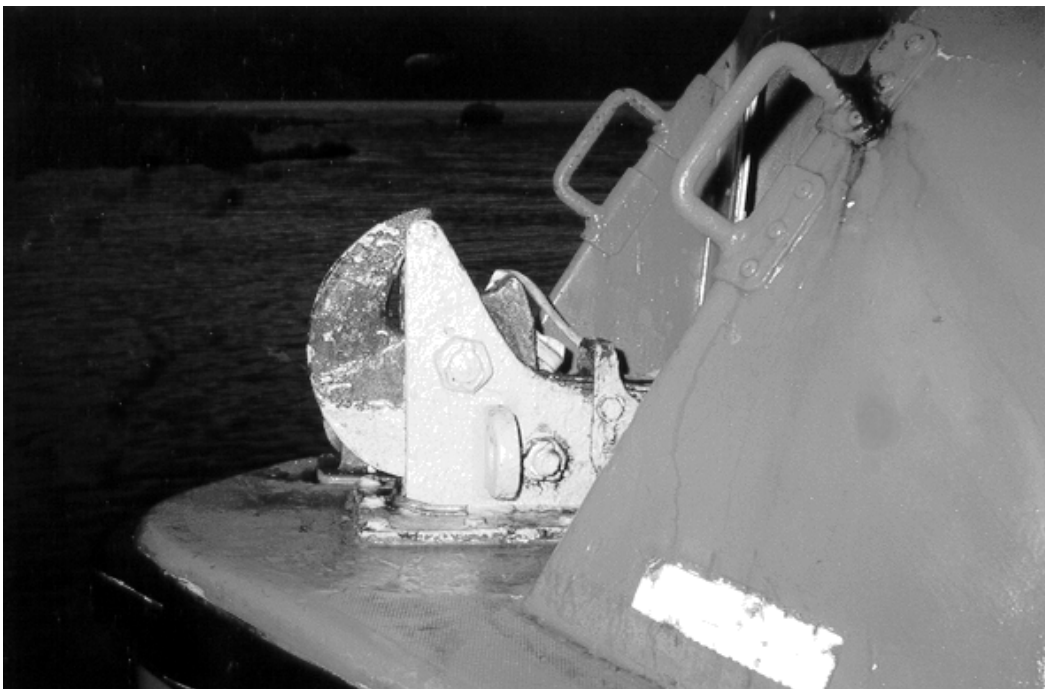
Appendix A - Photographs

An inspection of the port lifeboat was carried out two days after the occurrence, with the boat afloat. The hull was found to have been holed on the starboard side under the hook release quadrant. The hole had been made by the adjuster from the aft hook release cable that had tipped down into the hull. An examination of the under-deck hook securing mechanisms revealed that, with the forward cam lever in the position in which it was found, the pawl would only be partially engaged on the hook, while the after mechanism was found fully released with the adjuster on the inner end of the release cable down against the hull. The clevis pin connecting the forward cable adjuster to the quadrant under the floorboards did not have a split pin to secure it and prevent it from falling out. The forward hook had wear marks on only 25 percent of the pawl engagement area. Normally the pawl would engage for approximately 25 mm, but the marks indicated a long-term engagement of less than 6 mm at the tip. The after hook had no wear marks on the contact area and appeared to have had full contact on the pawl. The safety pin that should have secured the quadrant in the locked position was missing, while the pin that held the operating lever folded on the cabin sole was still securing that lever in its stowage bracket.

When the port boat was removed from the water it was found that the area in way of the hole in the hull had been recently repaired, as new paint had been applied. The master had discovered the hole two weeks before the occurrence and had directed the engineers to repair it. The repair method used was to sand off the outside of the boat hull and apply a patent plastic steel repair compound from the outside the hull. Neither the master nor the engineers repairing the hull looked inside the boat to find out what had caused the hole, they all assumed that it was made from the outside. The lifeboat manual supplied with the boat described and illustrated the correct method for repairing the glass-reinforced plastic boat hull. The correct method involves a full penetration patch repair that requires a backing support for the repair material being used. To effect a full penetration repair, the engineer would have had to have entered the boat and put a backing support inside the hull where the adjuster was found at the post-occurrence inspection.

3. The adjuster for the operating cable to the port boat after hook had pierced the hull below the quadrant when the cable deflected as a result of the hook being incorrectly reset. This had occurred some time earlier but had not been investigated by the crew.

1. The starboard lifeboat hook release mechanism was inspected by a Canadian Port State Control Officer and the "IOLCOS GRACE" detained pending repairs. Independent marine surveyors were hired to oversee the repairs done by shore-side contractors. The cable adjustments were reset to the correct settings and the cams and pawls checked for operation. After a demonstration of the operation of the release and resetting of the hook locking mechanism, the vessel was released by Port State Control. A liferaft, approved by the Flag State Inspector was substituted temporarily for the damaged lifeboat.
