RAILWAY INVESTIGATION REPORT
R02C0013

DERAILMENT

CANADIAN PACIFIC RAILWAY
FREIGHT TRAIN NO. 275-03
MILE 30.2, ALDERSYDE SUBDIVISION
CARMANGAY, ALBERTA
03 MARCH 2002

Report Number R02C0013

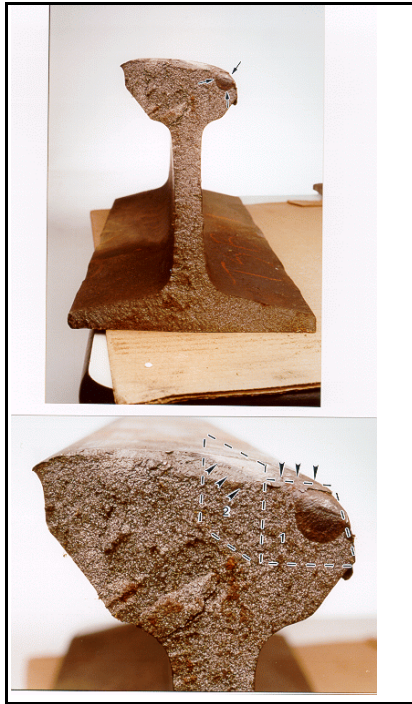
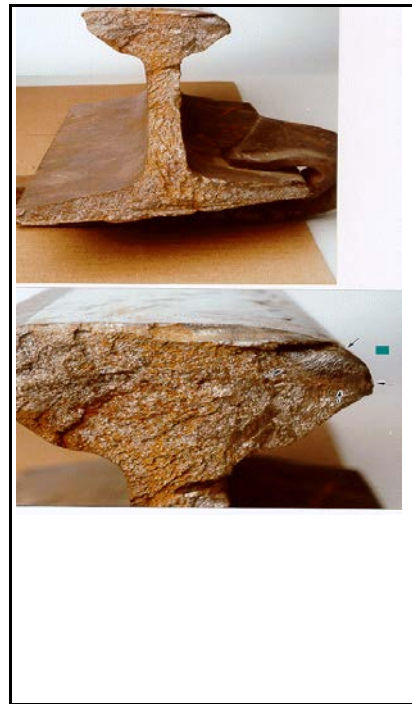
- Two of the rail pieces had fracture surfaces which contained progressive transverse defects on the gauge side of the rail, comprising approximately five and three per cent of the fractured surface area (see figures 2 and 3).
- Significant surface defects (surface cracking, material flow, shelling, flaking) were observed along the gauge side of the rail pieces.
- The transverse defects initiated from surface cracks (surface defects) on the gauge side of the rail. There were no impact marks.
- Wear measurements indicated that the rail was just within maximum allowable wear limits². The rail head had lost 26 per cent of its original surface.
- No material deficiencies which could have contributed to the failure of the rail were identified.

There was no indication from the examination of the train wheels that an excessive load impact had caused the rail failure to occur. In addition, there was no indication that a material defect had contributed to the failure of the rail. The transverse defects were initiated on the gauge side surface of the rail. When double-shoulder tie plates were installed, and the rail cant was reduced, the contact stresses from wheel loading shifted onto the gauge side of the rail, accelerating the propagation of surface cracks. Further development of the surface cracks, and the excessive rail head wear, reduced the ability of the rail section to resist crack growth. Subsequently, surface cracks formed subsurface cracks that turned downward and developed into two transverse defects. Rail failure occurred when these transverse defects reached a critical size.

6. The derailment occurred when the rail broke under the load of the train.
7. The rail failed when surface defects propagated to transverse defects and reached a critical size.
8. When double-shoulder tie plates were installed, the wheel contact stresses shifted onto the gauge side of the rail, accelerating the propagation of surface cracks.
9. Because there were no inspection criteria for surface defects, remedial grinding of the rail was not deemed necessary and consequently the surface defects were not corrected and developed into transverse defects.

Canadian Pacific initiated a switch-and-crossing grinding program in May 2002 and completed the grinding of all the main track switches on the Aldersyde Subdivision.
