RAILWAY INVESTIGATION REPORT
R04H0014

CROSSING COLLISION

CANADIAN PACIFIC RAILWAY
TRAIN NUMBER 120-03
MILE 51.05, OTTAWA VALLEY RAILWAY
CHALK RIVER SUBDIVISION
CASTLEFORD, ONTARIO
06 OCTOBER 2004

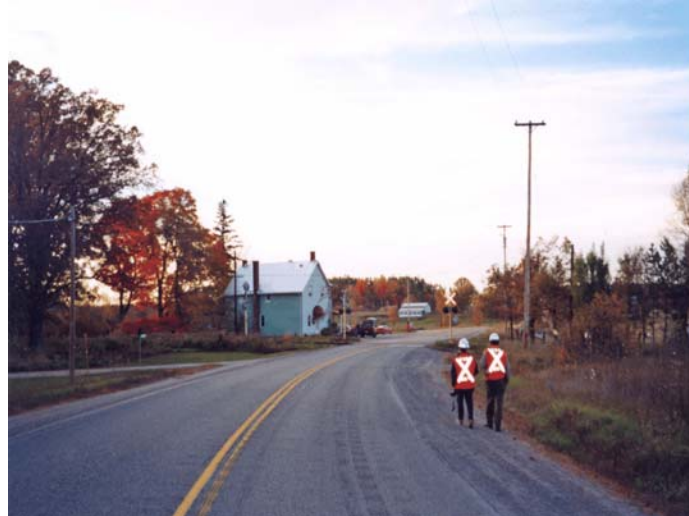
For northbound traffic on River Road, the view of the crossing signal warning lights was severely restricted by trees growing next to the highway on the highway right-of-way and on adjacent property, and by a right-hand horizontal curve. Because of the horizontal curve and its downward slope, the highway approaching the crossing is difficult to navigate at speeds higher than the speed limit. The 250 m radius curve met the province of Ontario's minimum geometric design standards for a highway design speed of 80 km/h. In Ontario, roadway design speeds are typically 20 km/h higher than the posted maximum operating speed.

Photo 1. Crossing approach from about 300 feet

It was determined that the distance at which the front crossing signal warning lights (right side) were focused and visible to the operator of an approaching vehicle was approximately 450 feet. A driver operating at the highway speed (80 km/h) would traverse the distance between the point at which the signal lights were visible (450 feet) and the actual crossing in 6.2 seconds. It was also determined that the mast and back signal warning lights (left side) were visible, but not conspicuous, from approximately 580 feet. A flashing light aspect was not visible from a range of 1000 feet because of a forested area on the inside of the curve approaching the crossing. The distance from the crossing at which an eastward train became visible from a northbound vehicle was 295 feet.
