**RAILWAY INVESTIGATION REPORT
R08W0058**

MAIN-TRACK COLLISION AND DERAILMENT

**CANADIAN PACIFIC RAILWAY
FREIGHT TRAINS 498, 497, AND 292
MILE 97.5, WEYBURN SUBDIVISION
CENTENNIAL STATION, NEAR RALPH, SASKATCHEWAN
07 APRIL 2008**

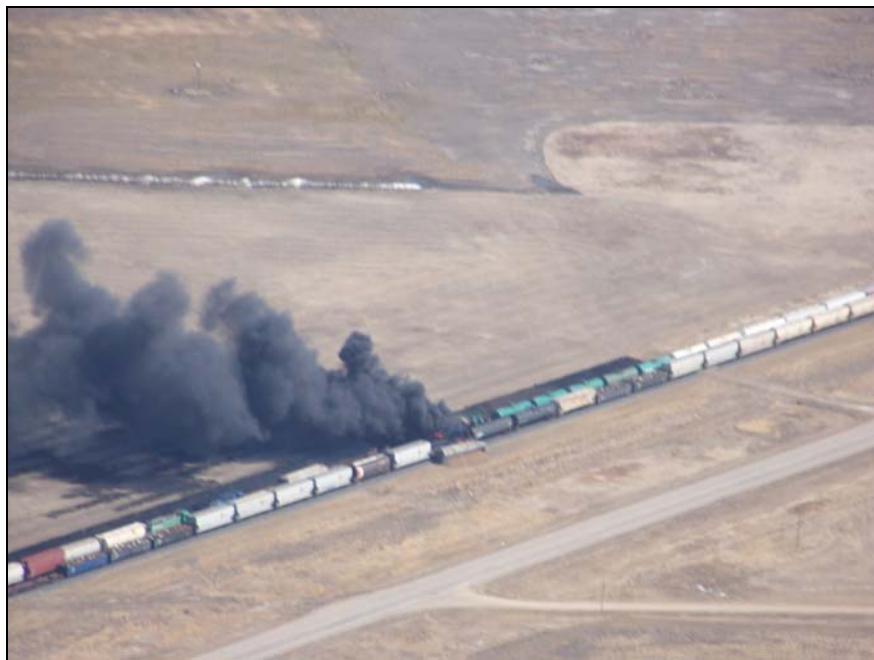
Subsequent to the derailment, the locomotive engineer from train 498 initiated an emergency call. As a result of the damage to the cars, a fire erupted at the tail end of train 292 (see Photo 1). Five cars were involved in the fire: two loaded tank cars containing glycol (UN 3082), a tank car containing vinyl acetate (UN 1301), a residue liquefied petroleum gas (UN 1075) tank car, and one bulkhead flat car. The crews on train 498 and train 497 evacuated from the immediate derailment area. There were no injuries to any of the crew members.

Photo 1. Resulting fire after collision (Source: CPR)
