Air Transportation Safety Investigation Report A18A0018

IN-FLIGHT ELECTRICAL ARCING

Porter Airlines Inc.
Bombardier DHC-8-402, C-GLQG
Fredericton, New Brunswick, 45 nm SW
10 March 2018

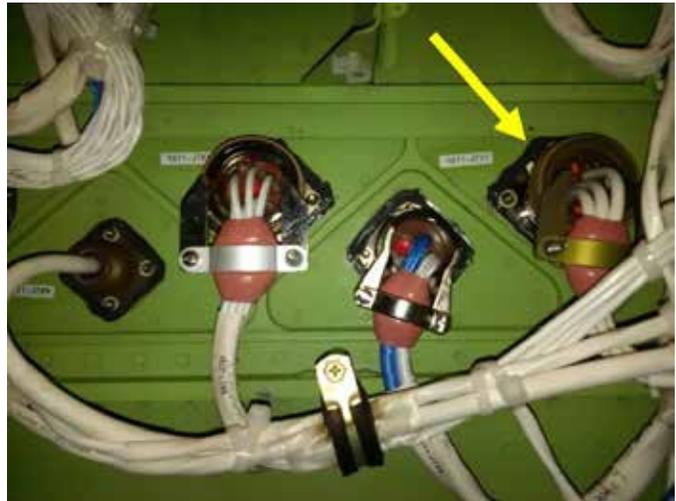
The 9811-J711 connector (part number MS3450L24-11S) is a bulkhead-mount-type electrical connector with a threaded coupling nut. The wires of the 9811-J711 connector are crimped into connector pins that are retained in the connector insulation insert using pin-locking mechanisms, and are secured in position by a strain relief clamp on its 90° backshell (Figure 1). The current carrying capacity of each of the 8-gauge sockets in connector 9811-J711 is rated at 46 A.

Figure 1. The 9811-J711 electrical connector, indicated by the arrow (Source: Bombardier Aerospace, with TSB annotations)

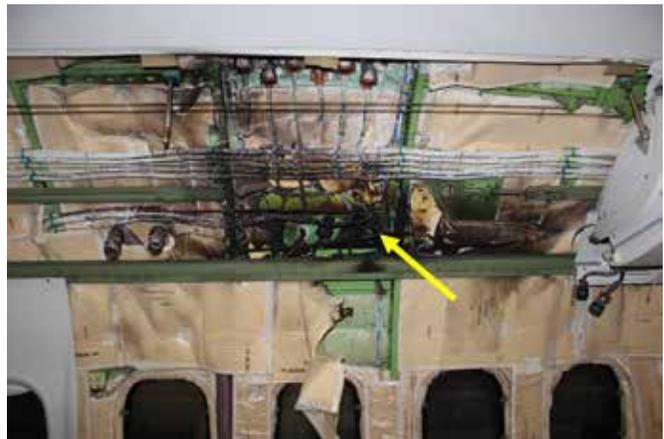
The electrical arcing that occurred before the 50 A thermal-type circuit breaker tripped caused minor pitting damage to adjacent wiring bundles, and heat damage and sooting to the insulation blankets and the structure of the outer panel of the overhead baggage compartment (Figure 2 and Figure 3).

Figure 2. Area of heat damage at row 14 of the occurrence aircraft, shown with left cabin wall upholstery removed (arrow indicates electrical connector 9811-J711)

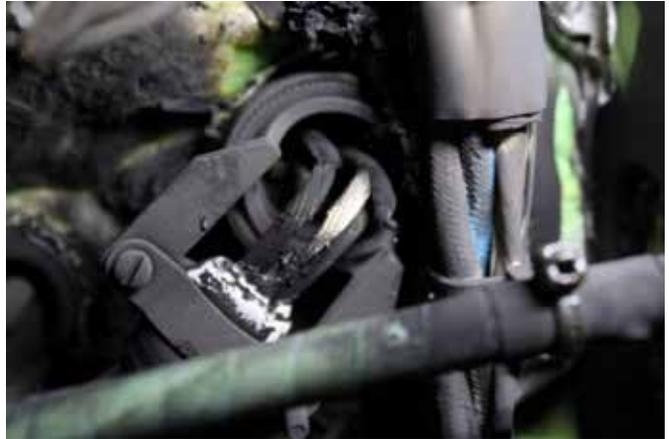
The 50 A thermal-type circuit breaker in the left engine nacelle AC control box was found to have tripped. The source of the smoke and heat damage was determined to be arcing from the 9811-J711 electrical connector plug assembly in the fuselage at the left-wing-root area. The arcing damage of the electrical connector is consistent with an electrical short circuit within the connector. Because of the destructive nature of this arcing, the connector pin-locking mechanisms and insulation insert material were obliterated, and the source of the electrical short could not be identified.

The TSB Engineering Laboratory performed a computerized tomography (CT) scan of the occurrence electrical connector, then generated 3-dimensional models of the connector superimposed on wiring to represent the manufacturer-specified minimum and the maximum wiring bend radius between the pin-locking mechanisms and the strain relief clamp. The 3-dimensional models were compared to occurrence images, and it was determined that the wiring alignment was correct and that the actual bend radius of the wiring was within manufacturer specifications.

Figure 3. Electrical connector 9811-J711 on the occurrence aircraft

Following this occurrence, Porter Airlines began a campaign to carry out the inspections and repairs specified in Service Letter DH8-400-SL-24-016 at a rate of 2 aircraft per month until the entire fleet has been completed.
