AVIATION OCCURRENCE REPORT

A99A0046

INJURIES TO PERSON WHILE DEPLANING

BOEING 767-200, C-FBEM

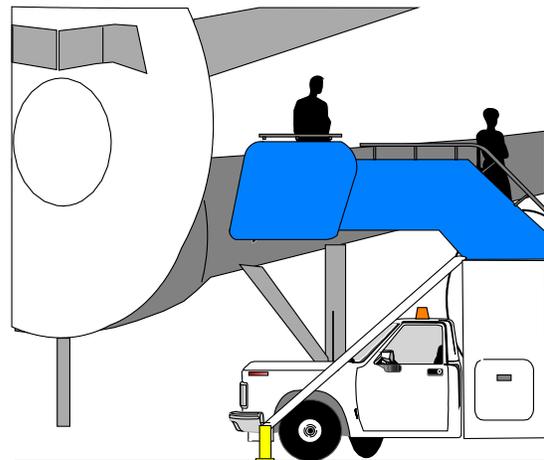
Air Canada Flight 861 arrived in St. John's, Newfoundland, from London, England. As there is no direct access to the customs area from the company passenger bridge at the St. John's Airport, the aircraft was marshalled to a gate on the open ramp. A passenger stand was positioned at door L1 of the aircraft and two employees ascended the stairs to open the aircraft door and position the side gates. After approximately 10 to 12 passengers had exited the aircraft, a flight attendant carrying an infant in a car seat deplaned. When the flight attendant stepped on the passenger stand, he noticed that it was descending slowly away from the aircraft. He turned to tell the in-charge flight attendant, but at the same time as he turned, the infant's five-year old brother, who was following with his mother, stepped out and fell between the aircraft and stairs to the apron below. The child suffered a broken arm and lacerations to the head in the fall and was taken to the hospital for treatment and observation.

The passenger stand (Trailbec BMH series unit No.15) used for the deplaning of Air Canada Flight 861 is designed for use on various aircraft of different door sill heights. The stair height is adjusted by means of a moveable upper stair portion which is raised and lowered by an hydraulic cylinder. The upper stair portion is held in the raised position by a mechanical pawl and dog locking system. This pawl is normally held in the engaged (locked) position by a spring and it is disengaged by an electric solenoid which functions in opposition to the spring. The solenoid is energized by a “deadman”

Several tests were carried out on the locking mechanism after the accident. In about half of these tests, the pawls failed to engage or only partially engaged. In tests where the pawl partially engaged the dog, the upper stair remained in place for a short period, then, as the pawl slipped off the dog, the stair descended. In tests where the pawl failed to engage the dog, the stairs began to descend immediately.

The locking mechanism was not functioning properly, and as a consequence, disengaged allowing the upper stairs to descend away from the aircraft. Contributing to the occurrence were the failure to follow the GSE maintenance schedule and the absence of a requirement to visually inspect the locking mechanism of the passenger stand before use.
