## **AVIATION OCCURRENCE REPORT**

**A99A0046**

### **INJURIES TO PERSON WHILE DEPLANING**

**BOEING 767-200, C-FBEM**

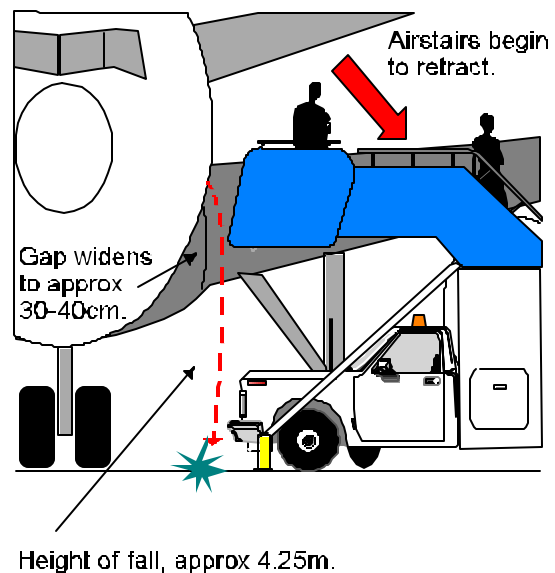
The passenger stand (Trailbec BMH series unit No.15) used for the deplaning of Air Canada Flight 861 is designed for use on various aircraft of different door sill heights. The stair height is adjusted by means of a moveable upper stair portion which is raised and lowered by an hydraulic cylinder. The upper stair portion is held in the raised position by a mechanical pawl and dog locking system. This pawl is normally held in the engaged (locked) position by a spring and it is disengaged by an electric solenoid which functions in opposition to the spring. The solenoid is energized by a “deadman”

(spring- loaded to the off position) button in the cab of the vehicle. The stair is raised a half step above the desired height and then lowered against the stop.

Several tests were carried out on the locking mechanism after the accident. In about half of these tests, the pawls failed to engage or only partially engaged. In tests where the pawl partially engaged the dog, the upper stair remained in place for a short period, then, as the pawl slipped off the dog, the stair descended. In tests where the pawl failed to engage the dog, the stairs began to descend immediately.

Visual verification that the locking mechanism was fully engaged was hampered by the pawl, the dog, and the background being painted a uniform dark green and by the fact that, on this
