Transportation Safety Board
of Canada

**AVIATION INVESTIGATION REPORT
A06P0224**

LOSS OF VISUAL REFERENCE - COLLISION WITH TERRAIN

**VIH HELICOPTERS LTD.
BELL 206B (HELICOPTER) C-GWUF
KNIGHT INLET, BRITISH COLUMBIA
25 OCTOBER 2006**

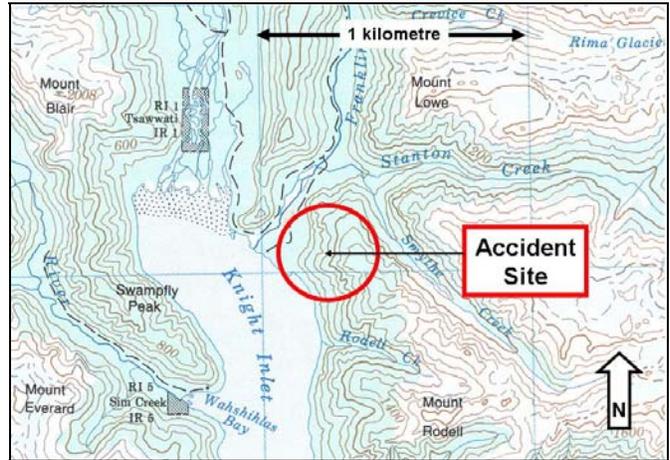
Figure 2. Close-up of accident site

The landing site was a terraced ledge, about 40 feet wide, in a steep gorge on the west face of the mountain, and adjacent to a rapidly flowing waterfall. The site was surrounded by tall trees and almost-vertical rock faces, and the landing surface consisted mainly of loose rock and forest debris, constantly wet from the waterfall flow. The distance from the touchdown point to the waterfall rock face was about 50 feet, and the helicopter ended up about 20 feet away from the waterfall (see Photo 1).
