AVIATION INVESTIGATION REPORT

A09Q0210

DECREASE IN ROTOR SPEED FOLLOWED BY COLLISION WITH TERRAIN

**ROBINSON R44 II (HELICOPTER) C-GDSF
MONTRÉAL, QUEBEC
16 DECEMBER 2009**

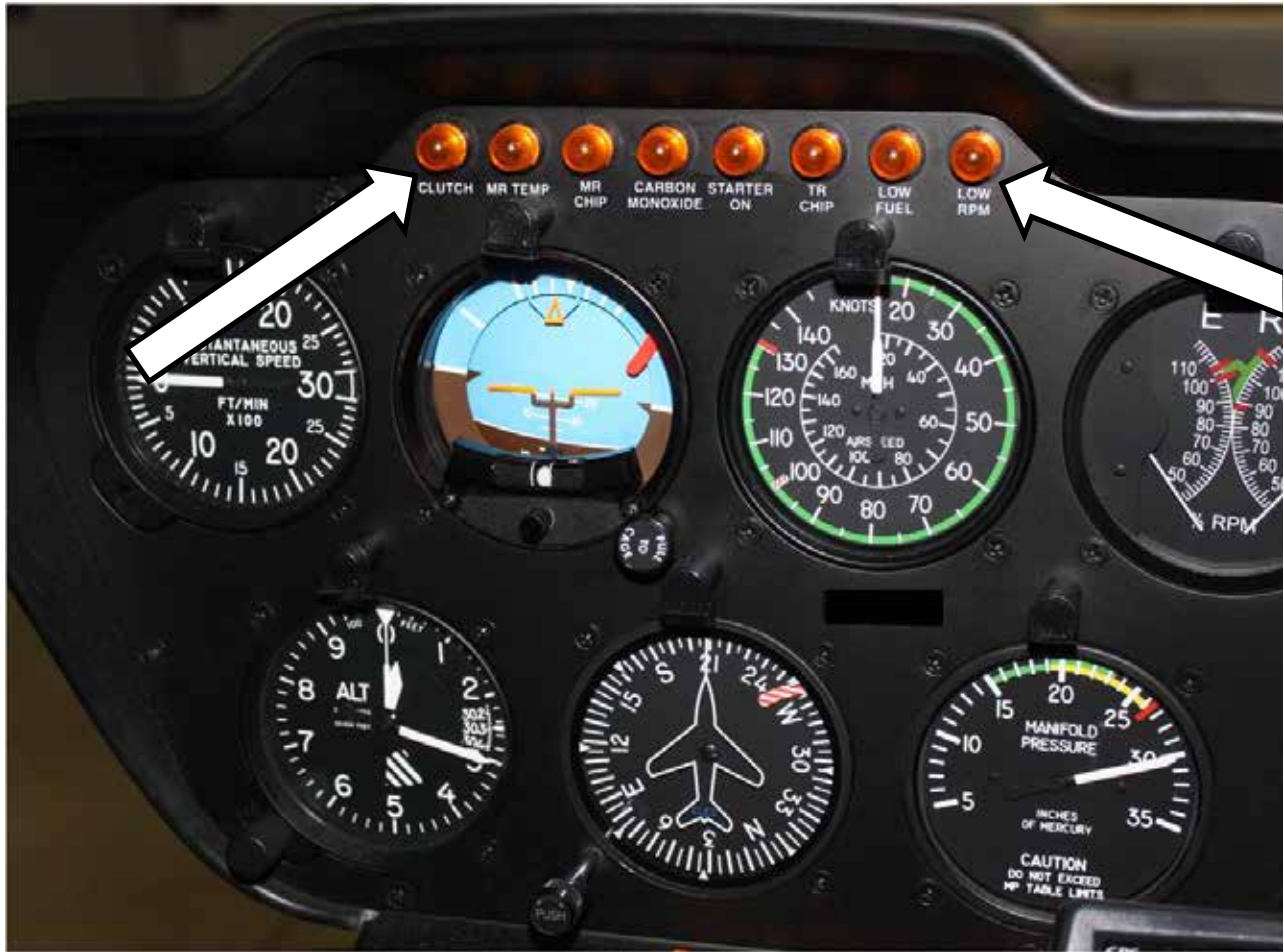
Photo 2. Instrument panel of a typical R44

The Robinson R44 has a single warning horn that activates when the rotor RPM is low. The warning horn sounds and a LOW RPM amber caution light (see Photo 2) is illuminated to indicate that rotor RPM has fallen below the established 97% safe limit. The horn stops and the amber caution light is extinguished when:

During the pre-flight checks on the morning of the occurrence, the warning horn and light were working normally.
