**AVIATION INVESTIGATION REPORT
A11C0047**

DOUBLE ENGINE POWER LOSS AND FORCED LANDING

**FUGRO AVIATION CANADA LIMITED
CASA C-212-CC40, C-FDKM
SASKATOON, SASKATCHEWAN
01 APRIL 2011**

Report Number A11C0047

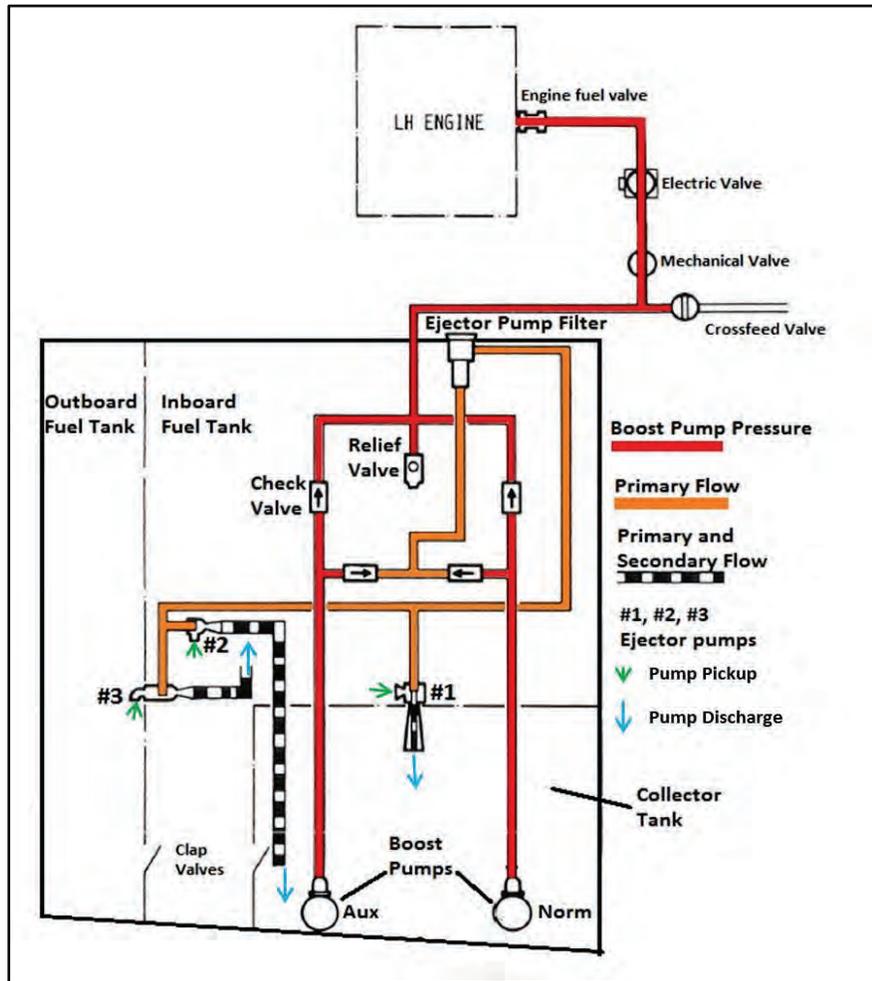
The left and right wing fuel systems are identical but independent. A crossfeed line with a mechanical valve controlled from the cockpit permits fuel from either wing to be supplied to the engine on the opposite wing (Figure 1). Throughout the flight, the fuel crossfeed valve remained closed. Normal operating procedures and the engine failure in flight procedure (Appendix B) did not require it to be opened.

Figure 1. Simplified schematic of the left wing fuel system (source: CASA C-212-200 Maintenance Manual, chapter 28-20-10, p. 20)
