**AVIATION INVESTIGATION REPORT
A11W0144**

LOSS OF CONTROL AND COLLISION WITH BUILDING

**ARCTIC SUNWEST CHARTERS
DE HAVILLAND DHC-6-300 TWIN OTTER, C-GARW
YELLOWKNIFE, NORTHWEST TERRITORIES
22 SEPTEMBER 2011**

Report Number A11W0144

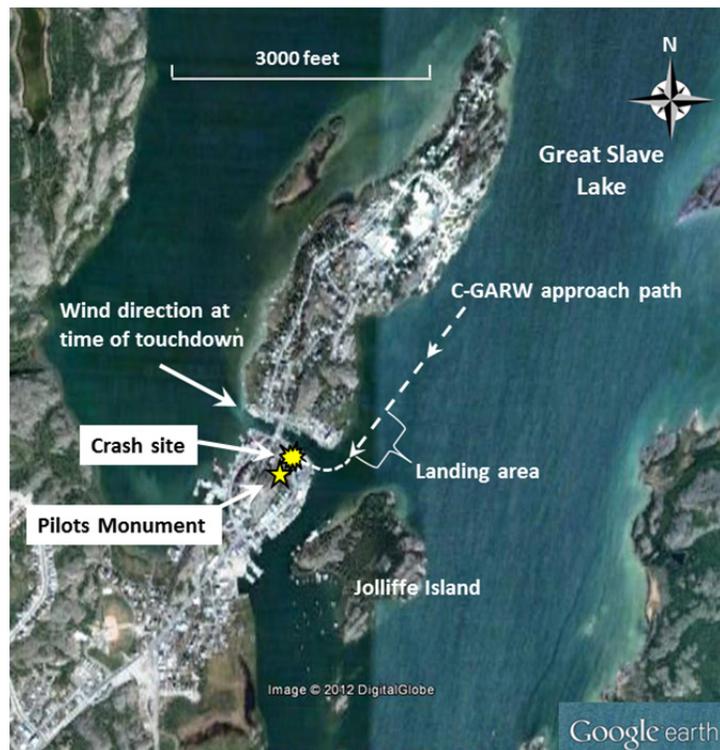
Figure 1. Yellowknife float-plane base

Due to the 2- to 3-foot waves (rollers) on the lake, the crew planned their approach so as to land close to the shore and to avoid entering the passage between the shore and Jolliffe Island (Figure 1). The captain also advised that the airspeed should be kept above 80 knots indicated airspeed (KIAS), which is 10 KIAS above the normal approach speed of 70 KIAS, for the full-flap (37.5°) approach and landing. During the approach, the captain cautioned the FO twice about the airspeed getting too low. The aircraft touched down in the intended landing area and bounced, then contacted the water a second time with the right float first. The float dug in, and the aircraft yawed to the right, turning towards the shore. The stall warning sounded for about 0.3 seconds.
