## **AVIATION INVESTIGATION REPORT A12P0134**

### **ENGINE POWER LOSS AND DITCHING**

**HELIJET INTERNATIONAL INC.  
SIKORSKY S-76A (HELICOPTER), C-GHJT  
LANGARA ISLAND, BRITISH COLUMBIA  
13 AUGUST 2012**

Report Number A12P0134

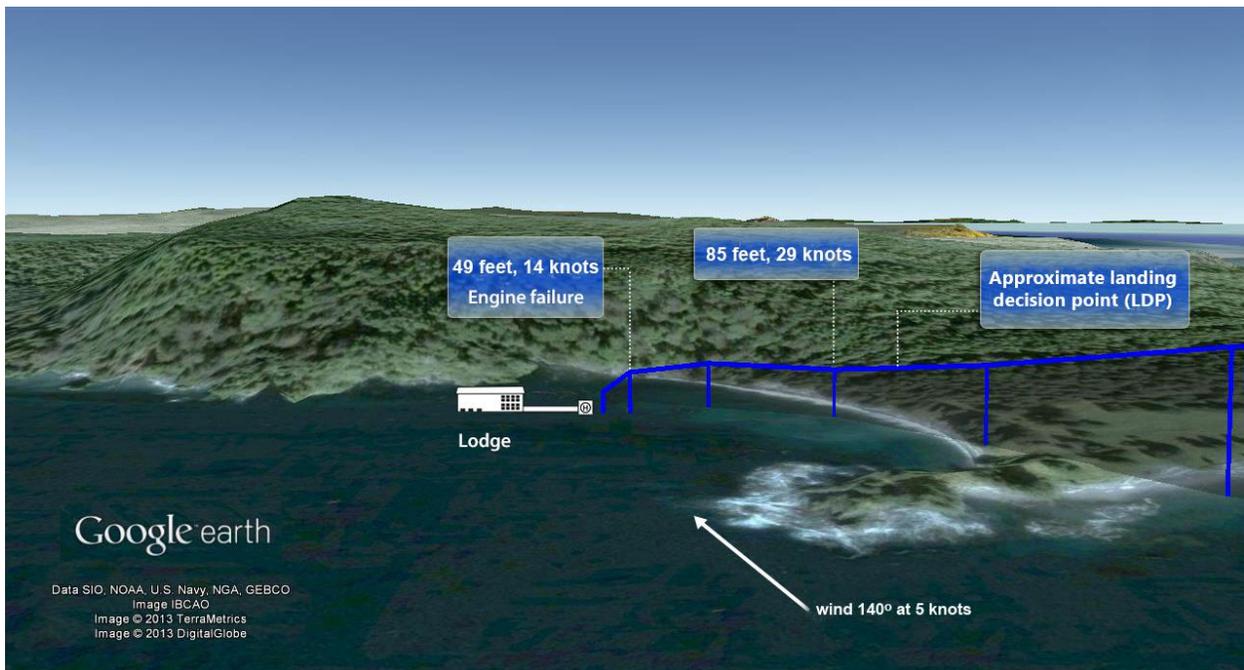
At the time of the power loss, the helicopter was about 75 feet away from the helipad and 49 feet above the water, with an indicated airspeed of about 14 knots. The pilot was in the process of beeping up <sup>2</sup> the No. 1 engine to match the torques, as the No. 2 engine torque was indicating 95% and the No. 1 engine torque was between 80 and 85%. In response to the power loss, the pilot pulled up on the collective to decrease the rate of descent and pitched the nose down in an attempt to land on the helipad. It became apparent that the helicopter could not be landed safely on the small floating helipad. Therefore, the pilot stopped the forward flight of the helicopter and ditched in the water beside the helipad with the emergency floats deployed (Figure 1).

**Figure 1.** Final flight path of the helicopter relative to the fishing lodge and floating helipad

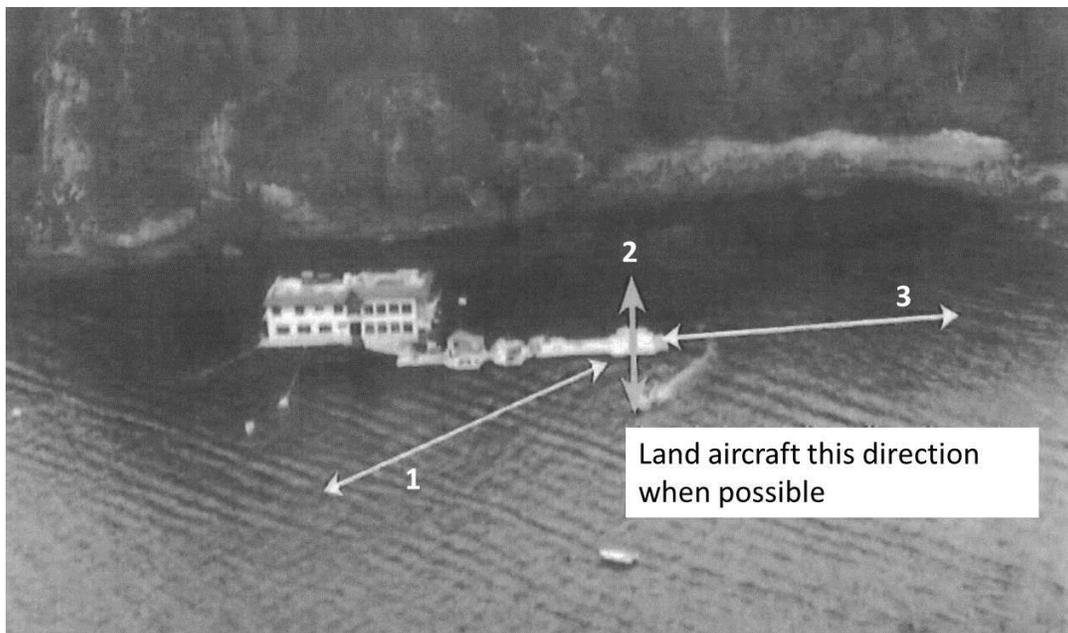
**Figure 2.** Company approach chart for the fishing lodge
